Summary of Intersection Evaluation MD 4 at Briscoes Turn Road/Skinners Turn Road

March 2008

MD 4 and Briscoes Turn Road/Skinners Turn Road

Calvert County

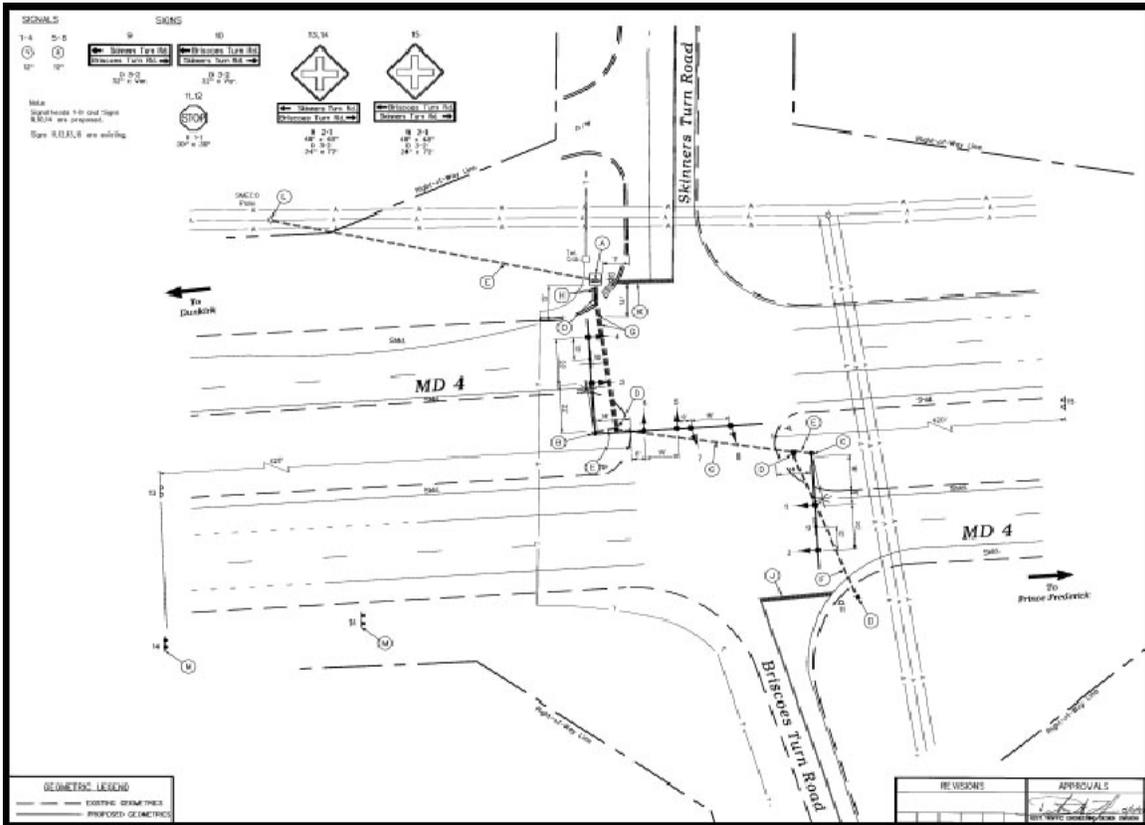
Figure 2: Existing MD 4 and Briscoes Turn Road/Skinners Turn Road

Currently the intersection is controlled with an Intersection Control Beacon (ICB). It includes flashing yellow lights along MD 4 and flashing red lights along the side street approaches, supplemented with standard Stop signs. In addition, there are advanced intersection warning signs along northbound and southbound MD 4 including street name panels. *Figure 2: Existing MD 4 and Briscoes Turn Road/Skinners Turn Road* shows a detailed sketch of the existing intersection.

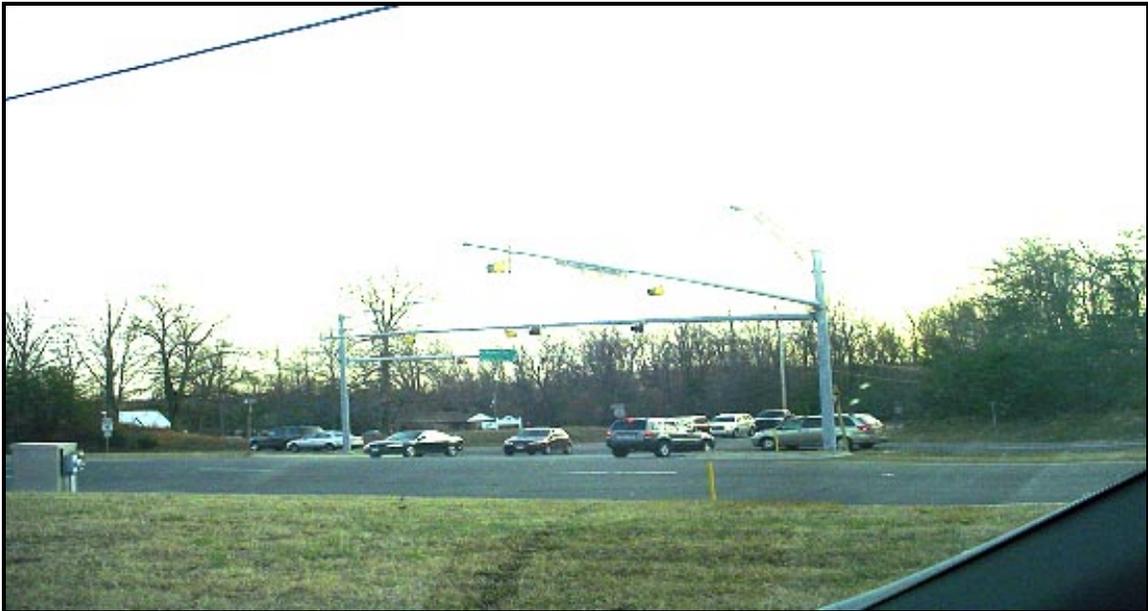
Observed vehicle queues along Skinners Turn Road were infrequent and were associated with minimal delay and thus cleared quickly, whereas queues along Briscoes Turn Road approach reached up to six vehicles with delays nearing sixty seconds. This delay resulted in some vehicles choosing relatively small gaps in southbound MD 4 traffic to access the median. Multiple vehicles from the Briscoes Turn approach were observed in the median area at the same time along with vehicles from the remaining approaches which appeared to result in driver confusion at times. *Refer to Photo A: Median Operation.* In the photo, there is a queue of vehicles waiting (on the far side of the intersection) along Briscoes Turn Road. The photo shows two of these vehicles in the median along with an SUV from the Skinners Turn Road side. In addition, a minivan along southbound MD 4 is waiting to turn left onto Skinners Turn Road. Please note that, in this case, the minivan actually has the right-of-way because mainline vehicles have the right-of-way over side street vehicles.

Photo A: Median Operation

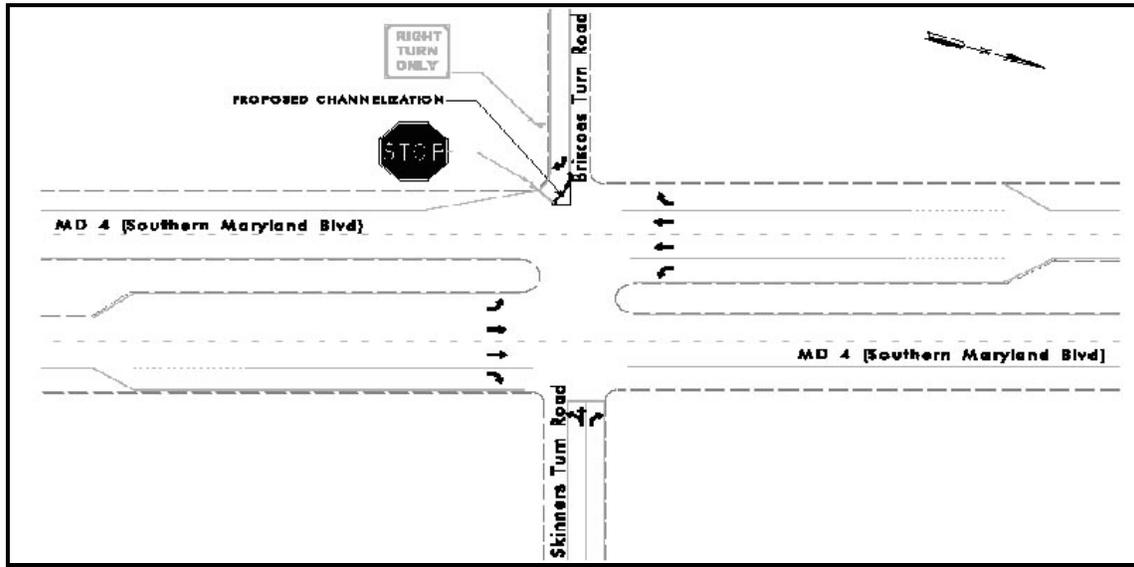
Figure 3: Proposed Briscoes Turn Road Channelization

- Delay as a result of queuing along the Briscoes Turn Road approach during peak hours.
- Multiple vehicles queuing in the median resulting in driver confusion.
- A pattern of incidents associated with Briscoes Turn Road.

As a result of the above, it is determined that the appropriate measure to address the primary operational issues is to restrict the left turn and through movements from the Briscoes Turn Road approach thereby allowing for right turns only. *Refer to Figure 3: Proposed Briscoes Turn Road Channelization.*
