**MARYLAND DEPARTMENT OF TRANSPORTATION
STATE HIGHWAY ADMINISTRATION**

RESEARCH REPORT

**Evaluating the Success of Meeting Design Objectives on
Previously Constructed OOS Stream Stability Projects**

August 2018

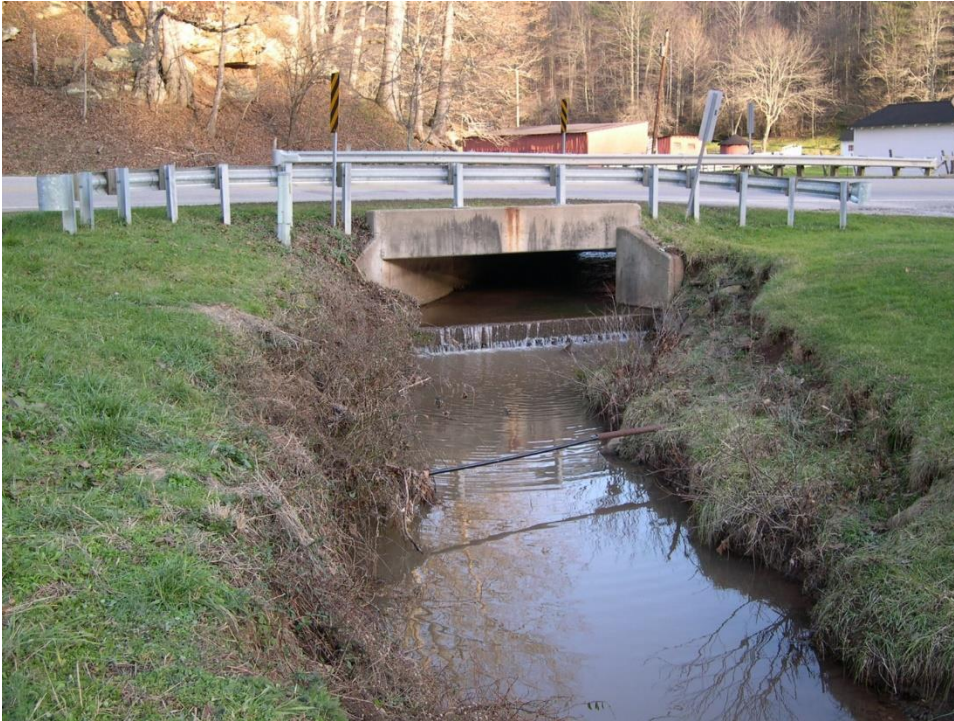
Figure 3. Stream channel degradation. U.S. Rt. 199 N, 0.8 km S of Gandeville, WV.

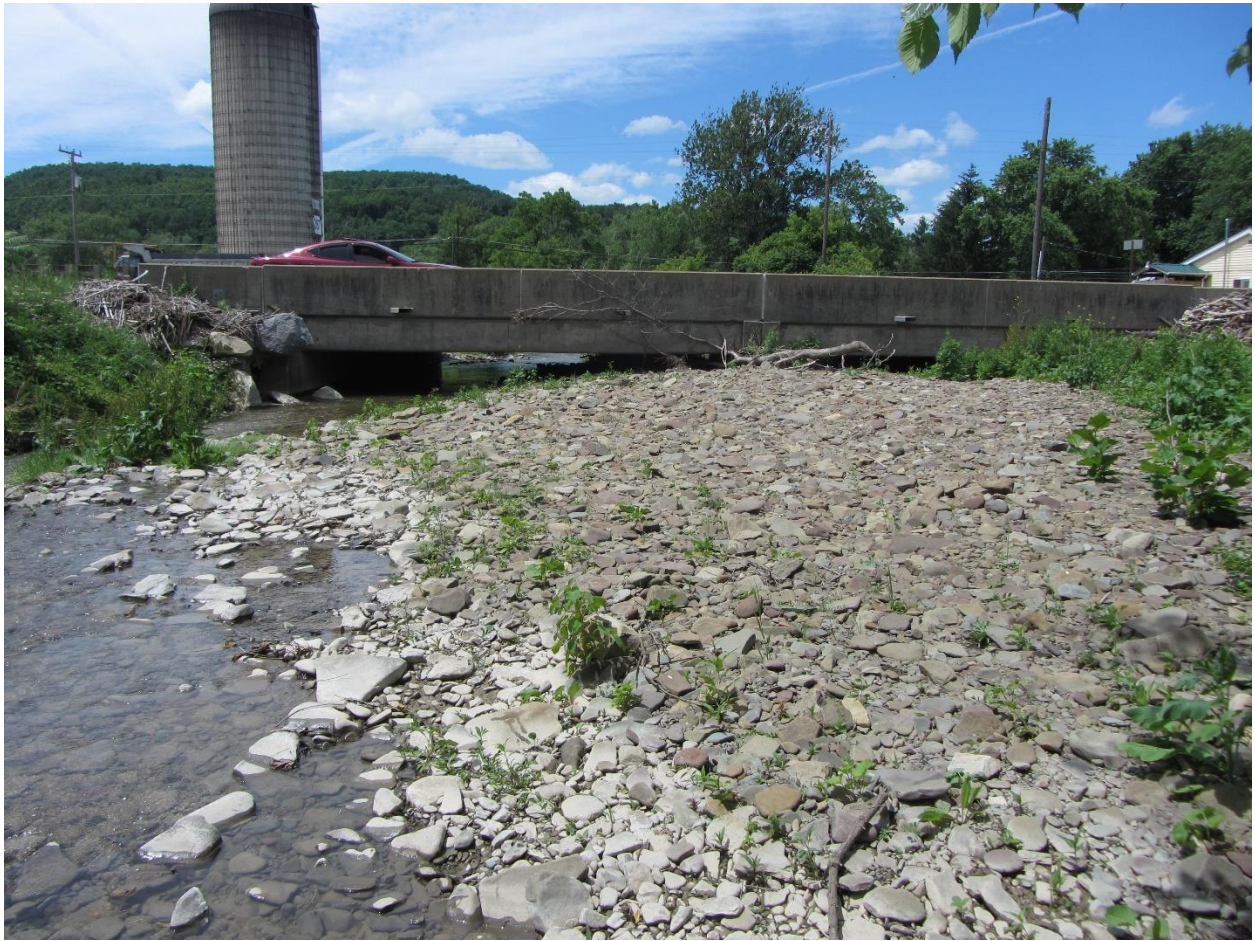
Figure 6. Severe sediment deposition at PA 287 over Mitchell Creek, north of Tioga, PA.

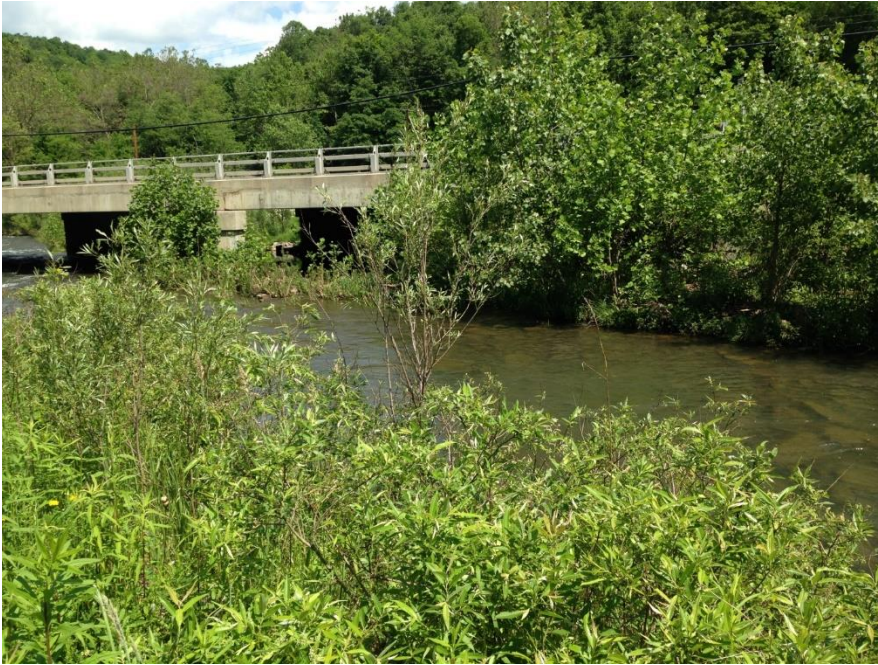
The site modifications included excavation of the floodplain on the left upstream bank and instream structures. Channel structures begin upstream with a cross vane, followed by three J-hook vanes, a series of three cross vanes, the bridge, and a downstream cross vane. The cross vanes are intended to control the grade and degradation through the reach. The J-hook vanes are intended for bank stability. Several of the J-hook vanes have rock that is fracturing and deteriorating. There is considerable deposition and vegetative growth upstream of the right span of the bridge (Figure 9). Data taken from the USGS gage 01653600 Piscataway Creek at Piscataway MD shows that this watershed experienced a 10-year, 20-year, and a 33-year return period storm since the reconstruction of this bridge in 2005. During site visits, widespread degradation and entrenchment were observed throughout the rest of the watershed, as were localized areas of deposition of large rocks.

MD 36 over Georges Creek is relatively undamaged, receiving ratings of none except for two ratings of moderate for Instream Countermeasures, and Sediment and Woody Debris Aggradation. The upstream J-Hook vanes were constructed of lower quality rock that flaked; however, that has had no noticeable effect on the project as a whole. There is sediment deposition and woody vegetation growth in one span of the bridge. Also noteworthy is the damage rating of none for Degradation. During site visits, widespread degradation and

entrenchment were observed throughout the rest of the watershed and localized areas of deposition of large rocks.

Figure 9. MD 36 over Georges Creek standing upstream on lowered flood plain showing aggradation and woody vegetation accumulating in right span.

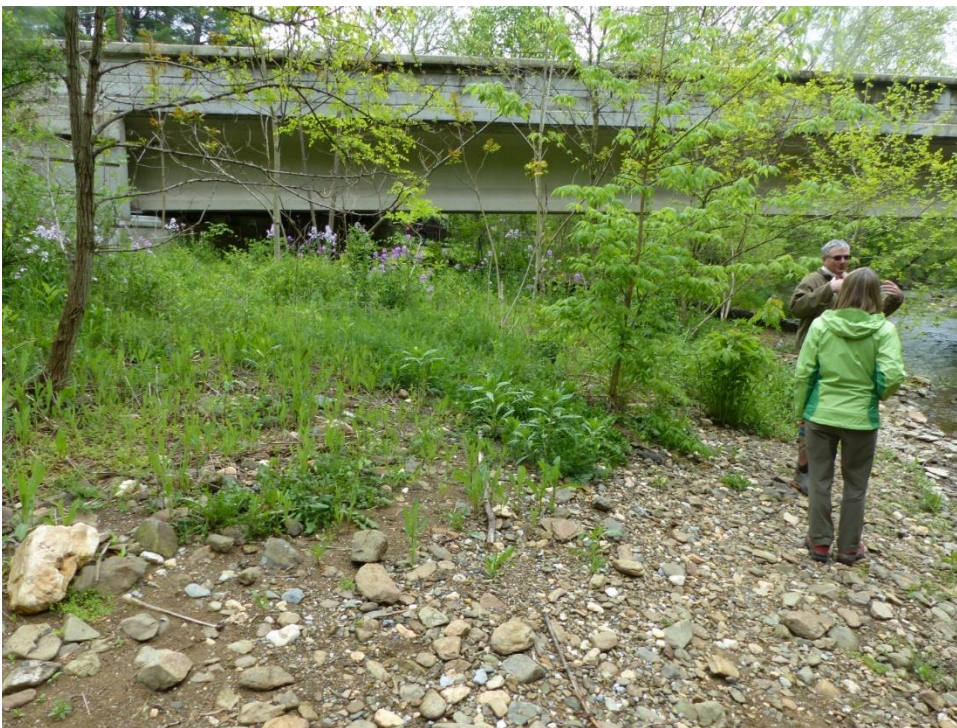
At high flows, the left floodplain, which is now a substantial bar, overtops, directing the flow toward the right abutment. The deposition of the bar may have been exacerbated by the sloped left abutment. Riprap at the downstream end of the right abutment is beginning to fail. A series of three vanes were constructed upstream to redirect flow away from the steep right bank and right abutment. A cross vane was also used downstream of the project to prevent head cuts from migrating up from the downstream gravel quarry. During a site visit on May 17, 2016, aggradation of the left bank under the bridge and undermining of the riprap stabilization on the downstream right bank were observed (Figures 10 and 11). During the site visit in February, 2017, a sediment sample was collected from the large bar that has developed within the project reach (see appendices). The outside bank upstream is experiencing erosion upstream of the rock vanes, and the inside bend has had extensive deposition. The lateral bar has pushed the channel against the bridge riprap on the opposite bank and eroded some of the riprap from the toe of the abutments. The bridge is still protected from lateral migration by riprap, geotextile, and the old crossing foundations. However, the riprap erosion will require maintenance. Due to the extent and depth of the lateral bar, the conveyance of the bridge is likely reduced from the design.

Figure 10. MD 17 over Middle Creek standing upstream looking downstream showing aggradation occurring on left bank.

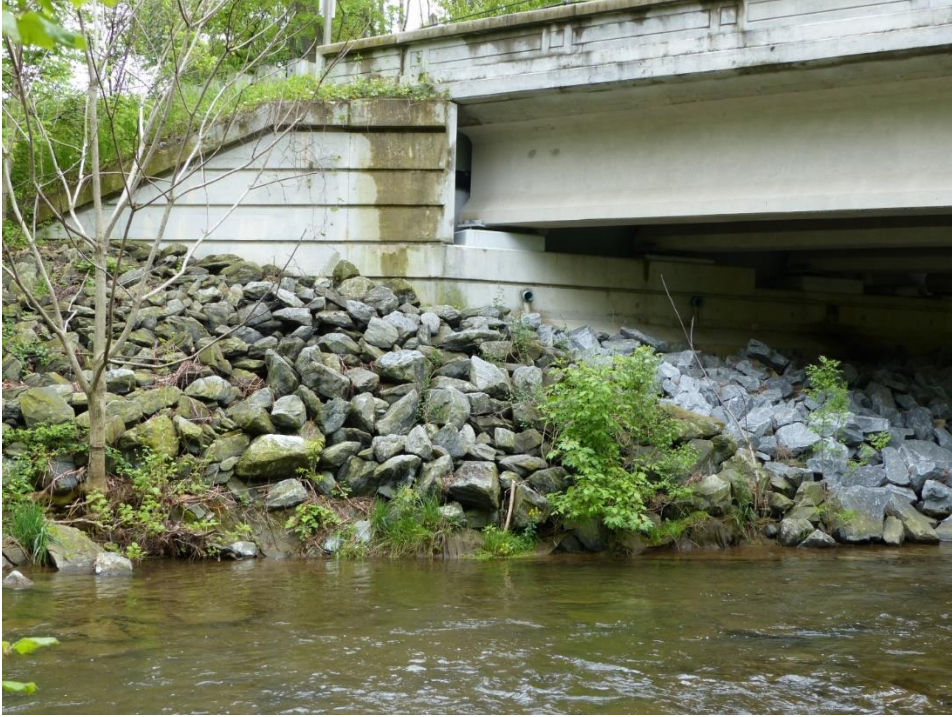
Figure 11. MD 17 over Middle Creek. Undermining of Riprap on downstream right bank.

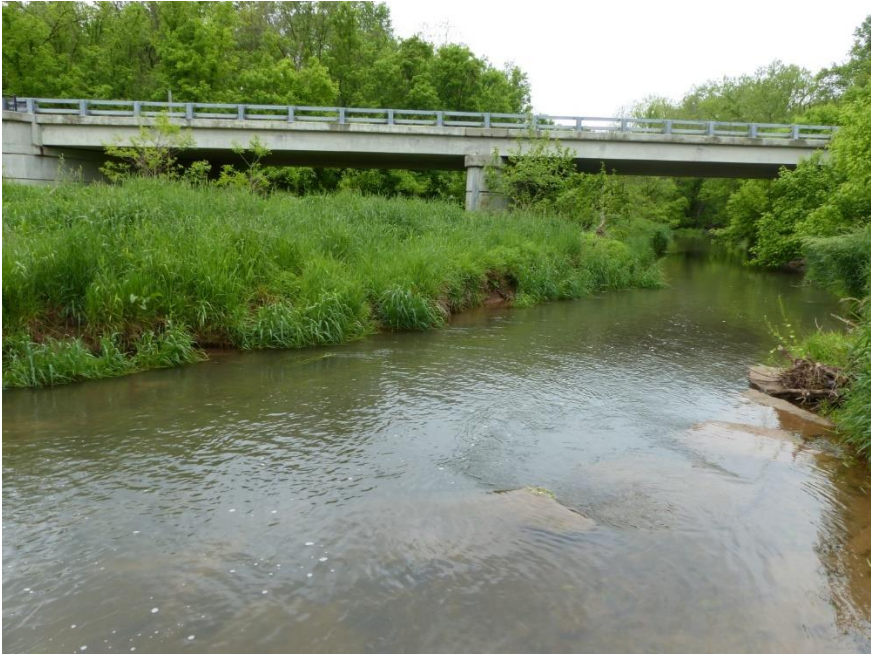
Aggradation of the excavated floodplain was observed during a site visit on May 17, 2016 (see Figure 12). Judging from observations made during site visits, the floodplain elevation has increased due to deposition by approximately 1-2 ft. Also, the downstream cross vane is buried under sediment; however, burial does not affect the vanes ability to prevent upstream head cut migration. The right span is well aligned with the low flow channel.

Figure 12. MD 28 standing upstream showing aggradation in left span and rock vane in bottom right of picture.

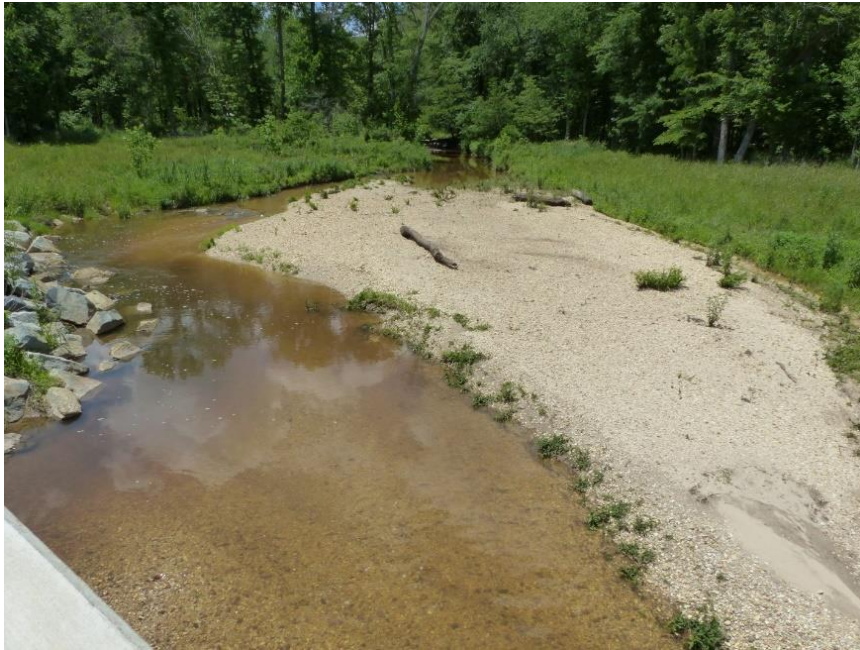
Figure 13a. Bar upstream of the bridge.

The MD 223 crossing over Piscataway Creek was replaced in 2012 due to frequent flooding of the roadway. The previous crossing was composed of four adjacent 2.97 meter x 2.01 meter (9.58 feet x 6.58 feet) corrugated metal arch pipes, each 55 feet in length. This configuration created a backwater condition upstream of the culverts that contributed to aggradation and flooding issues at the crossing. The replacement bridge was a single span slab bridge, 16.76 meters (55 feet) in length. For the new bridge, the primary practices used for the stream channel transition were lowering of the floodplain and clearing of debris. Although the new bridge realigned the channel and bridge opening, the bridge is still on the outside of a large meander; thus, deposition of sediment upstream of and within the bridge opening is a chronic problem, as shown in Figure 13. The upstream bar redirects the low flow such that the angle of approach to the bridge opening during low flow is increased and flow within the bridge opening is directed against the left abutment. At high flows the stream likely overtops these bars and approaches the bridge at a lesser angle. The opening beneath the bridge appears to be acting as a sediment trap. However, the observed bar downstream of the bridge opening indicates that at least a portion of the sediment is moving through the opening to the downstream channel.

Figure 13. MD 223 over Piscataway Creek.

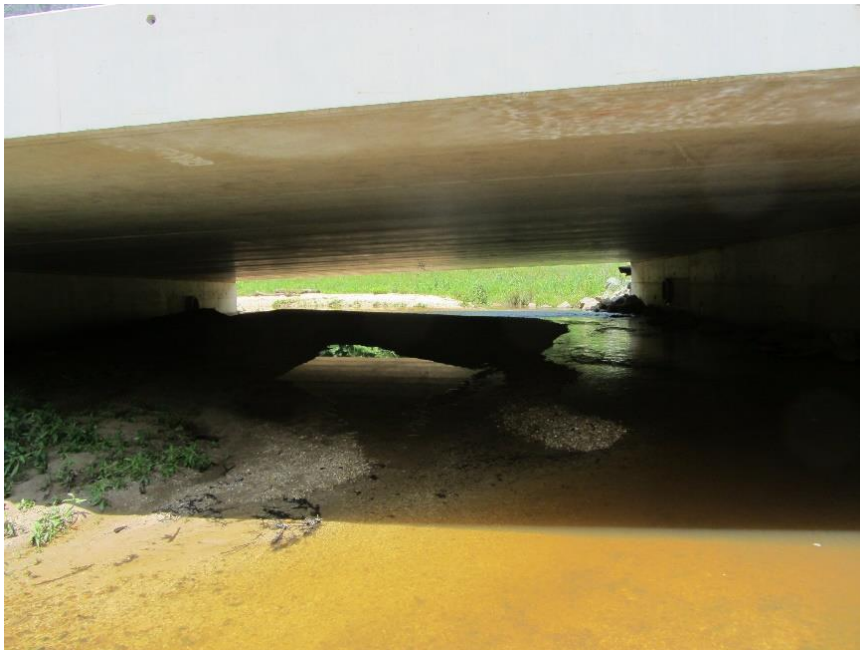
Figure 13b. Looking upstream under the bridge. Note the deposition in the left of the picture.

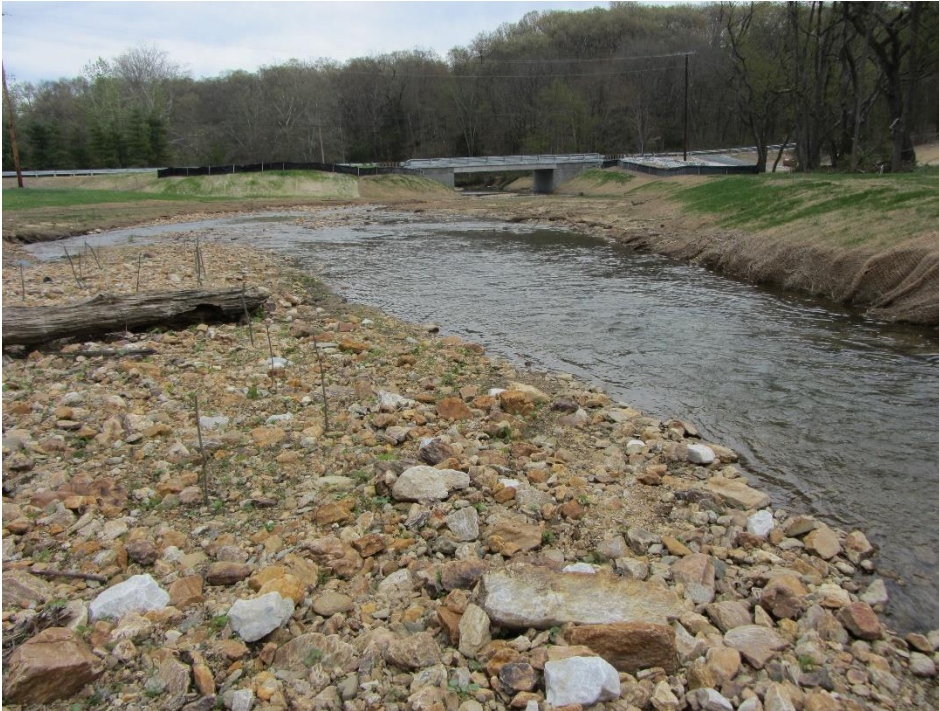
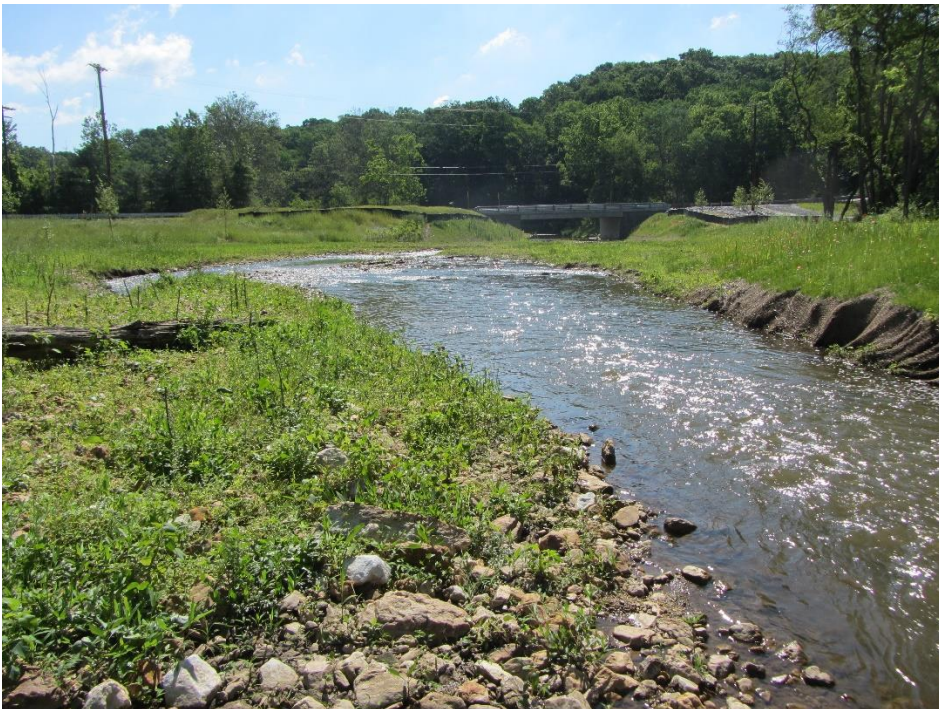
The MD 25 crossing over Georges Run was replaced in early 2016. Stream alterations made during reconstruction included excavation of the upstream floodplain, construction of upstream guide banks, excavation of a scour hole under the bridge (see Figure 14), and excavation of a forked channel downstream (see Figure 15). The excavation of the left floodplain was intended to provide storage for sediment. Sediment deposition in this newly excavated area was observed during visits in April and again in June, 2016. A large gravel bar extends downstream toward the bridge from the left guide bank. Debris accumulation in the upstream Peggy's Run may help to slow the downstream migration of sediment in the future. The forked channel created downstream of the bridge opening was intended to provide relief for high flows so that high stresses against the right bank are lowered. Cross vanes upstream of the bridge were observed to be partially buried during a site visit on June 6, 2016.

Figure 14. Looking downstream at MD 25 at excavated floodplain on the left, guidebank further downstream on the left at the bridge. Note sediment deposition on the left.

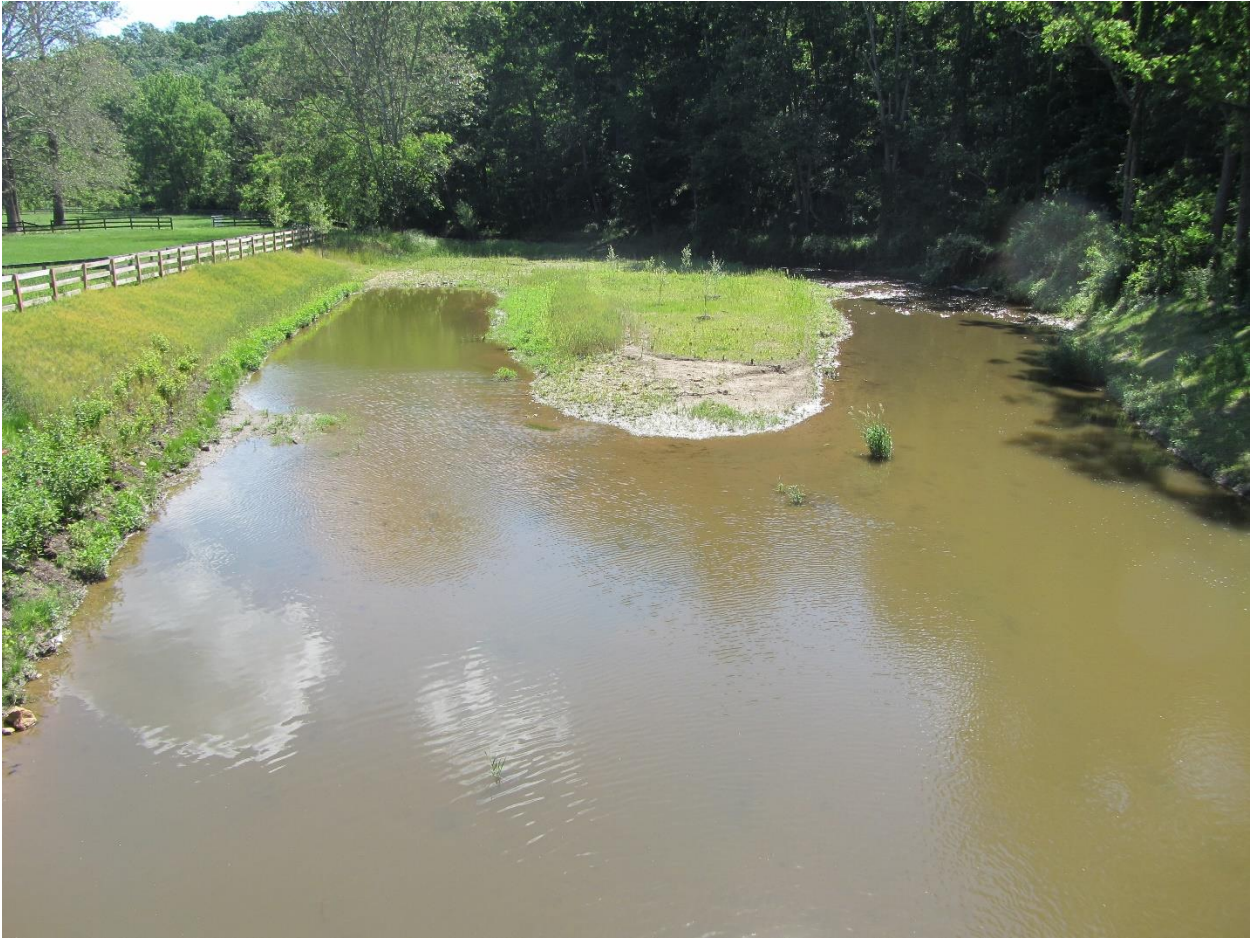
Figure 15. Forked channel downstream of MD 25 at Georges Run.

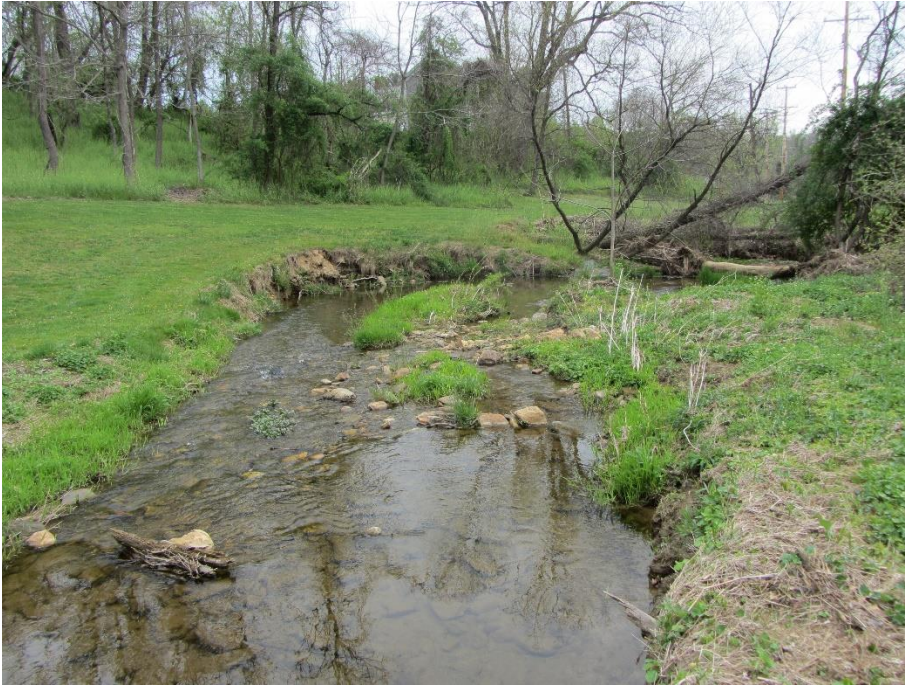
Figure 16. MD 165 over tributary to the West Branch of Winters Run, facing downstream toward the bridge. Note the lateral erosion, poorly functioning vanes, and woody debris in the channel.

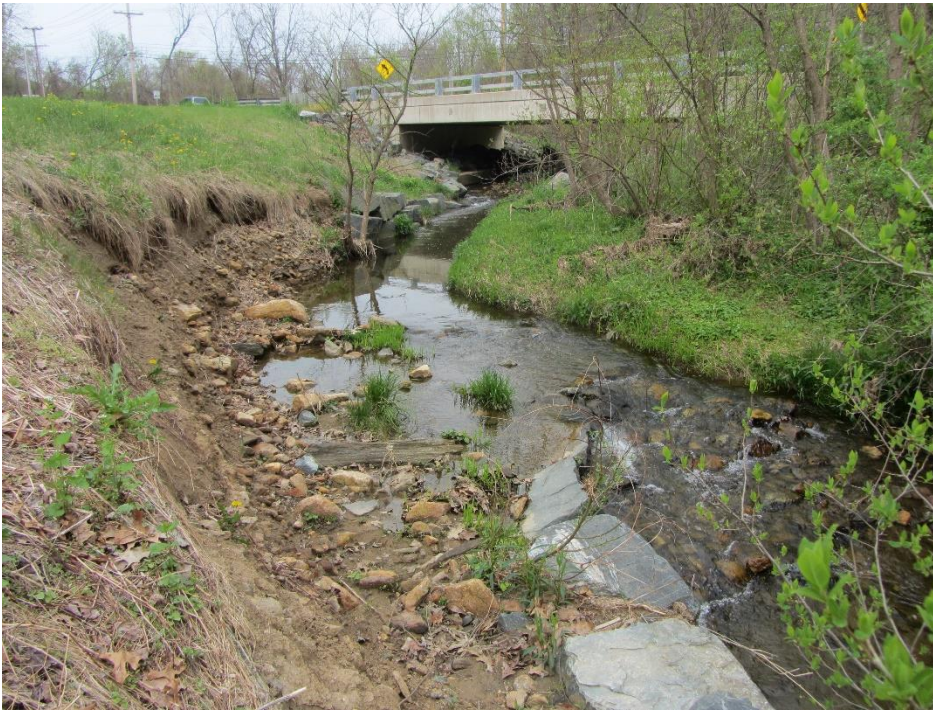
The MD 165 crossing over West Branch tributary was replaced in 2004 due to issues with scour. It was replaced to accommodate a 25-year storm. The hydraulic modifications made during construction included realigning the channel to a previous location, the installation of a rock vane, and construction of three cross vanes to control grade through the bridge. As of a site visit on June 6, 2016, there was woody debris in the upstream channel and the channel is laterally migrating toward the left bank (see Figure 16). All instream structures upstream of the bridge are no longer functioning as intended since the channel has migrated. However, the opening itself appears to be free of debris and sediment accumulation and is aligned with the channel. Downstream of the bridge, the project included a rock wall on the right bank and a J-hook. There was significant bank erosion downstream of the rock wall (Figure 17); thus, it appears that the J-hook is not functioning as intended.

Figure 17. Downstream of MD 165 over tributary to the West Branch of Winters Run, facing upstream. Vanes in the channel have failed to control bank erosion on the right bank.

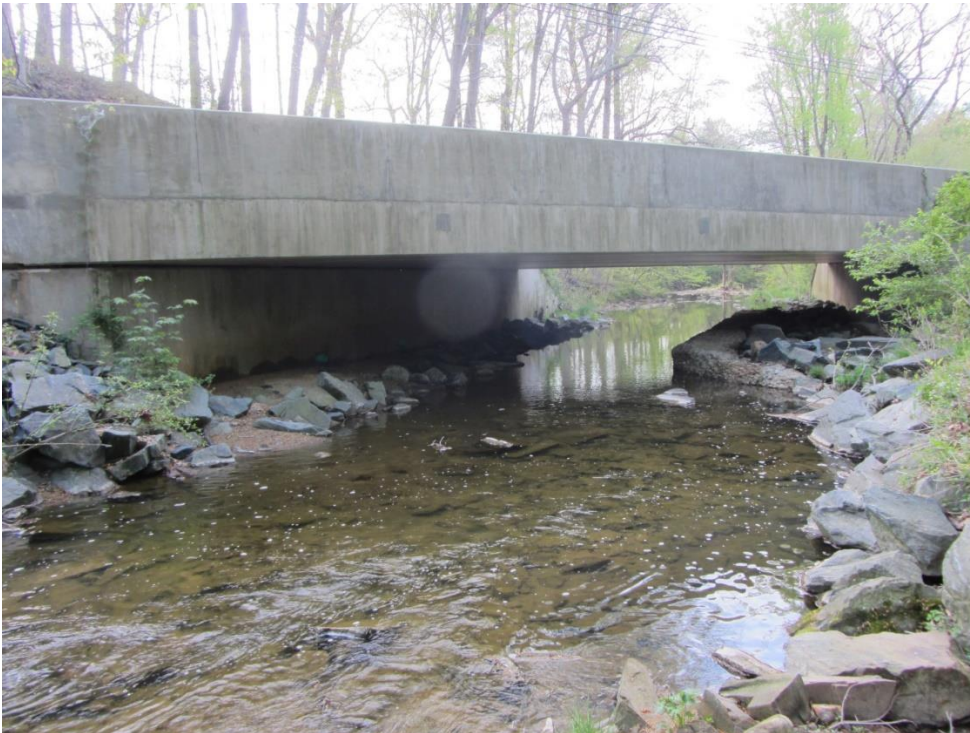
The MD 136 crossing over Broad Run was rebuilt in 2006 due to deterioration of the superstructure and frequent overtopping. The existing bridge was a single span of 8.5 meters (28 feet) in length. No stream channel alterations were made at this site during reconstruction. Upstream of the bridge, the left bank is being undermined and a sediment bar has accumulated (see Figure 18). The channel is well aligned with the bridge opening and sediment accumulation does not appear to be an issue (see Figure 19).

Figure 19. MD 136 over Broad Run looking downstream at the bridge opening. The previous bridge abutments were left under the reconstructed bridge.

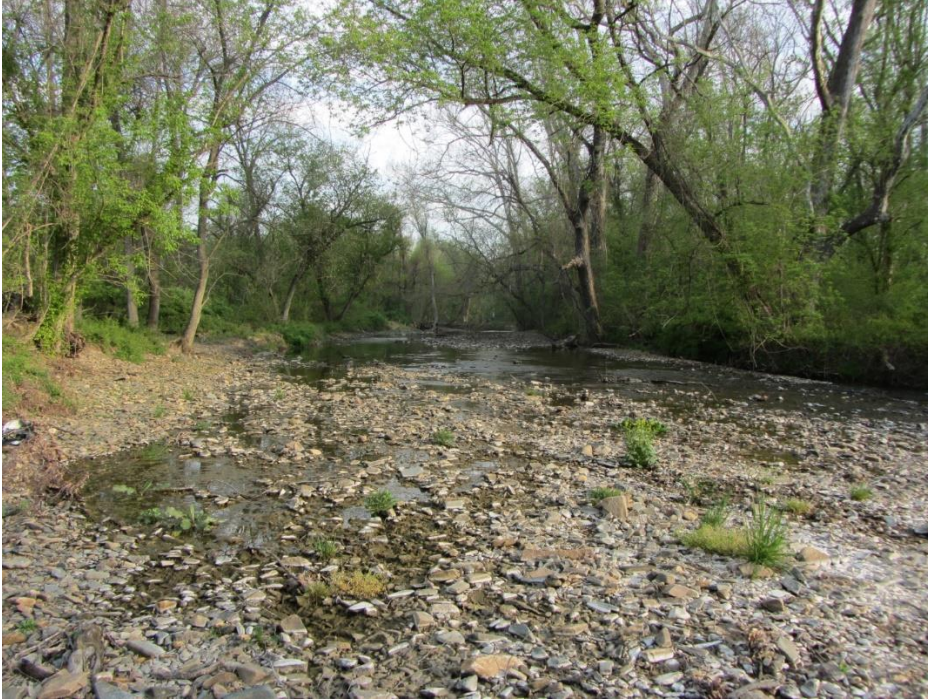
Figure 20. Facing upstream from MD 7 over James Run.

The crossing was reconstructed in 2014. No stream alterations were made at this site during reconstruction. The stream transports a significant gravel load (see Figure 20). Sediment and debris has accumulated upstream and beneath the bridge, but appears to be moving through the opening and downstream (Figure 21). Given the unstable upstream conditions with woody debris being added to the stream, debris accumulation will likely be ongoing. The channel was well aligned with the bridge opening.

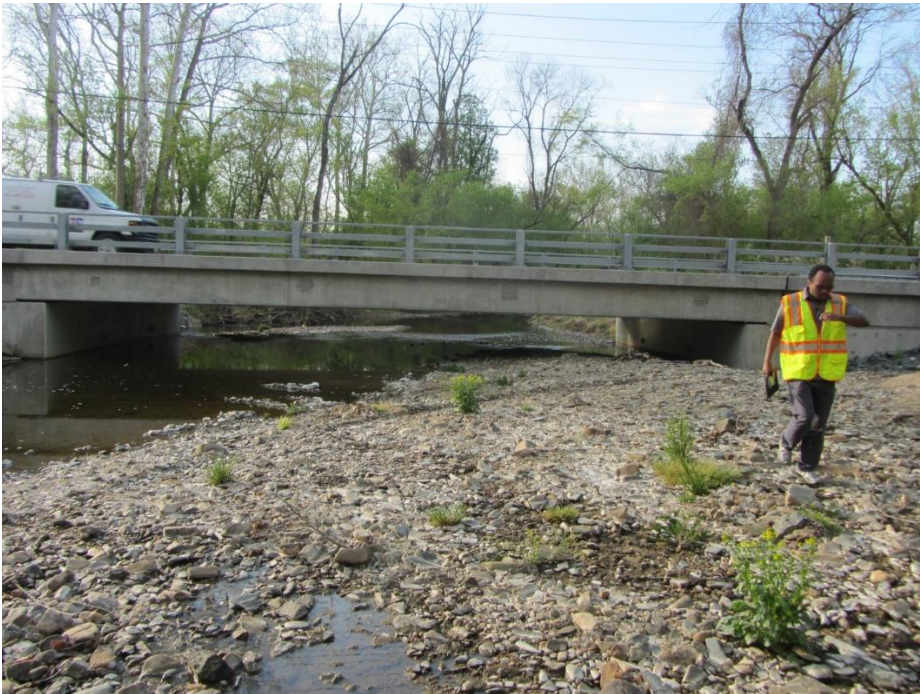
Figure 21. Looking downstream at MD 7 over James Run. Sediment accumulation on the right bar appears to be moving downstream through the bridge opening.
