MARYLAND DEPARTMENT OF TRANSPORTATION STATE HIGHWAY ADMINISTRATION

Highway Rock Cut Inventory and Failure Potential, Allegany County, Maryland

FINAL REPORT

May 2020

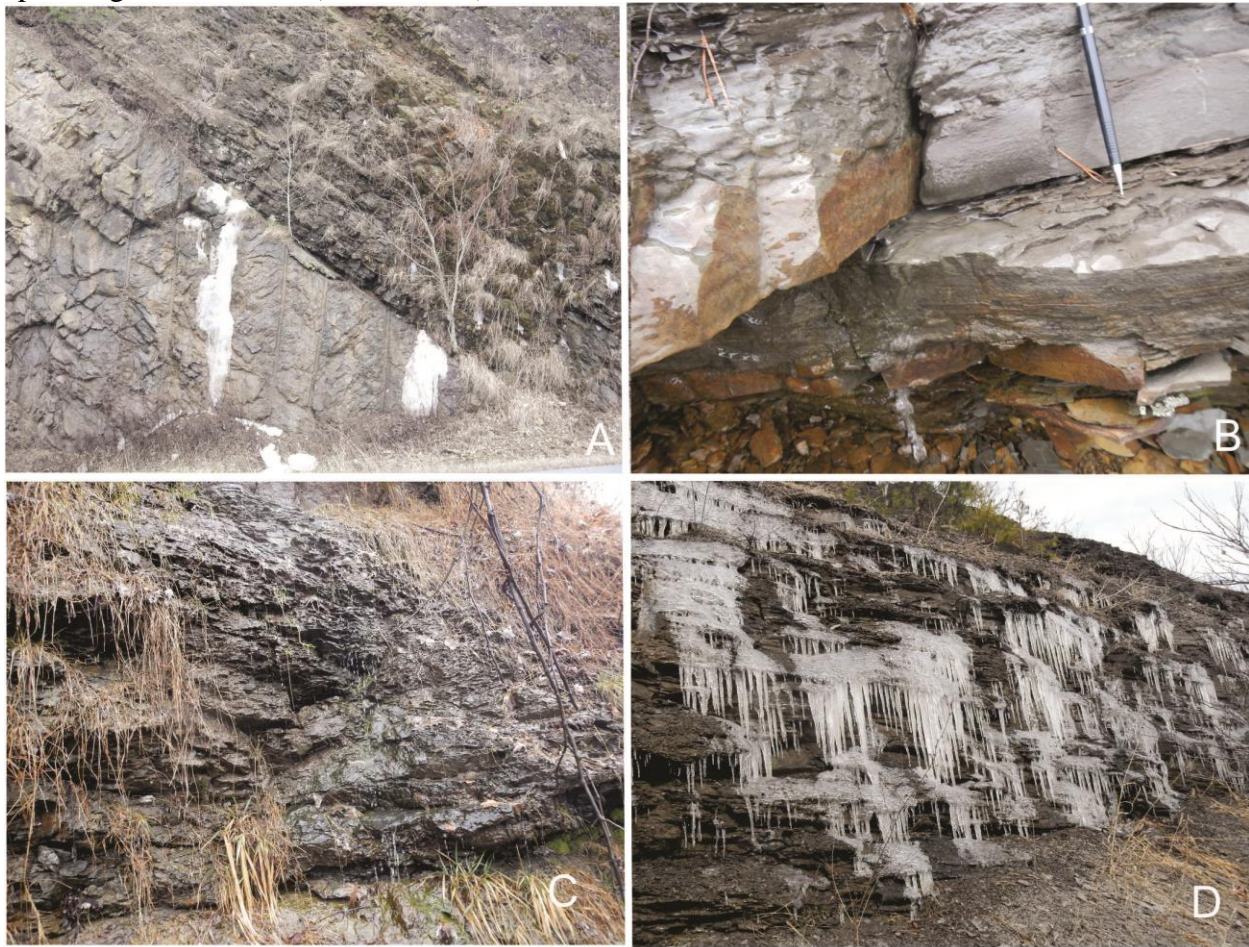
Water seeping from or running on rock slopes constitutes a significant secondary contributing factor to roadside slope failure potential for several reasons (Figure 7). Most importantly, water can serve as a lubricant that reduces friction between rock layers and along fractures and parting surfaces. This reduced friction, especially where failure planes are steeply inclined, can contribute to the triggering of slope failure events. Where subvertical, fractures can increase the conductivity of the water downward into subsurface stratification planes and reduce friction along those surfaces.

Figure 7. Degrees of variation in the amount and distribution of water on roadside slopes. A, Water seeps along stratification. B, Water seeping along joints and fractures. C, D, Water covering the surface of outcrops.

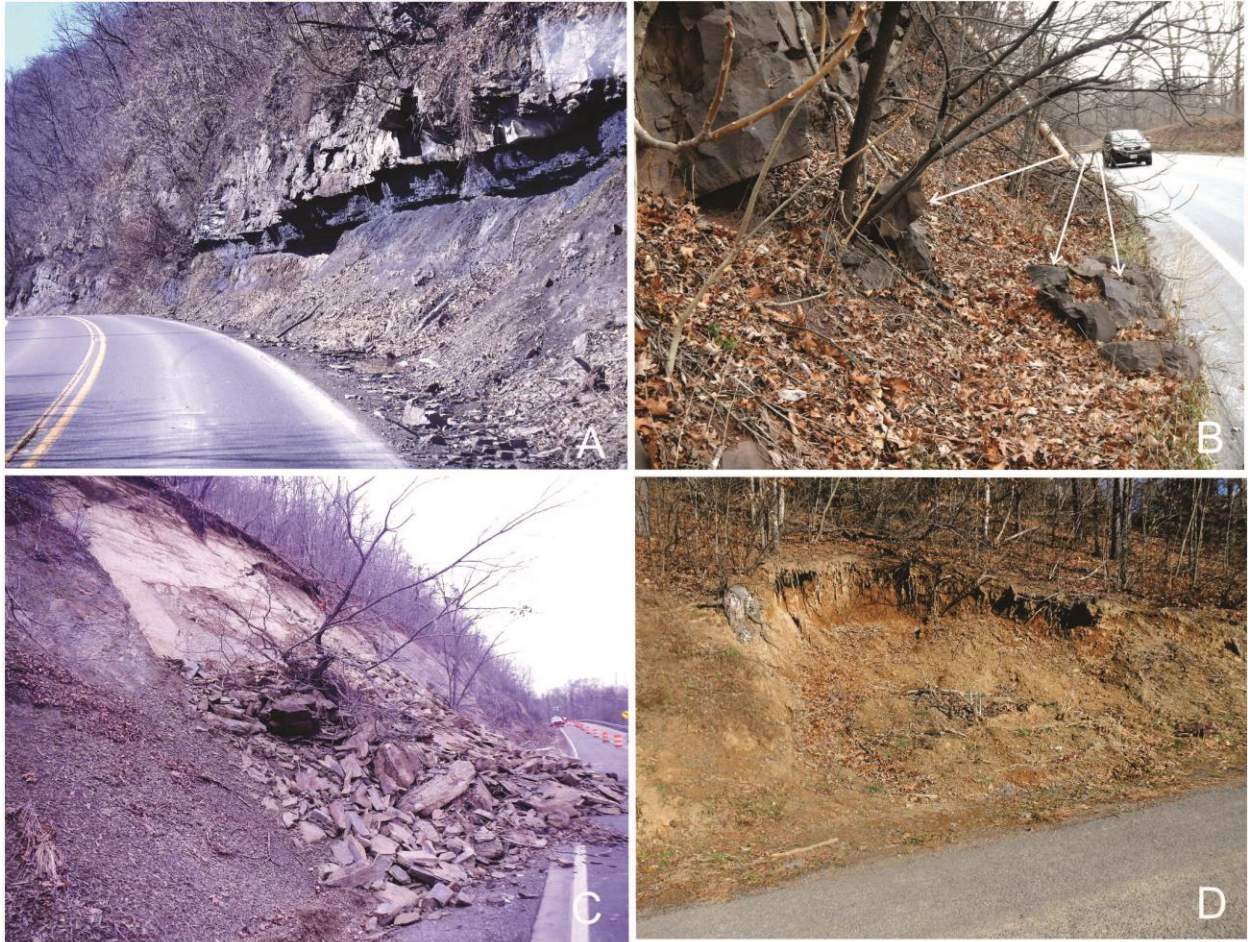
Four generalized categories of slope failure were utilized for this study. The first of these hazards is rockfalls, which encompasses rock topples of other authors (Hung et al., 2013). This type of failure requires a precipitously steep slope at the outcrop, often in excess of 70 degrees. Moreover, adverse failure planes frequently create greater potential for this type of failure (Figure 10A). The second category of slope failure is termed rock roll (Figure 10B). This most common type of failure varies in prominence based upon the inclination of the slope. Commonly, slope angles between 50 and 70 degrees yield rock rolls. Lithologies that typically are associated with rock rolls are interbedded sandstone/limestone and shale where differential weathering is prominently identified. Rock slides are a failure type that tends to occur where stratification is inclined towards the highway (Russell et al., 2008) (Figure 10C). This category includes detachments that are parallel to subparallel to bedding surfaces. Slide type failures tend to be intricately associated with the presence of intersecting groups of joints that can be oriented sub-perpendicular to the direction of the slide. The jointing, whether discontinuous or continuous, provides areas that allow detachment of rock slabs near the head of the slide. These types of slope failures are much more common in the highly folded strata of the Ridge and Valley Province. The last category of hazard considered was slump or rotational slides (Figure 10D). This type of hazard tended to be observed in outcrops that were highly weathered and vegetated, or where thick soil intervals had developed on steep slopes.

Figure 10. Type of slope failures and resulting hazards identified during this study. A, Rockfall. B, Rock roll. C, Rock slide. D, Slump (rotation) scar.

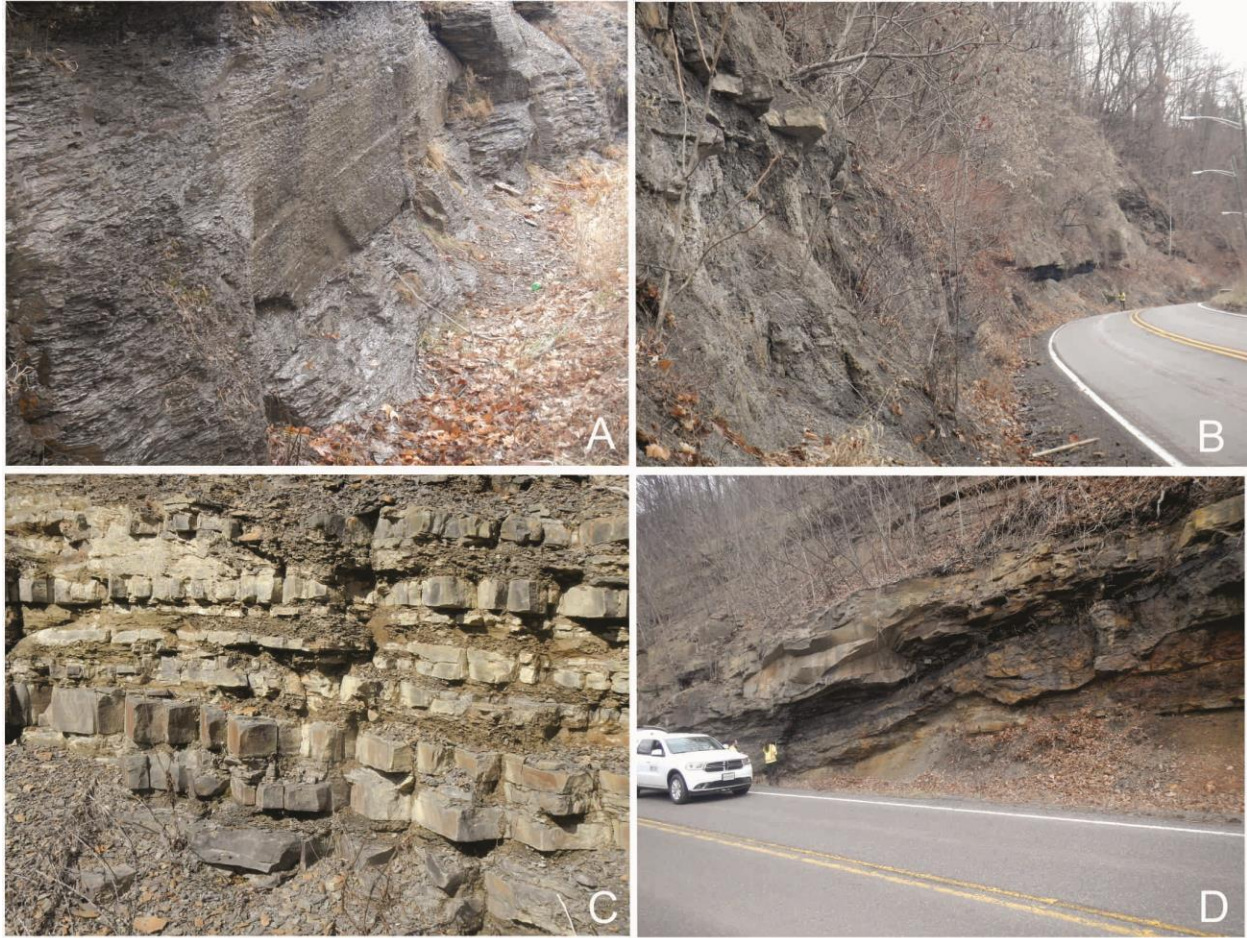
subvertical wall with little overhang. In contrast, interbedded lithologies provide varying levels of both weathering and erosion. This variation is known as differential erosion (differential weathering of Vanderwater et al., 2005). The pervasiveness of interbedding is also a key component in the potential for the number and prominence of differential erosion features (Figures 13B, C). With greater differential erosion there is an increased likelihood for the formation of overhanging ledges (Figure 13D), which therefore present greater potential for both rockfall and rock roll events.

Figure 13. Differential erosion. A, Minor differential erosion within massive siltstone. B, Occasional differential erosion along sandstone interbeds. C, Many differential erosion surfaces within interbedded sandstone and shale. D, Major differential erosion at the contact between the Pottsville and Mauch Chunk formations.

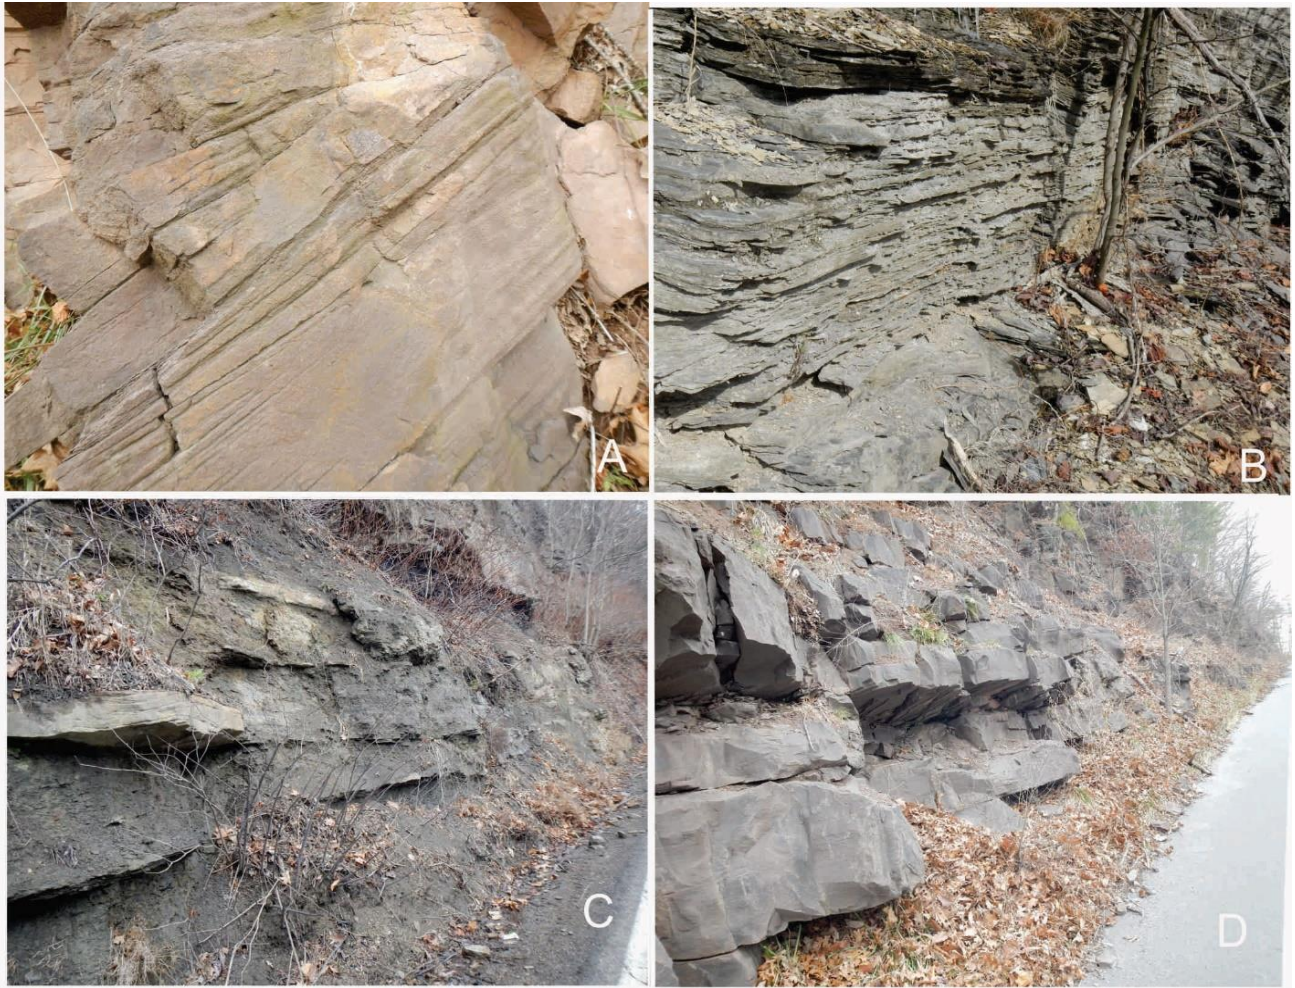
interbedded lithologies, where more massive intervals of rock are interbedded or underlain by more easily removed lithologies (Figure 14D). In this case, weathering produces overhanging ledges created by major differential weathering and erosion. Overhanging ledges appear to be more prevalent where higher levels of freeze-thaw cycles and precipitation are present. Thus, rock exposures of the Appalachian Plateaus Province show greater levels of differential weathering.

Figure 14. Weathering of outcrop. A, B, Weathered on surface. C, Weathered in relief. D, Weathered with overhanging ledges.

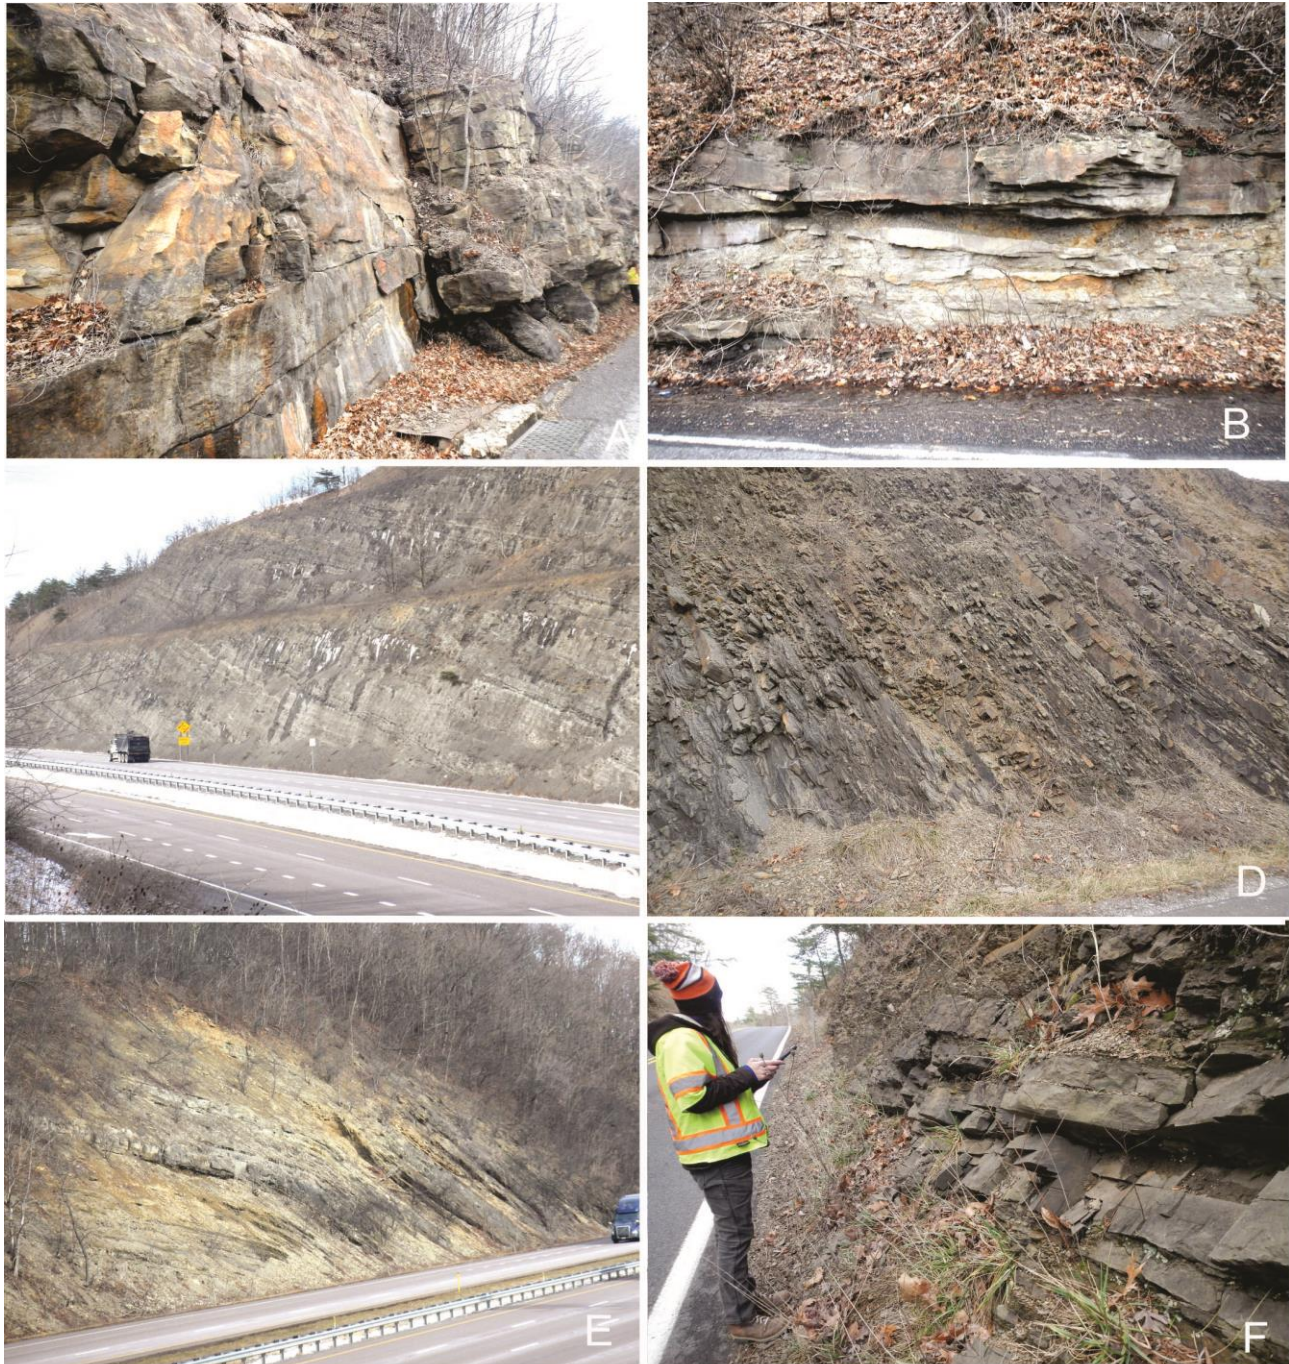
strata decoupling and sliding into the roadway (Figure 15C-D). Strata dipping into the roadway tend to present greater potential for slides, glides, or detached rock masses where rock can be displaced into the highway right-of-way (Figure 15E). Likewise, this orientation of stratification provides abundant potential for rock roll events where weathered and decoupled blocks can roll down the inclined slope and into the roadway. By contrast, strata dipping away from the roadway can present steep slopes, but a reduced potential for either slides, falls, and rolls (Figure 15F).

Figure 15. Stratification. A, Massive with stratification poorly discernible. B, Stratification horizontal. C, Stratification inclined parallel to road at <45 degrees. D, Stratification inclined parallel to road, > 45 degree angle. E, Stratification inclined into roadway. F, Stratification inclined away from roadway.

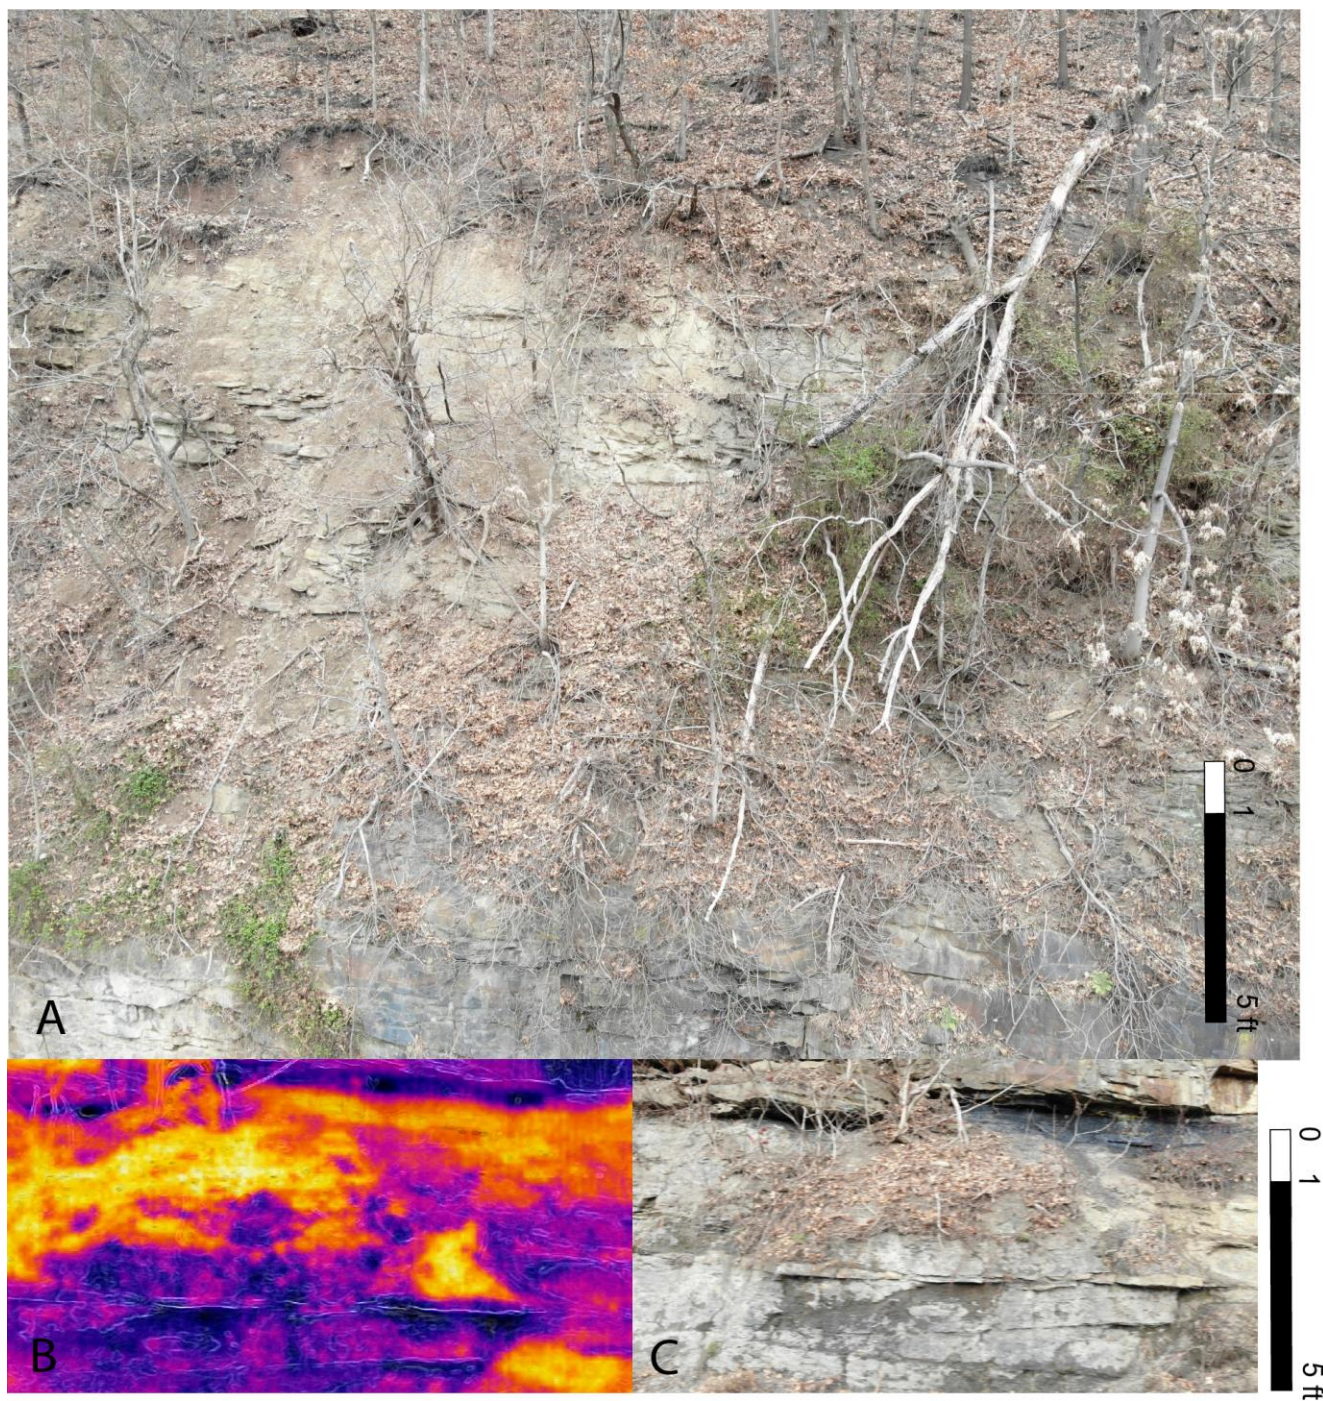
Figure 17. Drone imagery. See Figure 18A for location. A, Slide scarp approximately 50 feet above road, on hillside above two massive sandstone layers. Not visible from road level. B, Infrared drone imagery (orange/red = warm, purple/black = cold) of bedrock layers (purple) with water (black) exiting along stratification in the Allegheny Formation. C, Visible drone imagery, same area as B.

Examination of drone video footage, in visible light and side-by-side with infrared light, emphasizes the importance of groundwater exiting along bedrock stratification, and delineates a slope failure above the height visible from the roadside on MD 135, both east and west of Westernport. The groundwater seepage and slope failure are likely related; both features may be

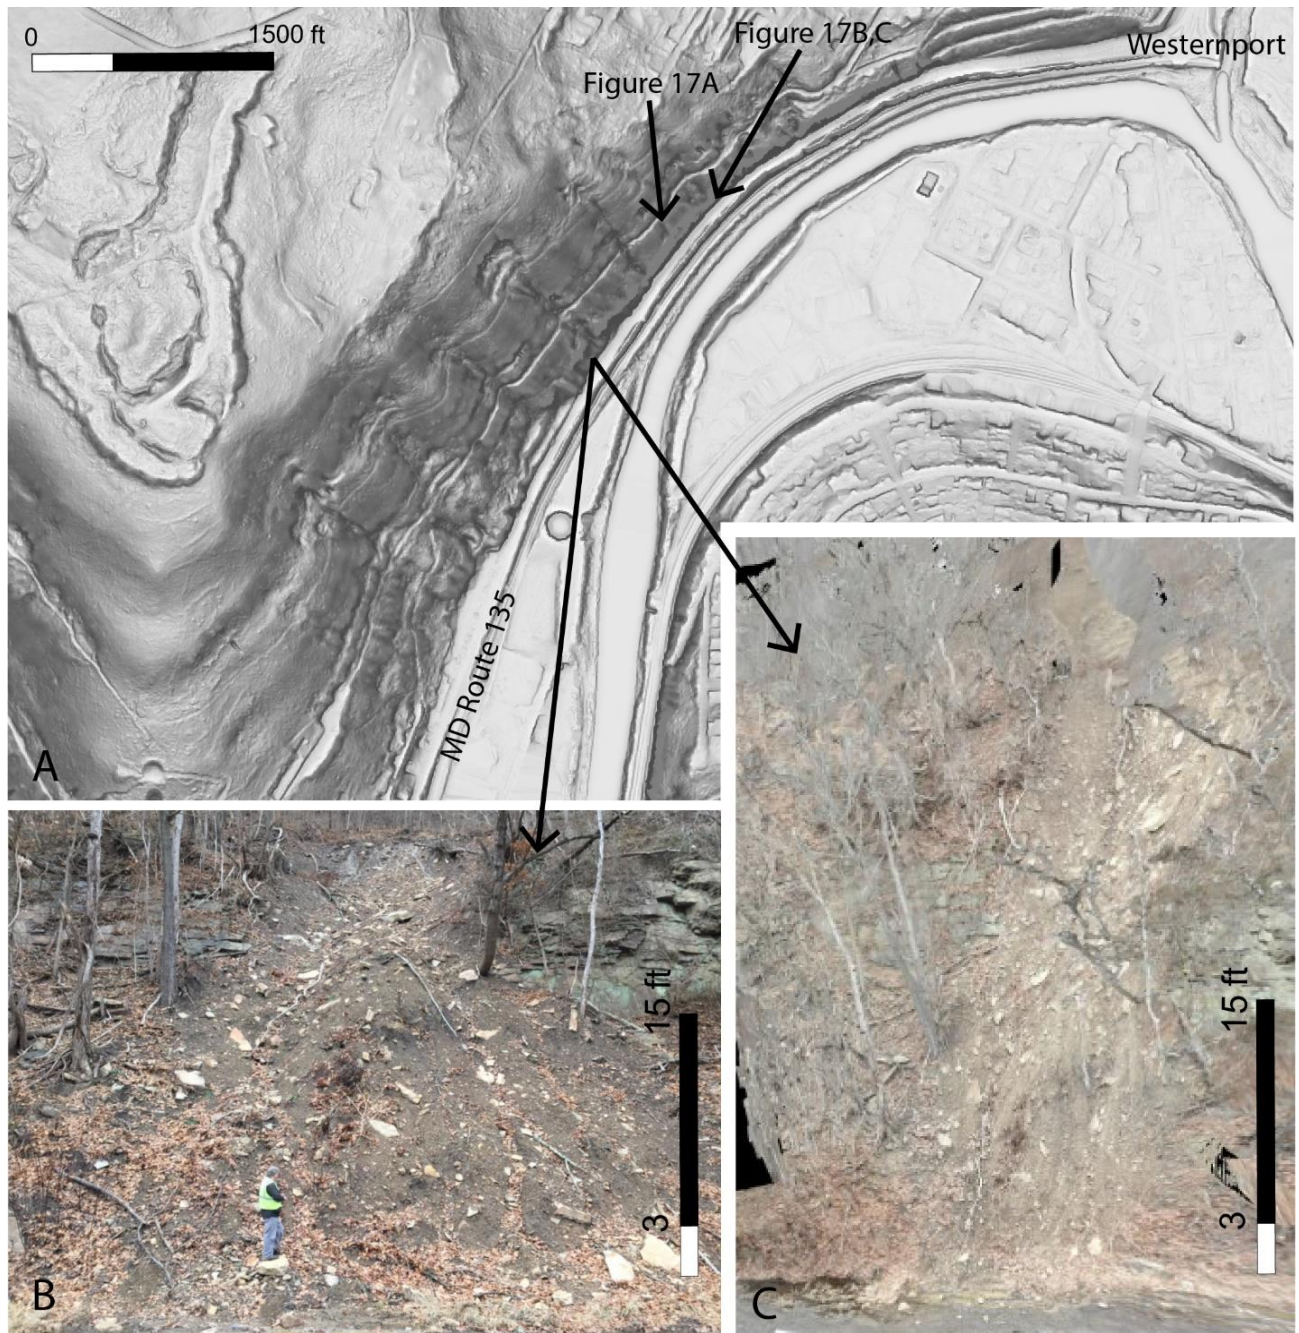
However, there were challenges to drone imagery collection. Safety of the drone survey crew and passing drivers was the first concern. Even with one lane of traffic control in place, the drone crew did not have abundant room to maneuver themselves and keep the UAV a safe distance from passing vehicles. Second, there were obstructions to the drone flight path, such as overhanging power lines and trees, and it was easy to lose sight of the drone when flying high enough (>100 feet) to capture images of the upper portion of the hillslope. Third, images produced by stitching drone photos together were somewhat distorted. Furthermore, processing was time-intensive without a super-computer or cloud processing features. For example, a stitched image of 850 photos for a 25-foot-wide slide area west of Westernport took approximately 15 hours to process (Figure 18C). Fourth, due to low resolution of infrared video capture, infrared images did not produce a coherent stitched image. Additionally, when the UAV was not flown far enough away from the outcrop, or was rotated while flying, the resulting stitched image was distorted (Figures 18B, C).

Figure 18. Slope failures. A, LiDAR image showing channel visible on hillslope above MD Route 135 that leads to slide area in photos B and C. Similar channels nearby also visible. B, Standard photo of slide area. C, Stitched image of drone photography, same location as B.
