RESEARCH SUMMARY

HIGHWAY ROCKCUT INVENTORY AND FAILURE POTENTIAL, ALLEGANY COUNTY, MARYLAND

REPORT NUMBER:
MD-20-P01837G-1

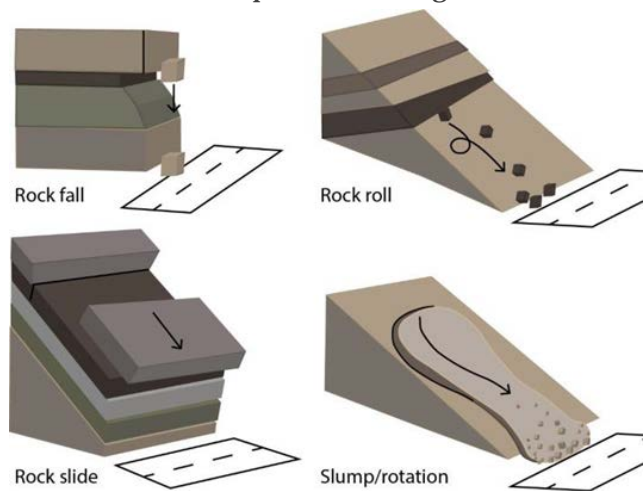
One of the main goals of the survey was to assess each road cut as to its potential for slope failure. Four types of potential slope failures were identified during the study: rock fall, rock roll, rock slide, and slump/rotation (Figure 1).

Figure 1. Types of slope failures utilized.

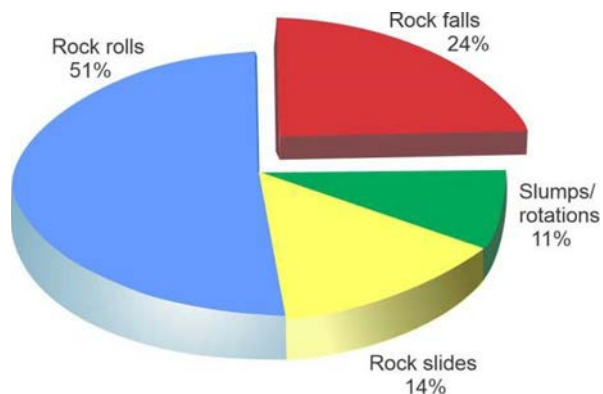
The four types of slope failure identified (rock fall, rock roll, slides, and slumps) differed in numbers and prominence based upon four geologic factors (Figure 2). The main geologic factors creating potential slope failure are

stratification, rock type, fracture character, and differential erosion.

Figure 2. Percentage of potential slope failure types determined from this study.
