**National Pollutant Discharge Elimination System
Phase I MS4 Permit No. 99-DP-3313 MD0068276**

Permit Term October 2005 to October 2010

Second Annual Report October 21, 2007

***Submitted by:
Highway Hydraulics Division
Maryland State Highway Administration
707 North Calvert Street, C-201
Baltimore, MD 21202***

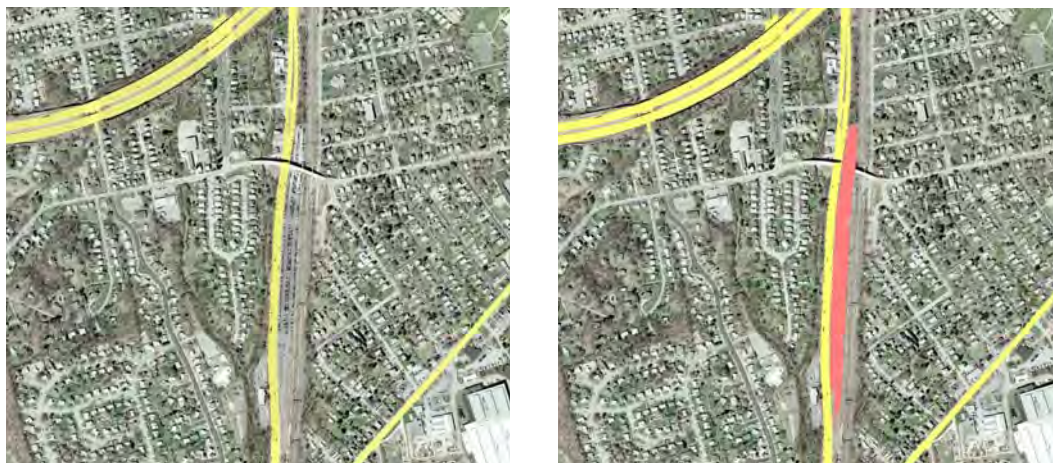
Figure 1-8 CADD Drawing Converted and Clipped into GIS Impervious Layer

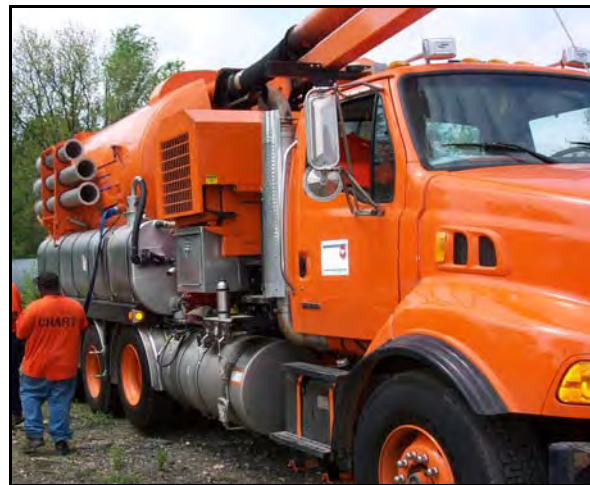
In addition to street sweeping, SHA owns and operates four vacuum pump trucks that routinely clean storm drain inlets along roadways. Sediment and trash make up the majority of the material that is removed. The vacuum trucks operate in central Maryland, spanning the following Counties: Anne Arundel, Baltimore, Calvert, Carroll, Charles, Frederick, Harford, Howard, Montgomery, Prince George's and St. Mary's. This practice ensures safer roadways through ensuring proper drainage and improves water quality in Maryland's streams.

Vacuum Pump Truck

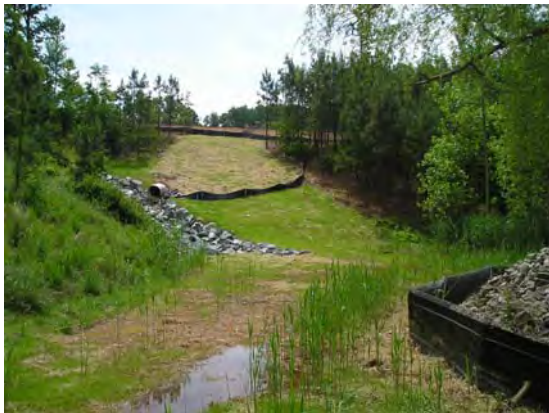
Figure 3-2 SWM Pond Major Maintenance

SHA performs major maintenance tasks that address significant deficiencies at BMPs through the time & material open ended contract lead by Highway Hydraulics Division. The intent is to restore performance of a BMP and/or to avoid failure of specific elements. SWM facilities that require major or remedial maintenance are assigned a "III" rating by SHA. Figure 3-2 shows an example of SWM Facility requiring major maintenance.

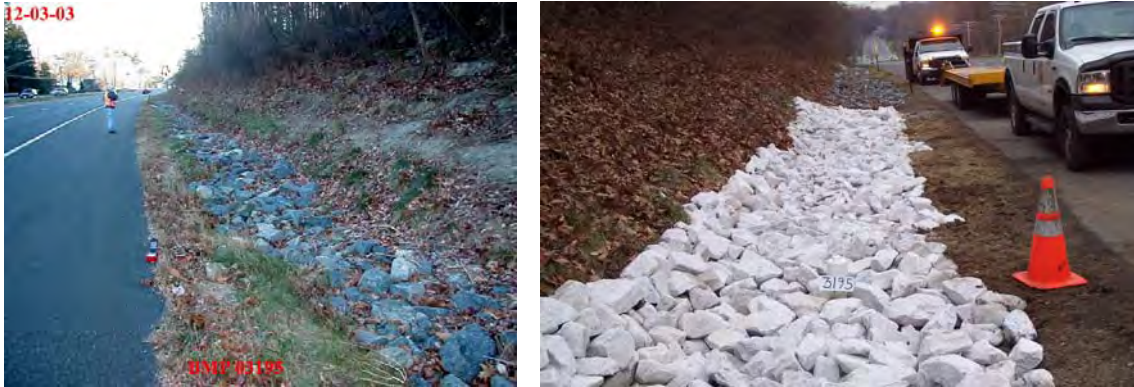
Figure 3-4 Installation of Infiltration Trench Monitoring Well and Media Replacement for BMP 3195 in Baltimore County

Field inspections also identified a significant number of trenches located throughout various counties without an observation well. In order to determine the functionality of the trench, a test pit has to be excavated. If the trench was more than 50% full of water, no observation well is being installed, and the trench is considered for abandonment or retrofit. If the trench is sufficiently dry an observation well is installed. Figures 3-4 and 3-5 show an installation of monitoring well by the SHA contractor.

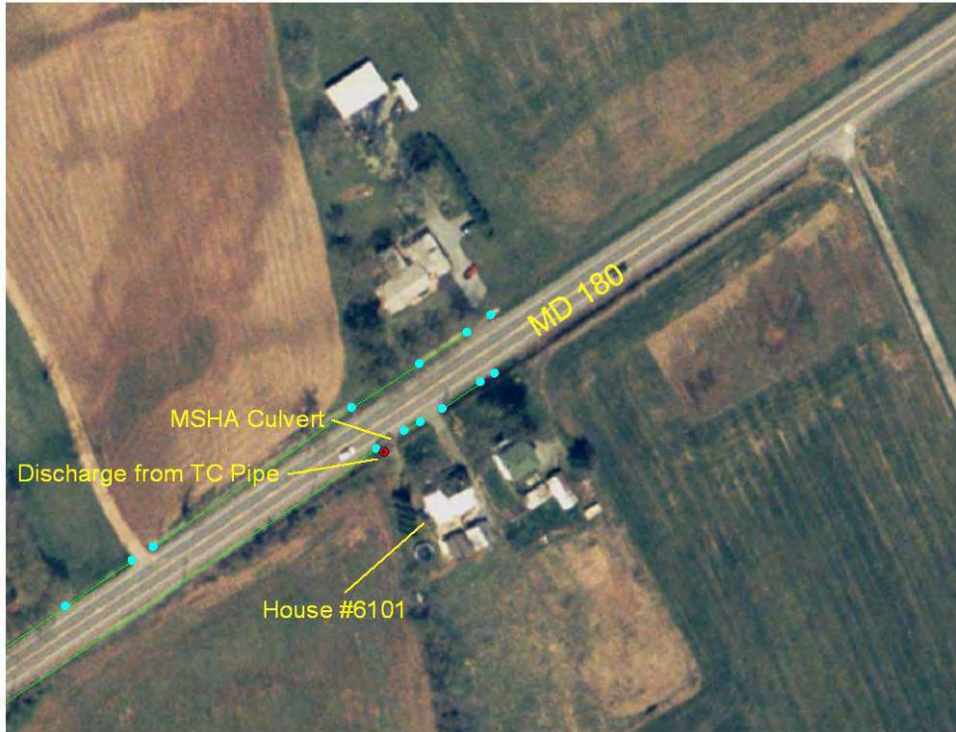
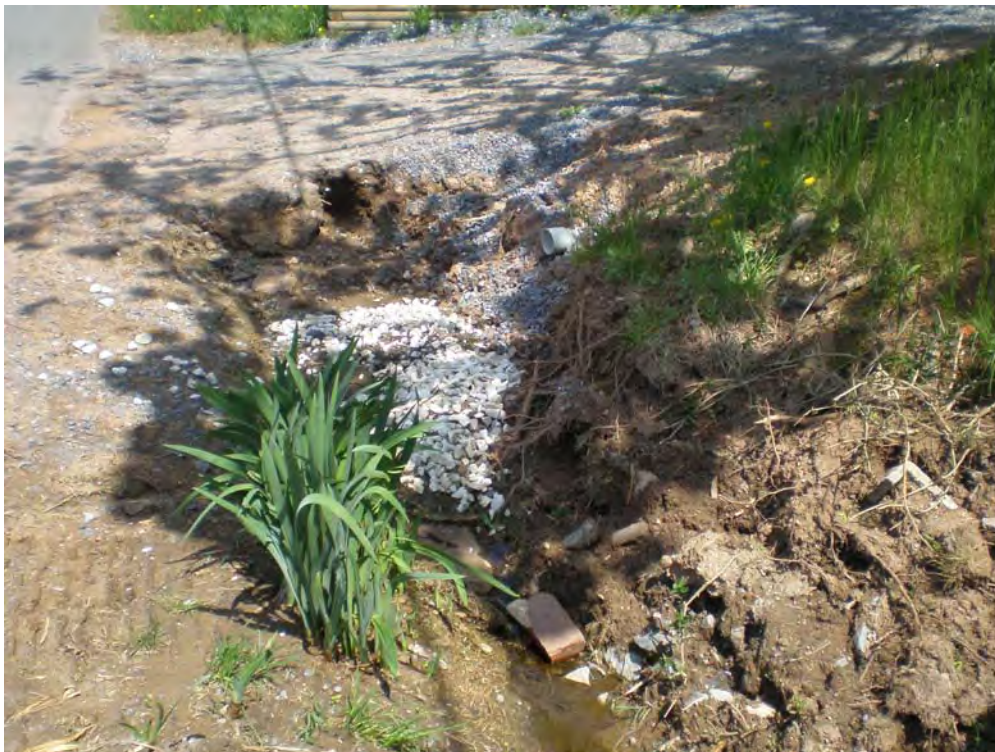
Sewage discharge at 6101 Jefferson Pike. Terra cotta pipe has been replaced with perforated PVC by the homeowner.

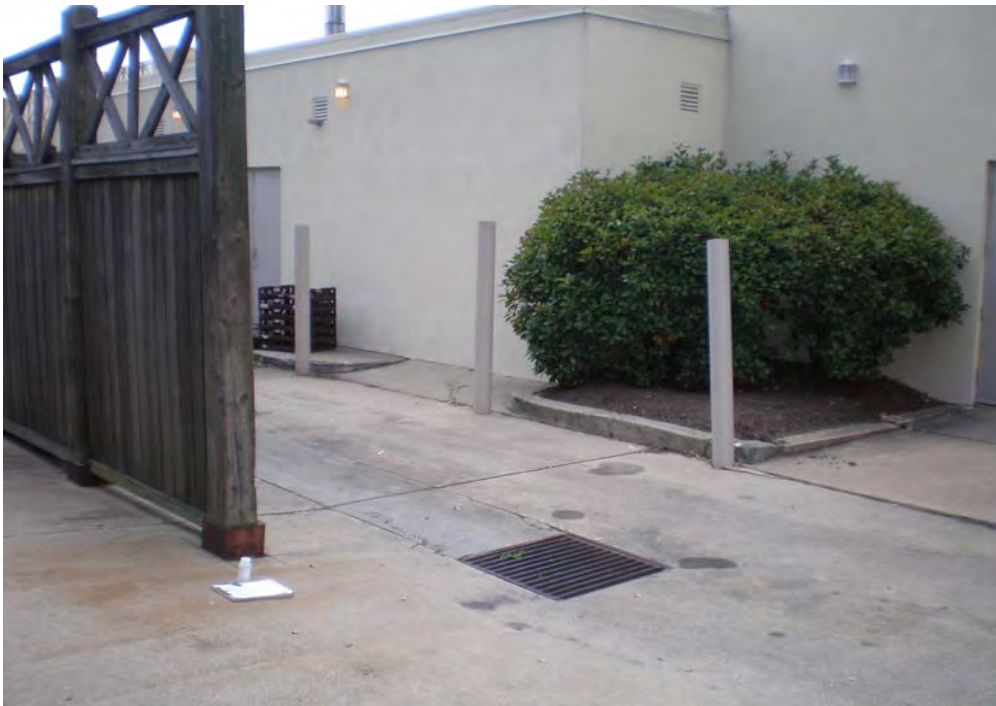
View of inlet where illicit flow was found.

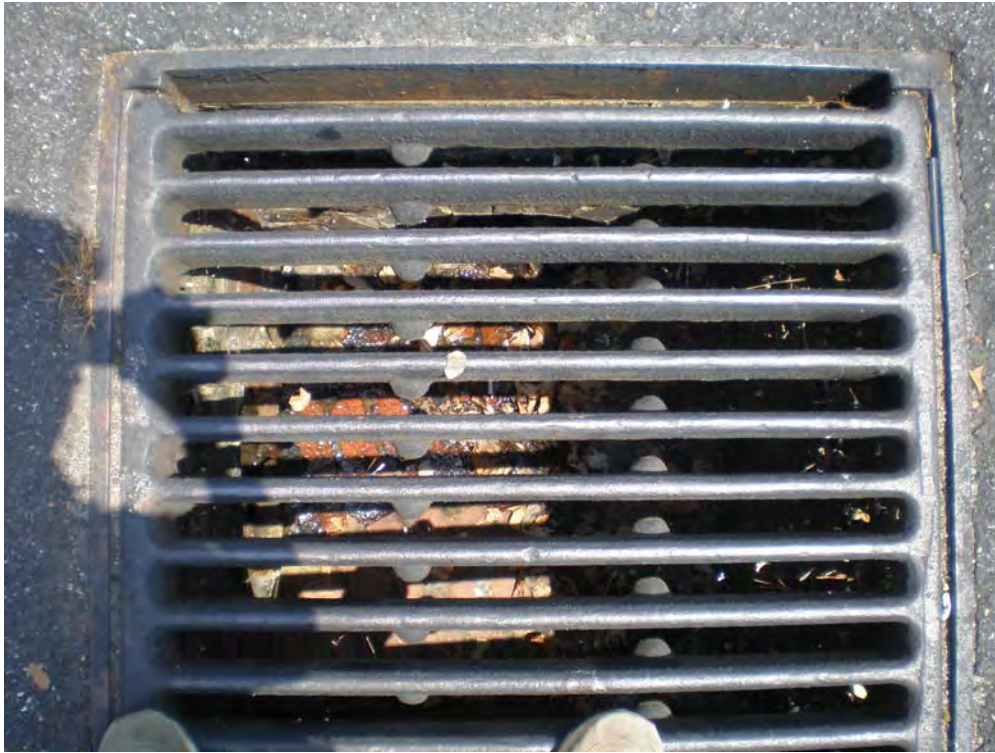
Downstream inlet showing path of illicit flow towards a SHA outfall.

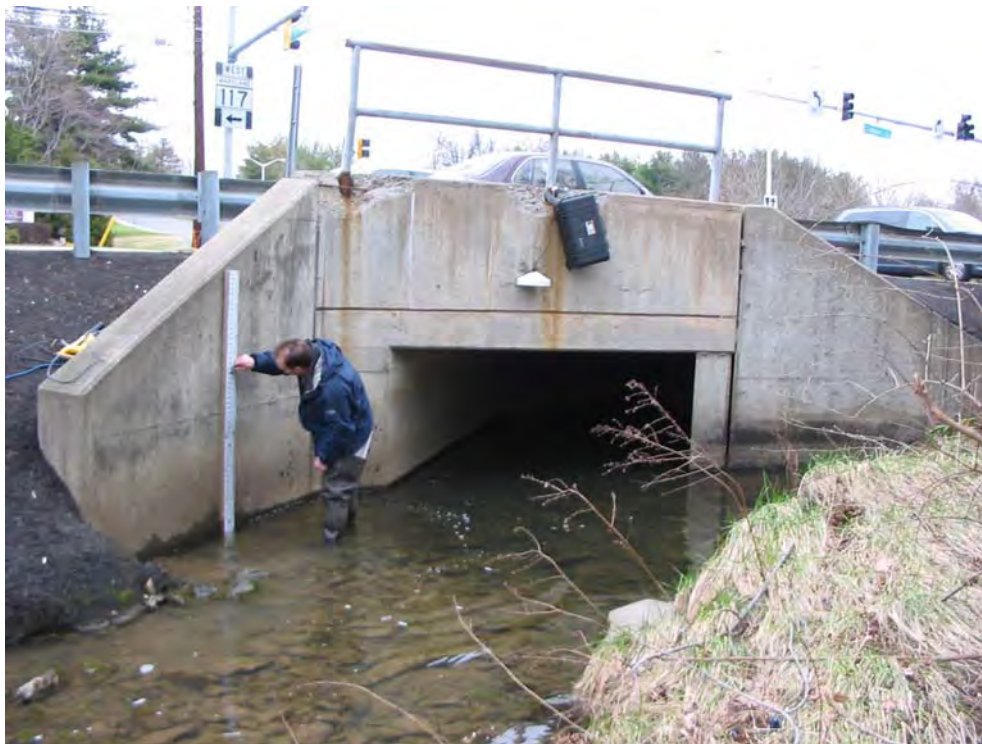
A meter (Teledyne Isco 4110 Ultrasonic Flow Logger), attached to the downstream side of the culvert at the Clopper Road crossing (MD 107 culvert) records water level continuously at 15 minute intervals (Figure 2.2). In conjunction with sampling events, the LimnoTech team also conducts flow measurements using a Marsh McBirney portable Flowmeter. Rainfall data is compiled from data collected by Montgomery County, MD at Dickerson, MD.

Figure 2.2: Continuous water level meter at upstream monitoring site
