Phase I&II National Pollutant Discharge Elimination System  
Permit No. 99-DP-3313 MD0068276  
Permit Term October 2005 to October 2010

# ANNUAL REPORT UPDATE OCTOBER 21, 2013

# Final Report: Evaluation of Transitional Performance of an Infiltration Basin Managing Highway Runoff

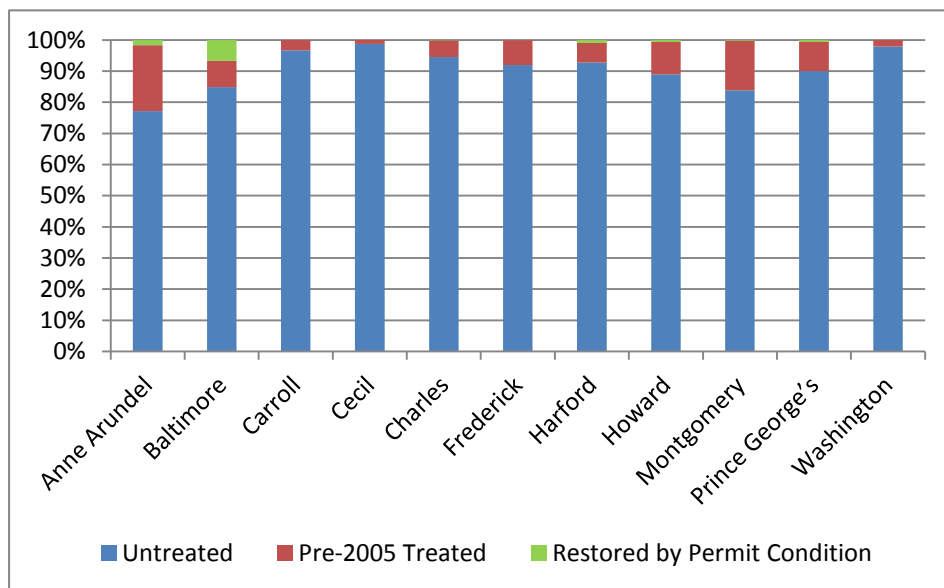
**Figure 1-4 SHA Impervious Restoration Progress by County**

We completed the impervious accounting requirement and the baseline accounting numbers were reflected in the 2010 report. Table 1-3 displays the baseline untreated impervious numbers for SHA by county and the progress of the restoration based on the requirement for twenty-five restoration projects (permit condition G.1). Figure 1-4 provides a graphic illustration of the progress.

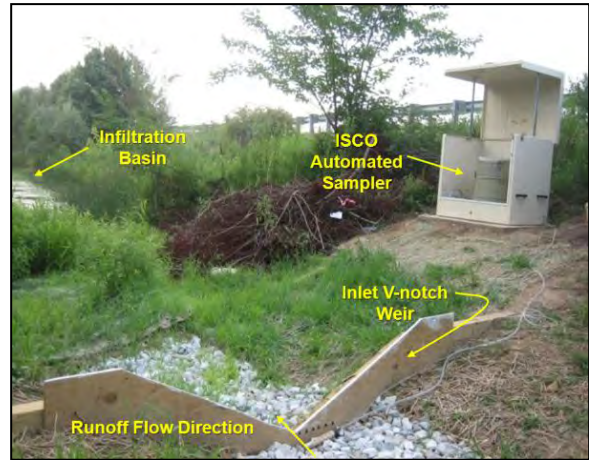
**Figure 1-5 Wet Infiltration Basin Study – Site Monitoring Set Up**

was included in the previous year’s report and the study was completed not long thereafter, and a study photo and diagram are included in Figures 1-5 and 1-6. This final report is included in Appendix B, *Final Report: Evaluation of Transitional Performance of an Infiltration Basin Managing Highway Runoff*.

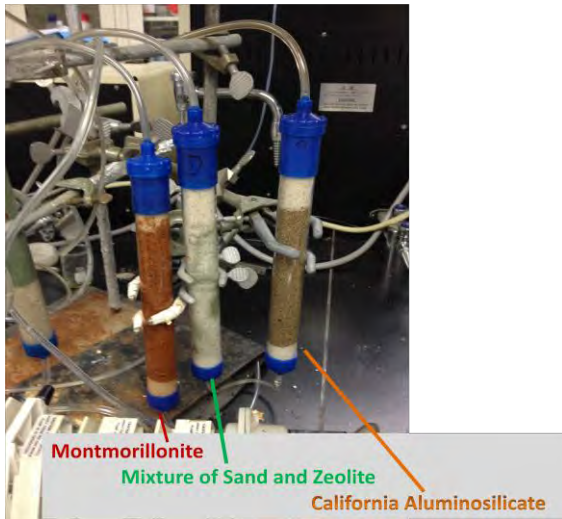
**Figure 1-8 Modified Conventional Sand Filter Testing**

To reduce nitrogen loading, a proposed design divides the sand filter into three zones to promote ammonification, nitrification, and denitrification as shown in Figure 1-8 above. Nitrification was observed to automatically occur during low nitrogen loadings and dry periods, without any modifications to sand filter design; however, to achieve adequate media contact time for key biological denitrification processes to occur, sorptive materials must be incorporated into the sand filter bed.

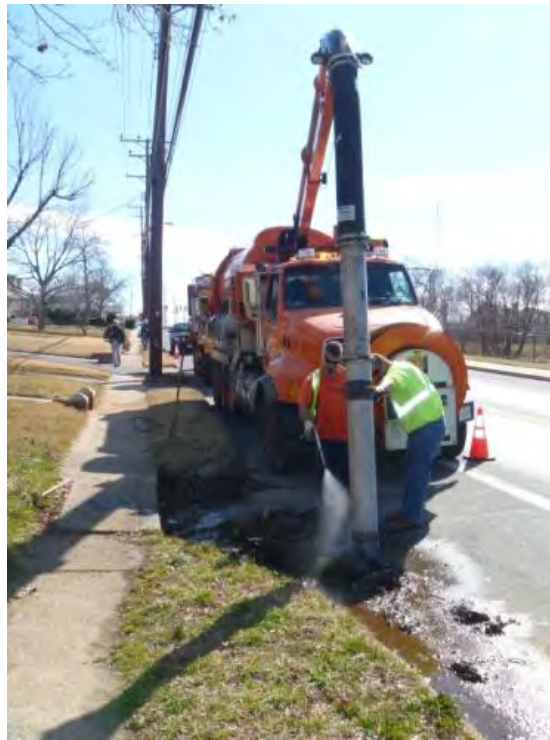
**Figure 1-12 SHA Shop Personnel Operating Vacuum Truck to Clean Roadside Debris**

SHA also owns and operates four vacuum pump trucks that routinely clean storm drain inlets along roadways. Sediment and trash make up the majority of the material that is removed. The vacuum trucks operate in central Maryland, spanning the following Counties: Anne Arundel, Baltimore, Calvert, Carroll, Charles, Frederick, Harford, Howard, Montgomery, Prince Georges and St. Mary's. This practice ensures safer roadways through maintaining proper drainage and improves water quality in Maryland streams by removing captured sediment and trash before they enter adjacent waterways.

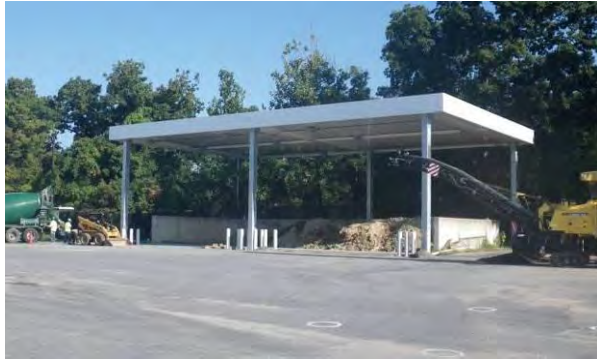
**Figure 1-14 Structure used for Inlet Cleaning  
Waste Dewatering**

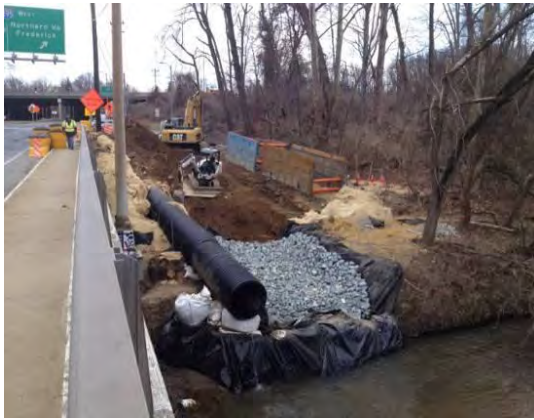
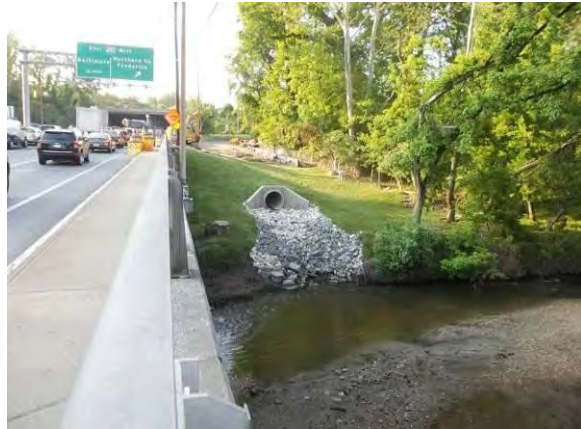
**Figure 1-17 MD185 at Rock Creek Outfall restoration during and after construction**

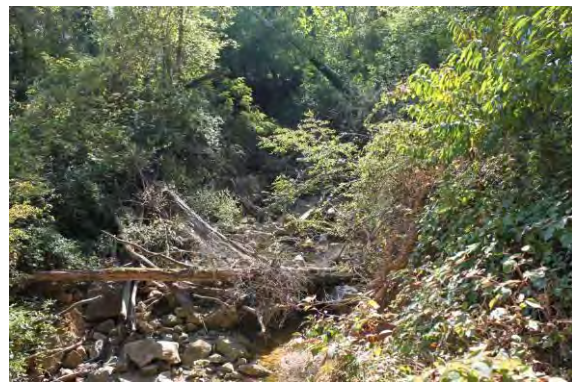
**Figure 1-33 Tributary to Minebank Run, degraded outfall channel downstream from Cromwell Bridge Road before restoration**

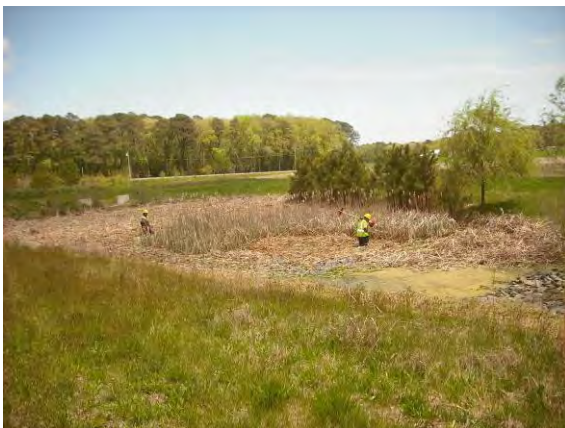
**Figure 2-2** Routine maintenance activities in progress on SWM facility 230011

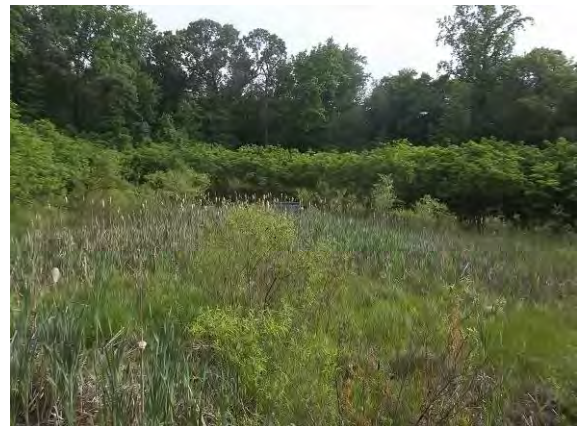
**Figure 2-3** SWM Facility 020697 prior to remedial maintenance

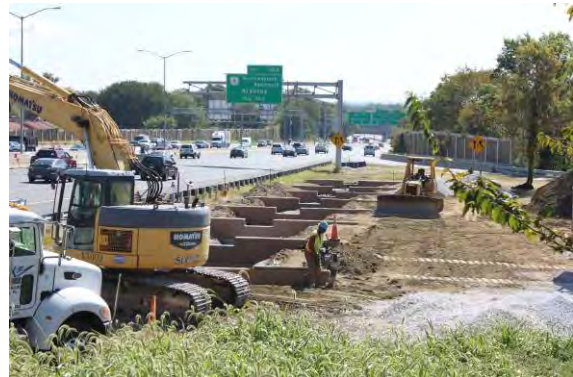
**Figure 2-8 I-695 Widening - SWM facility during construction**

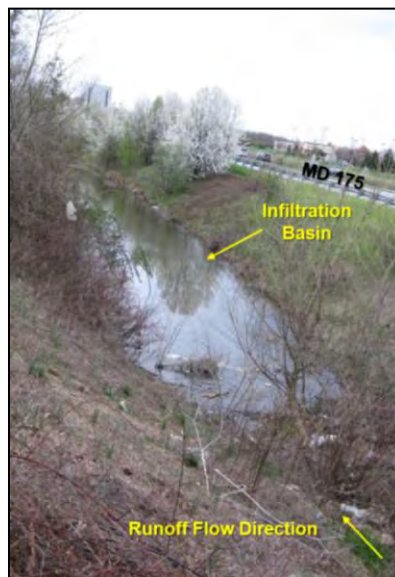
**Figure 1. Photograph showing the infiltration basin located along MD 175 East. Photo, looking west, shows single concentrated inflow point to the infiltration basin.**

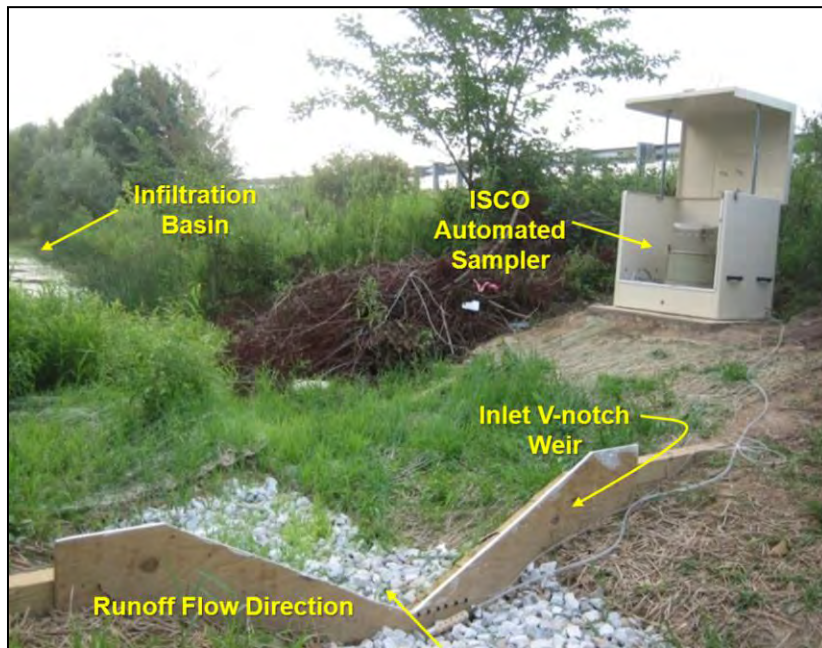
**Figure 3.** Photograph showing the sampler and weir installed at the inlet side of the infiltration basin.

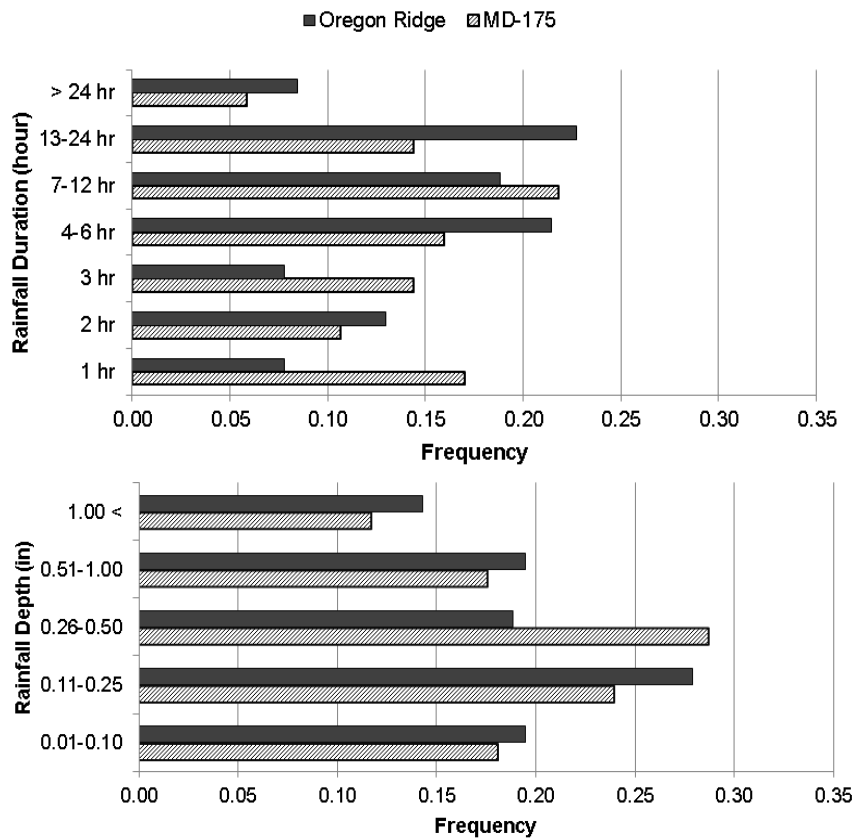
**Figure 7.** Rainfall depth-duration distributions for the MD 175 infiltration basin site and Oregon Ridge (reference site) for August 2009 to August 2012 period.

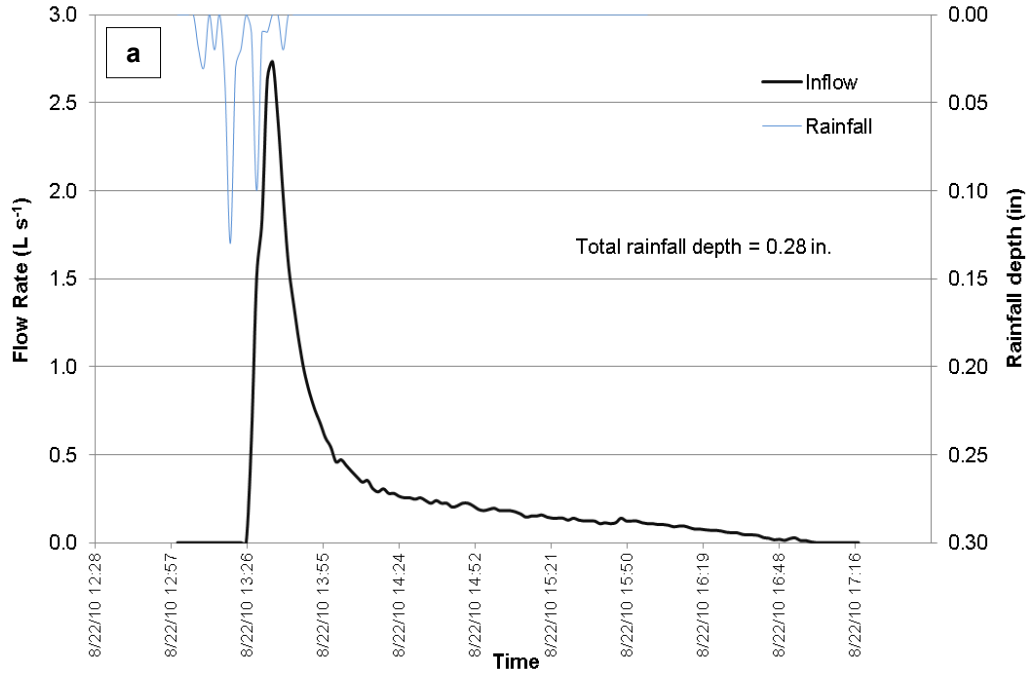
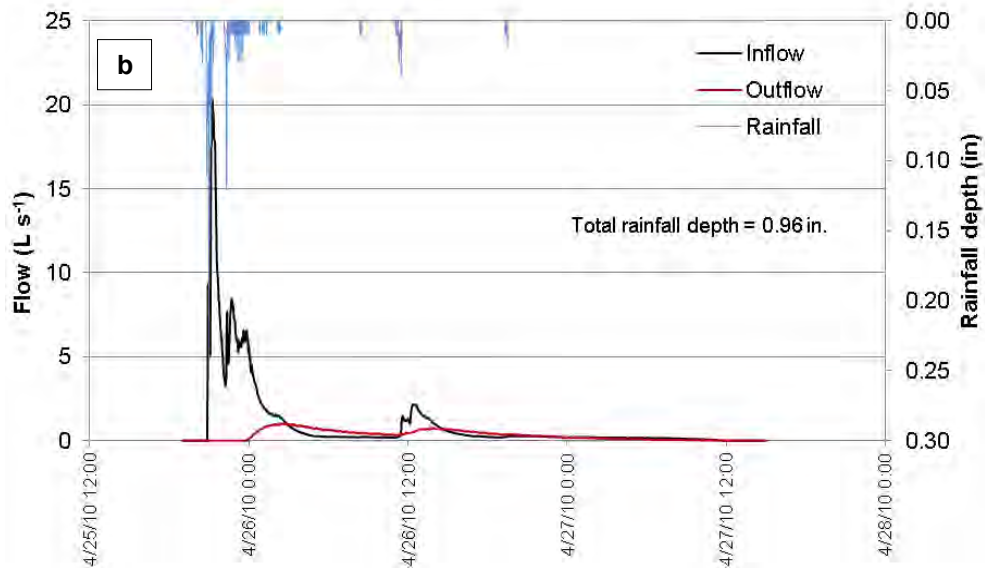
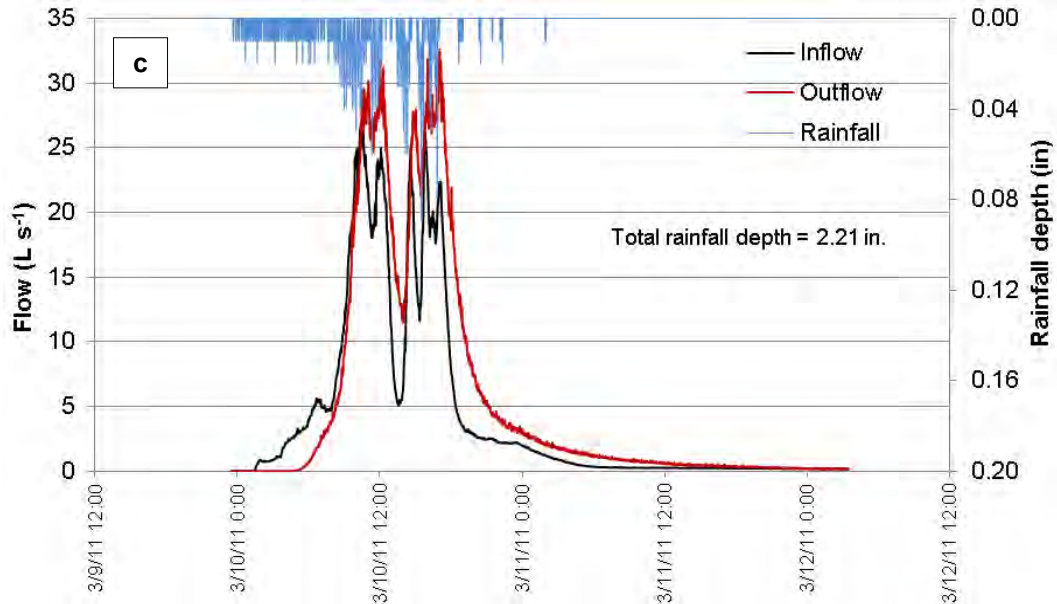
**Figure 8.** Hydrographs recorded during rainfall events on **a.** Aug 22, 2010 (no outflow) **b.** April 26, 2010 **c.** March 9, 2011 at the MD175 infiltration basin site.

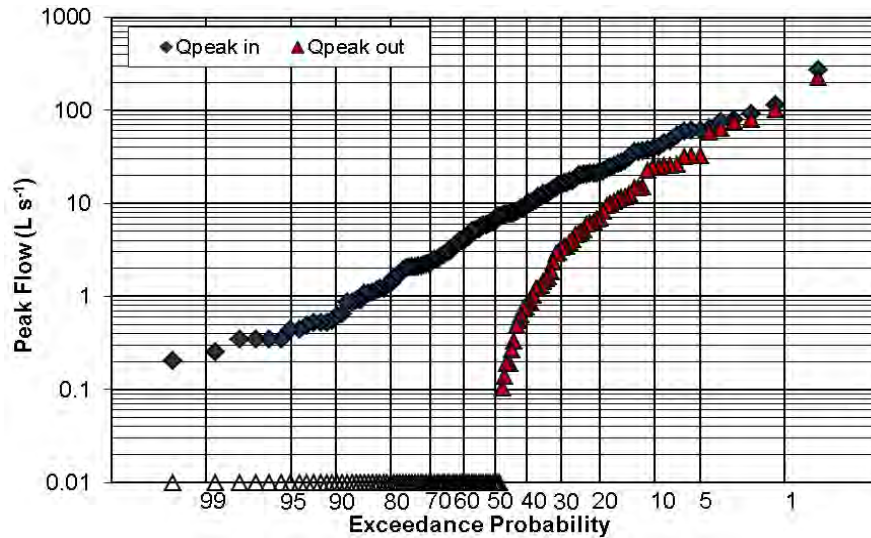
**Figure 9.** Probability plot for peak flows recorded at the MD175 infiltration basin site for the entire monitoring duration. Hollow points represent rainfall events with no discharge (complete capture of inflow).

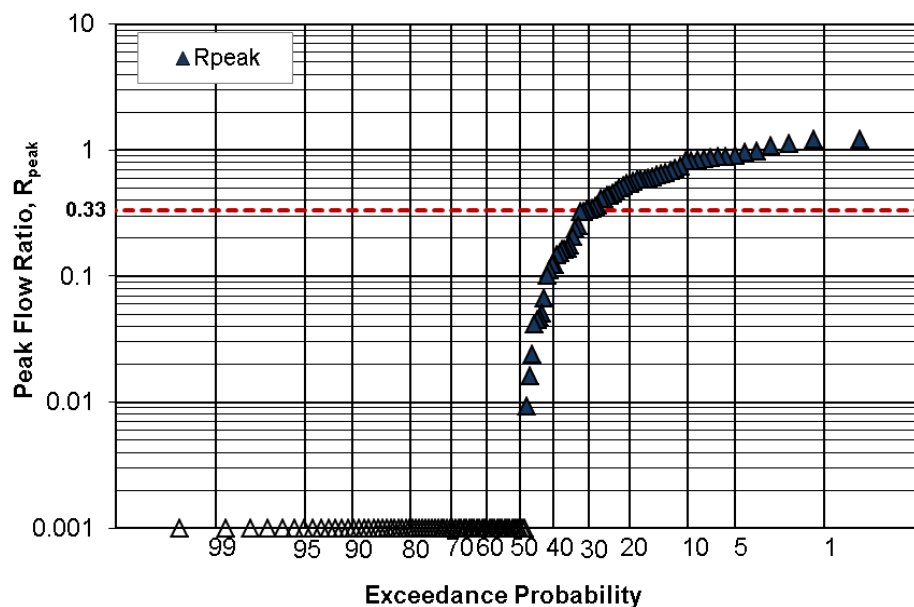
**Figure 10.** Probability plot for peak flow ratios ( $R_{\text{peak}}$ ) for 120 rainfall events recorded at the MD175 infiltration basin site. Hollow points represent rainfall events with no discharge (complete capture of inflow).

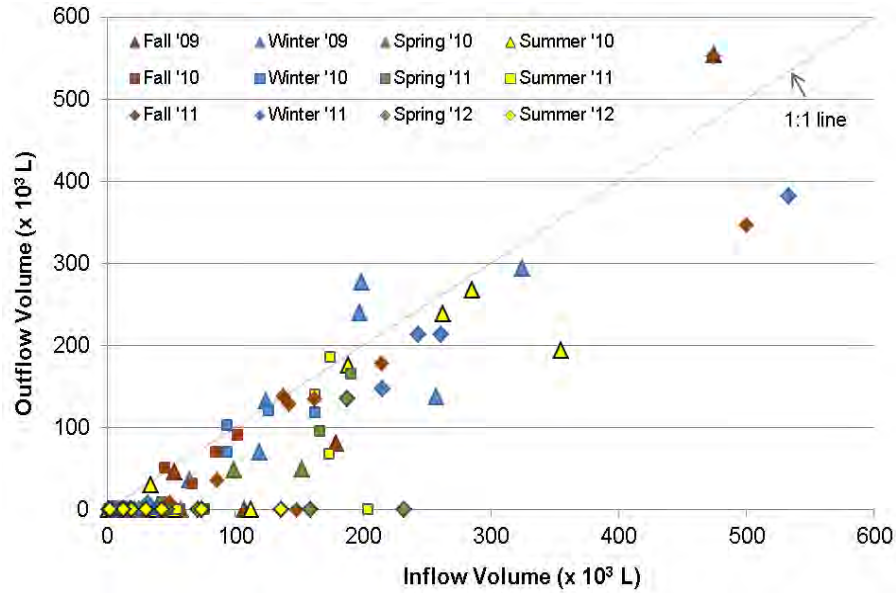
**Figure 11.** Inflow-outflow characteristics for 112 rainfall events recorded at the MD175 infiltration basin site from August 2009 to August 2012. (Eight large storm events were excluded to clearly show the distribution of the other data points).

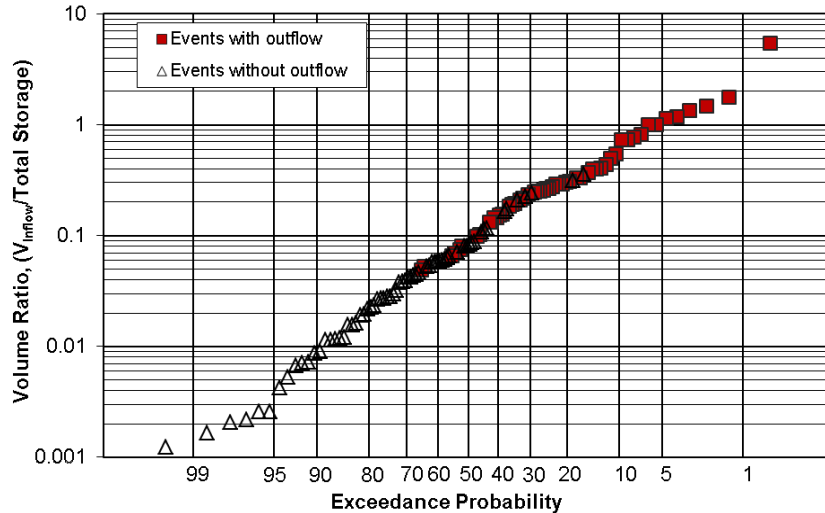
**Figure 13.** Probability plot for ratio of runoff inflow volume to design storage capacity of the infiltration basin for all rainfall events at the MD175 infiltration basin site. Data points are differentiated for rainfall events with and without outflow.

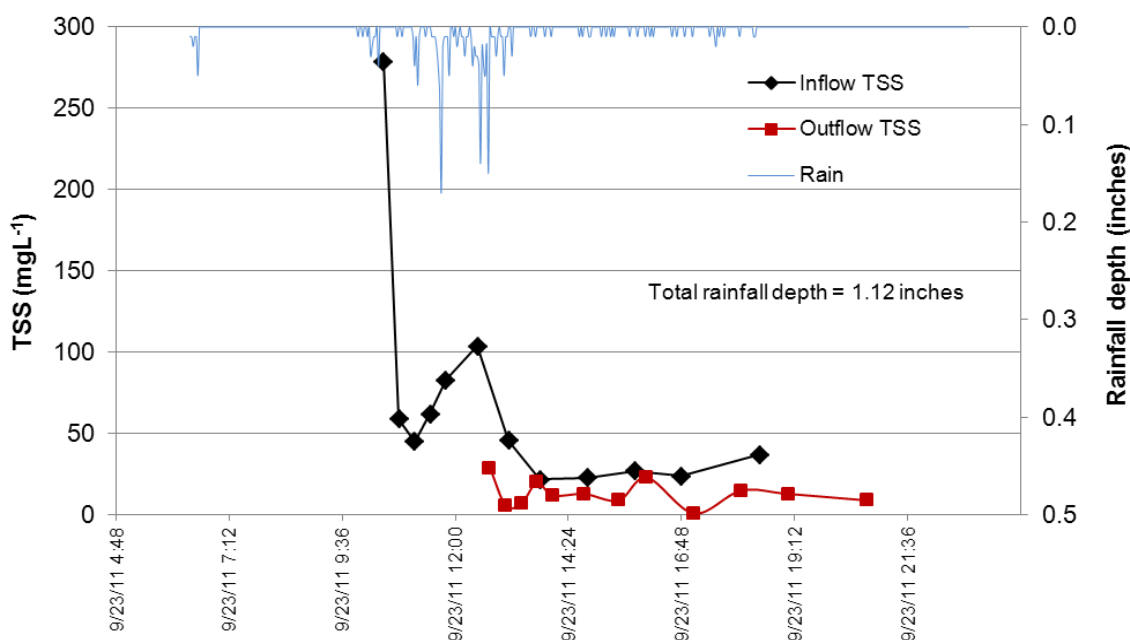
**Figure 21.** Pollutograph of inflow and outflow total suspended solids (TSS) recorded during the Sept 23, 2011, rainfall event at the infiltration basin.

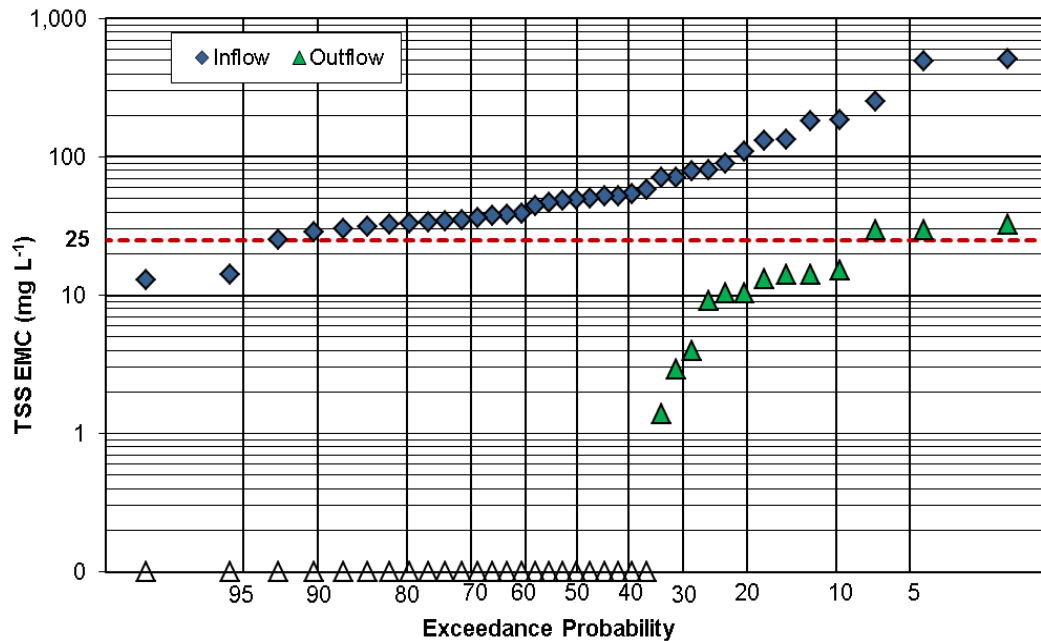
**Figure 22.** Probability plot for total suspended solids (TSS) EMCs at the infiltration basin. Open symbols represent storm events with no outflow. Dashed line represents the TSS water quality target criterion (25 mg L<sup>-1</sup>).

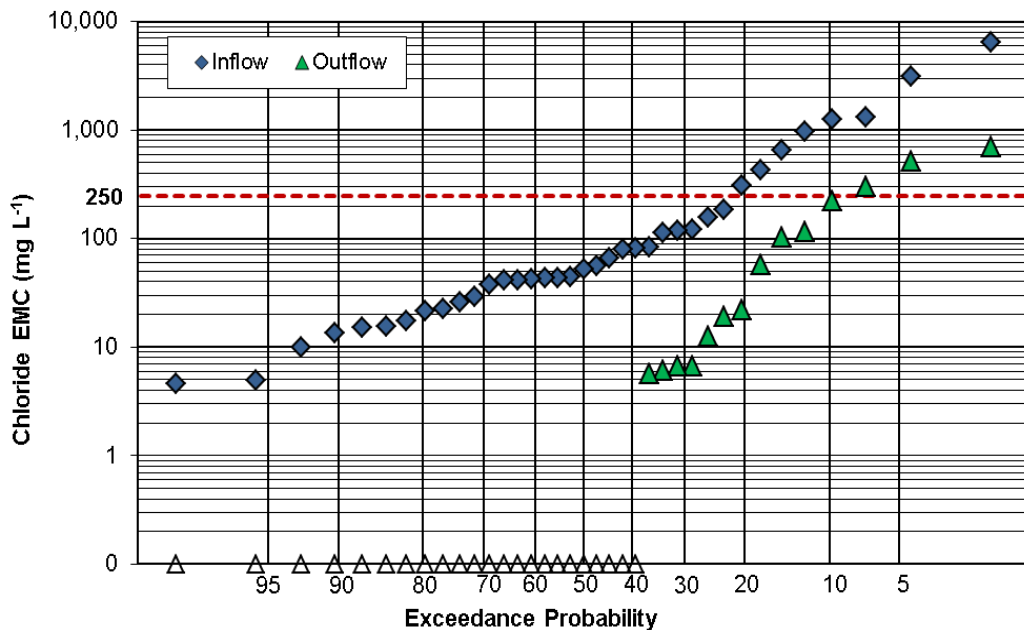
**Figure 31.** Probability plot for chloride EMCs at the infiltration basin site. Open symbols represent storm events with no outflow. Dashed line represents the chloride water quality target criterion ( $250 \text{ mg L}^{-1}$ ).

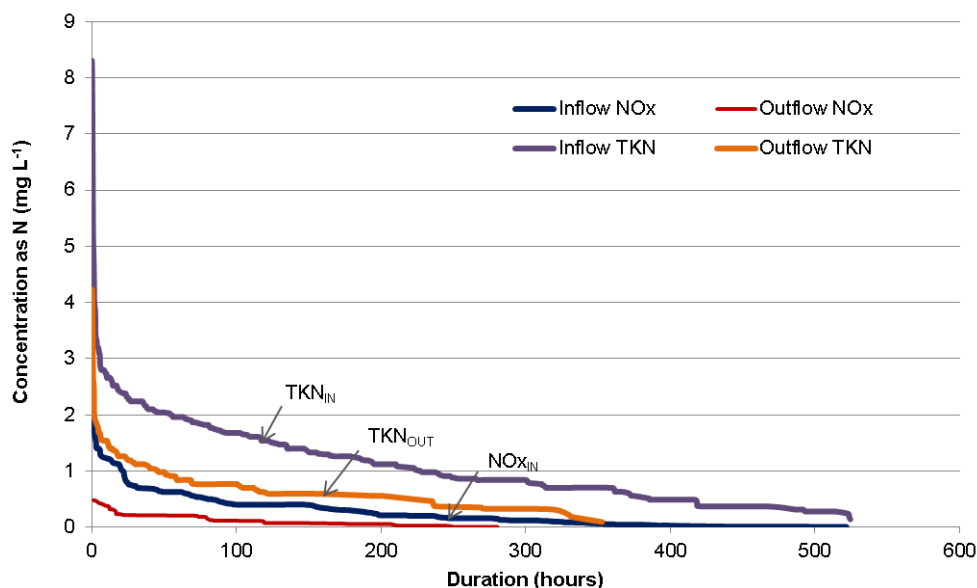
**Figure 39.** Pollutant duration curves for nitrogen species (TKN and  $\text{NO}_x\text{-N}$ ) at the infiltration basin site for the entire monitoring duration.
