National Pollutant Discharge Elimination System  
Phase I & II  
Municipal Separate Storm Sewer System  
Permit No. 99-DP-3313 MD0068276  
Permit Term October 2005 to October 2010

# Annual Report Update October 21, 2015

Re: Annual NPDES MS4 Phase I and II Report  
Update  
Permit No. 99-DP-3313 MD0068276  
Continuation

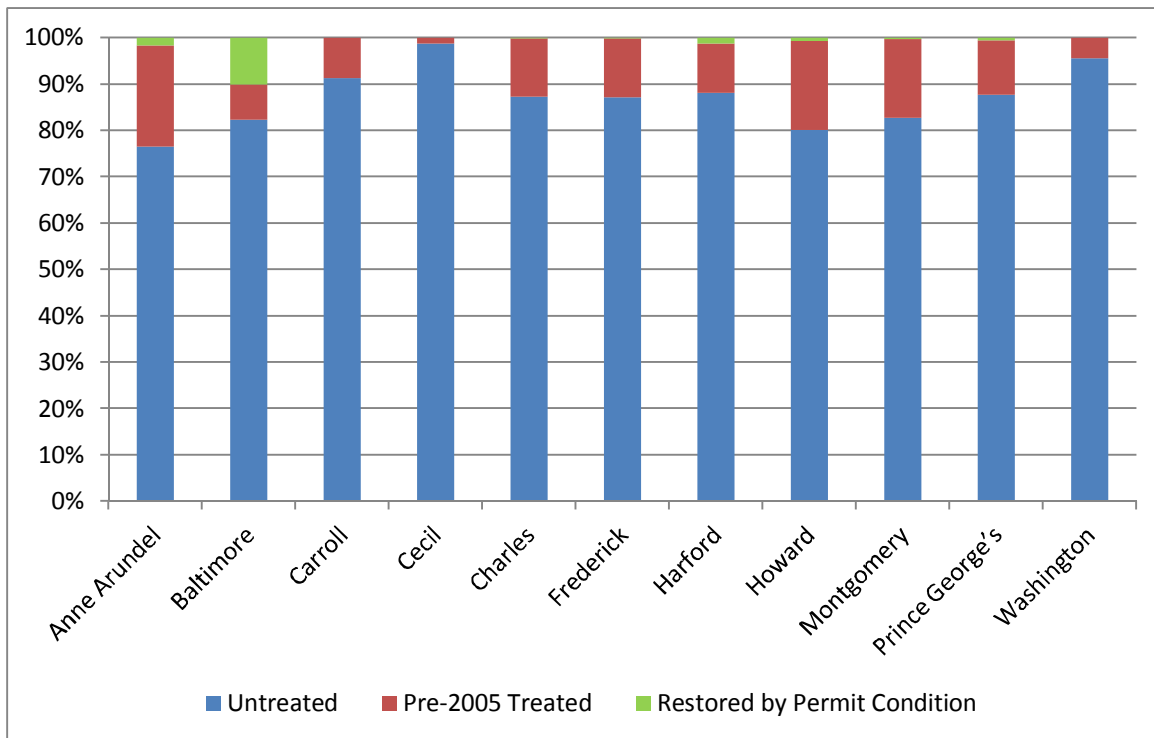
**Figure 1-4: SHA Impervious Restoration Progress by County**

We completed the impervious accounting requirement and the baseline accounting numbers were reflected in the 2010 report. Table 1-3 (on the following page) displays the baseline untreated impervious numbers for SHA by county and progress of the restoration based on the requirement for twenty-five restoration projects (permit condition G.1). Figure 1-4 (on the following page) provides a graphic illustration of the progress.

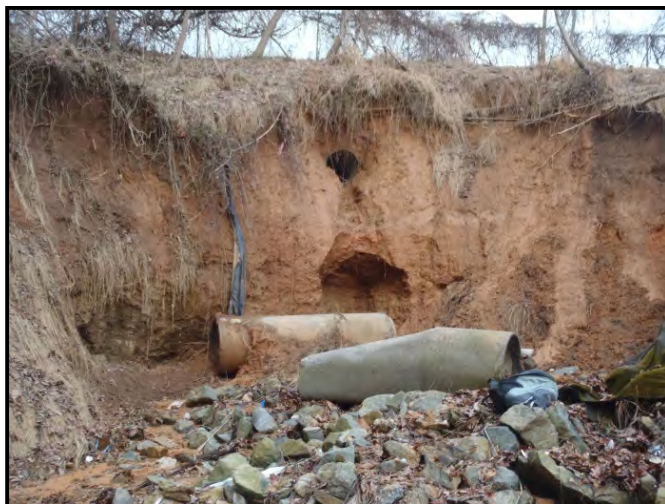
**Figure 1-10: Outfall in need of Stabilization, I-97 in Anne Arundel County**

As a case study the I-97 southbound Outfall Stabilization project is described, as seen in Figures 1-10 and 1-11 on the following page. This project is being designed by SHA-OED for TMDL crediting as part of their Capital Improvements projects. The I-97 outfall channel drains a 30 acre, 55% impervious watershed, and contains variable bank heights up to 21 ft consisting of primarily sand. Comparison between existing and equilibrium conditions indicates that 10,296 tons of material is expected to be eroded before the channel reaches equilibrium. Pollutant reductions using the alternative method are compared to the methods provided in CBP 2014 and the alternative method predicts eight times higher pollutant reduction on average than Protocol 1, assuming a 20 year timeframe. An imperious restoration equivalency that will allow the SHA to align outfall stabilization projects to the MS4 permit imperious restoration requirements is under development.

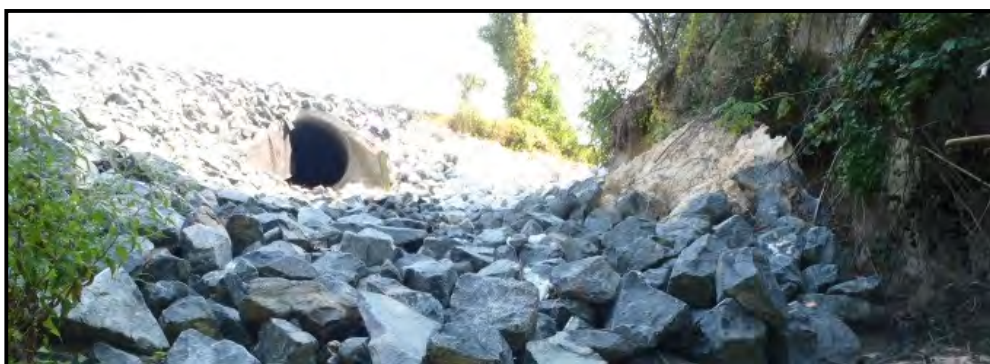
**Figure 1-11: Stabilized Outfall, I-97 in Anne Arundel County**

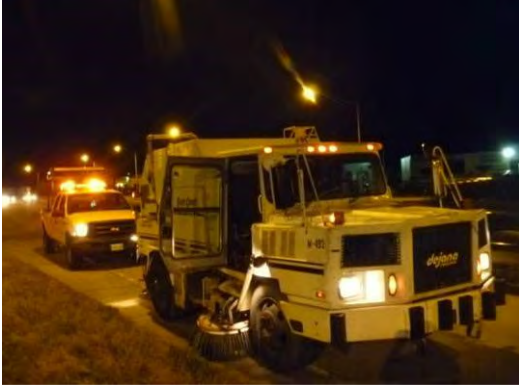
**Figure 1-14: Street Sweeping often takes place at night due to high traffic volumes in urbanized counties**

Mechanical sweeping of the roadway is essential in the collection and disposal of loose material, debris, and litter into approved landfills. This material, such as dirt and sand, collects along curbs and gutters, bridge parapets/curbs, inlets, and outlet pipes.

Sweeping prevents buildup along sections of roadway and allows for the free flow of water from the highway, to enter into the highway drainage system. See Figure 1-14 below for an example of SHA's street sweeping activity.

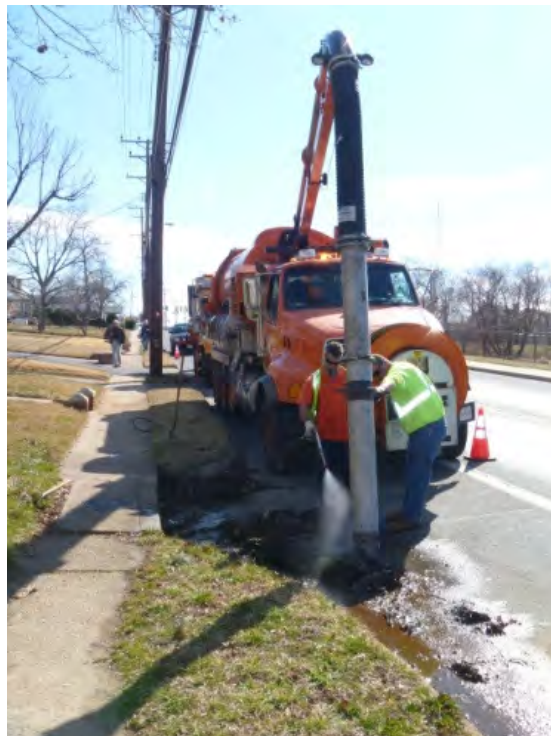
**Figure 1-15: SHA Shop Personnel Operating Vacuum Truck to Clean Roadside Debris**

In addition to street sweeping, SHA owns and operates four vacuum pump trucks that routinely clean storm drain inlets along roadways. Sediment and trash make up the majority of the material that is removed. The vacuum trucks operate in central Maryland, spanning the following counties: Anne Arundel, Baltimore, Calvert, Carroll, Charles, Frederick, Harford, Howard, Montgomery, Prince Georges and St. Mary's. This practice ensures safer roadways through maintaining proper drainage and improves water quality in Maryland streams by removing captured sediment and trash before they enter adjacent waterways.

See Figures 1-15 (below) and 1-16 (following page) for examples of street vacuuming and inlet cleaning.

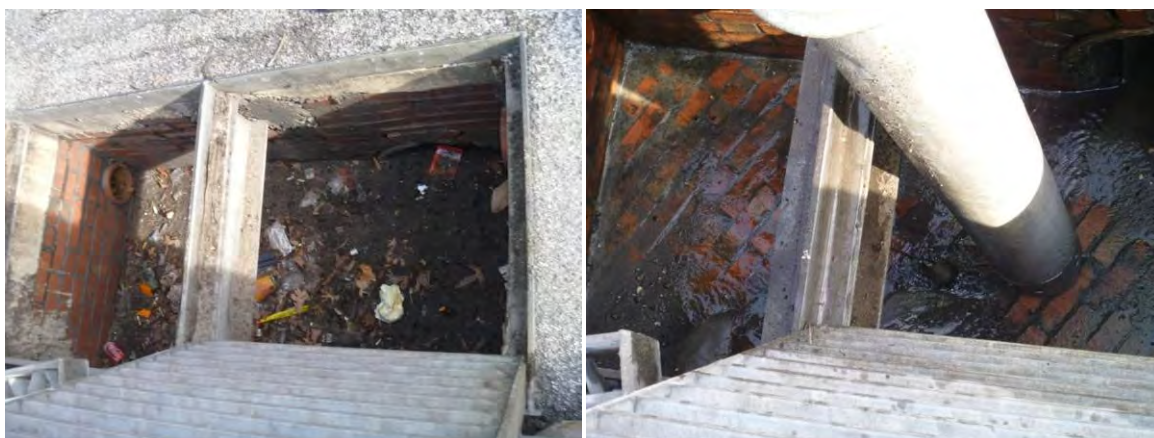
**Figure 1-16: Inlet Before and After Vacuuming**

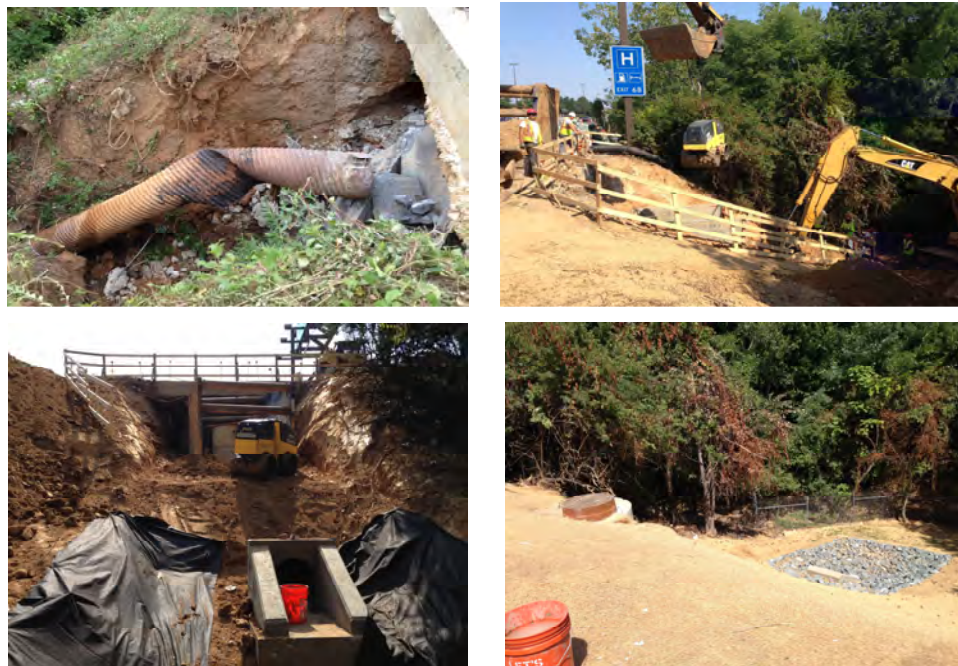
**Figure 1-17: Outfall Remediation at I-270 in Montgomery County**

allow SHA to efficiently deliver projects of an urgent nature such as emergency repairs. SHA typically manages three or four area wide contracts for drainage and stormwater asset remediation with annual expenditures of \$5-\$7 million. Examples projects constructed using these contracts are outfalls at I-270 in Montgomery County and Swan Creek stream stabilization in Harford County as shown in Figures 1-17 below and 1-18 on the following page.

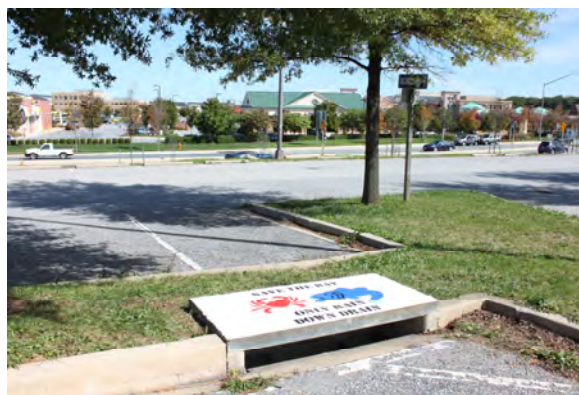
**Figure 1-24: Finished Stencil Design on Storm Drain**

SHA supported the Howard County Watershed Stewards Academy (WSA) who initiated a storm drain stenciling program in collaboration with local Boy Scout organizations. The goal of the project was to educate middle school-aged students about sources of stormwater pollution, provide them with information to help solve stormwater pollution problems, and reduce polluted runoff into the Chesapeake Bay. The first storm drain stenciling occurred at the Scaggsville Park and Ride off of MD 216 in Howard County. The stencil designs were developed by local Boy Scout Troops for competition with SHA staff serving as one of the judges. The winning designs were applied to the storm drains at the the Park and Ride to help raise awareness of the general public about water quality issues within our communities, the adverse impacts of urban pollutions to the water resources and potential stewardship measures. Figures 1-23 and 1-24 show stenciled inlets painted by local Boy Scout volunteers.

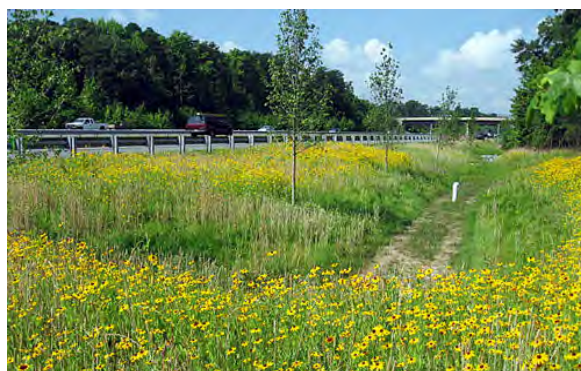
**Figure 1-28: SHA Sand Filter BMP Example used on the Website**

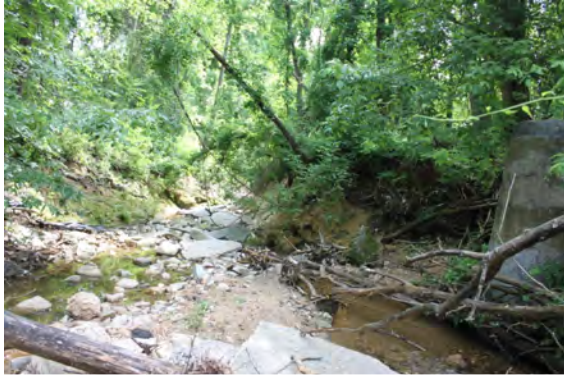
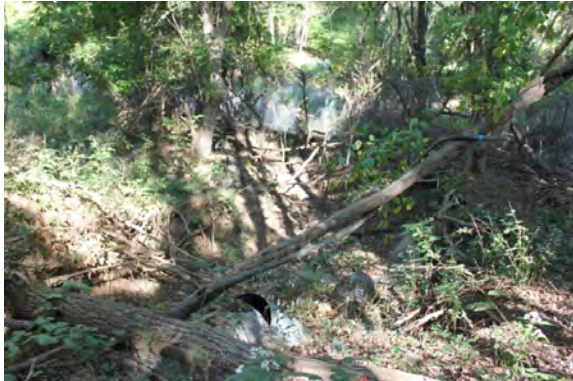
**Figure 1-31: Existing Conditions at Minebank Run**

Design activities continue for this project addressing multi outfall stabilization, stream restoration and SWM retrofits. Minebank Run is within the Gunpowder River Watershed that is targeted by Baltimore County for restoration. This reach is located between two stream restoration projects lead by Baltimore County, therefore SHA has been coordinating with Baltimore County on the restoration effort as well as relocation of sanitary sewer that is currently greatly impacted by the degrading channel. The final design plans will be developed in 2016. The project is scheduled for construction in 2017-18. This project will result in significant pollutant load reductions for the Gunpowder River Watershed as well as improve local drainage infrastructure issues and adverse impacts of the upstream urbanization through upland SWM water quality retrofit within I-695 interchange, providing stable conveyance of the surface drainage, stabilizing 4 degraded outfall channels and restoration of the main channel to address the stream degradation. See Figures 1-31 through 1-33 on the following page.

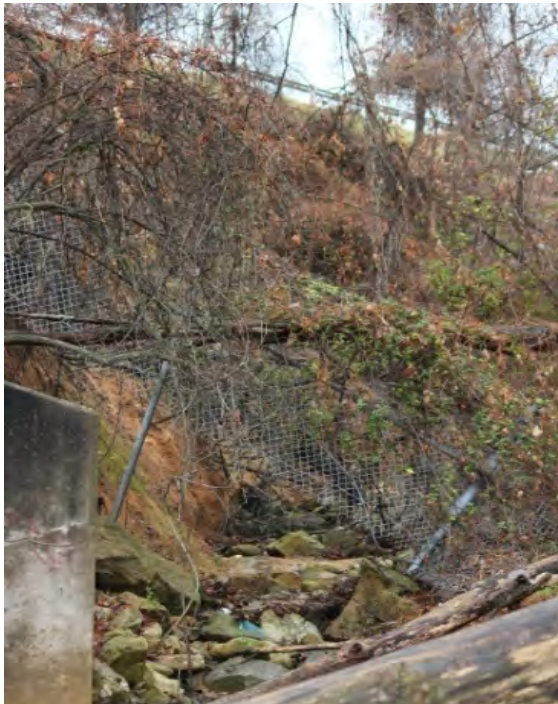
**Figure 1-32: Stormwater Retrofit Site at Minebank Run**

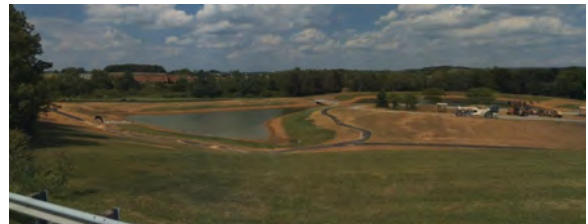
**Figure 1-34: Westminster Pond Stormwater Retrofit**

This project has been developed by Carroll County and the construction is completed. SHA's function was to provide a technical guidance through the procurement process and funding through Transportation Alternatives Program (TAP). The project is a SWM retrofit of a regional pond originally designed for flood control to treat currently untreated impervious surfaces within a 250 acre watershed. A total of 25 acres of SHA owned impervious surface will receive treatment when the project is completed. See Figure 1-34 below.

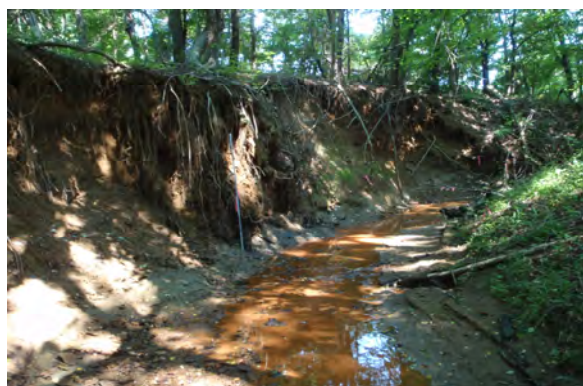
**Figure 1-35: Existing Conditions of Broad Creek**

SHA and South River Federation have partnered to restore the headwaters of Broad Creek, a significant source of sediment to downstream waterways including the Chesapeake Bay. See Figure 1-35 for a view of existing conditions of a steeply cut bank along Broad Creek.

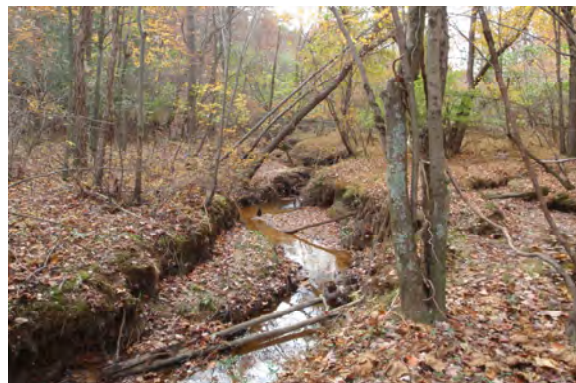
**Figure 1-36: Degraded Stream Banks along Jabez Creek**

SHA has completed the watershed assessment and restoration plan. We are working with the county to implement projects and will meet with the stakeholder group in late September to inform the groups of progress and opportunities for watershed group participation. The meeting is a continuation of ongoing dialogue and a March 2015 meeting where the watershed assessment was presented. SHA will be pursuing several projects and monitoring of downstream reaches. See Figure 1-36 for a photo of existing conditions.

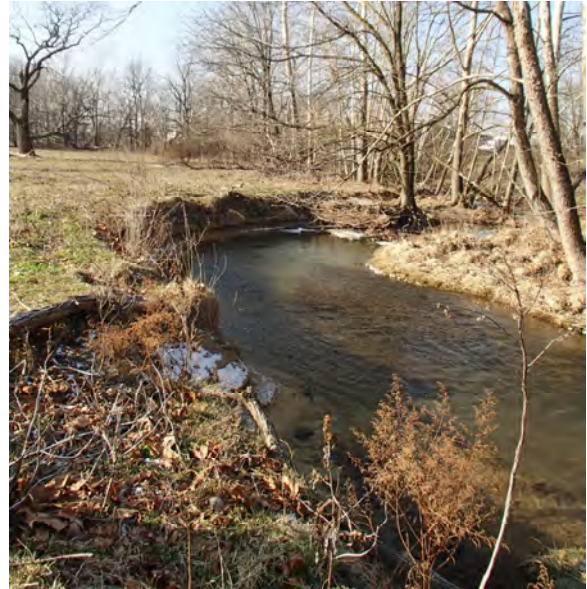
**Figure 1-37: Existing Conditions at Israel Creek in Frederick County**

A stream restoration of Israel Creek in Frederick County will extend into Woodsboro Park. SHA will partner with the Town of Woodsboro to repair and stabilize the reach within the park. SHA will begin design in late 2015 and construction will begin in 2019. See Figure 1-37.

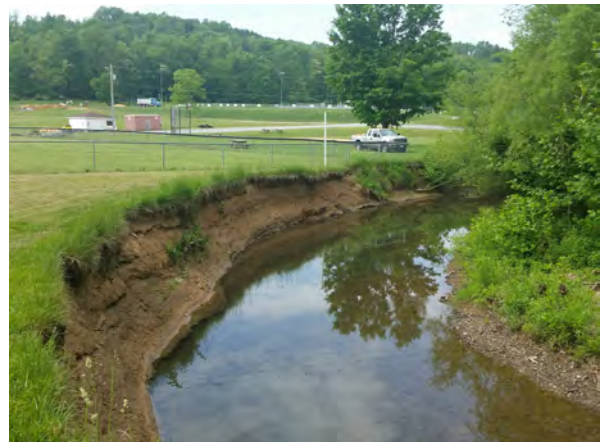
**Figure 1-38: Existing Conditions at Little Tonoloway Creek in Washington County**

Little Tonoloway Creek in Kirkwood Park is actively eroding threatening park facilities. SHA will partner with the Town of Hancock to stabilize the stream. SHA will begin design in early January 2016 and construction will begin 2018. See Figure 1-38 below.

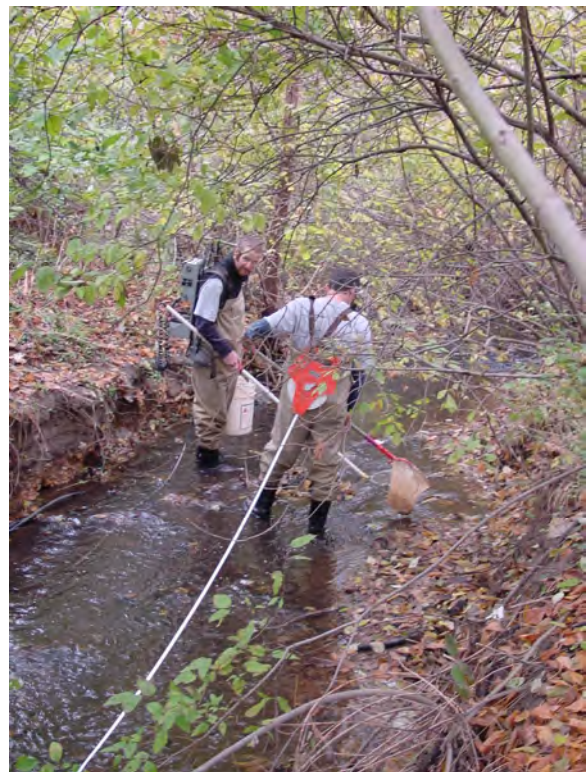
**Figure 1-39: Biological Monitoring Efforts**

Based on the previous approval of the Long Draught Branch project by MDE-WMA, significant pre-construction monitoring (physical, chemical and biological) was performed (See Figure 1-39). The final report for the pre-construction monitoring data was included in the SHA Third Annual Report, 2008, Appendix I. Since the project has been delayed, the post-construction monitoring data will not be available until after the construction is completed.

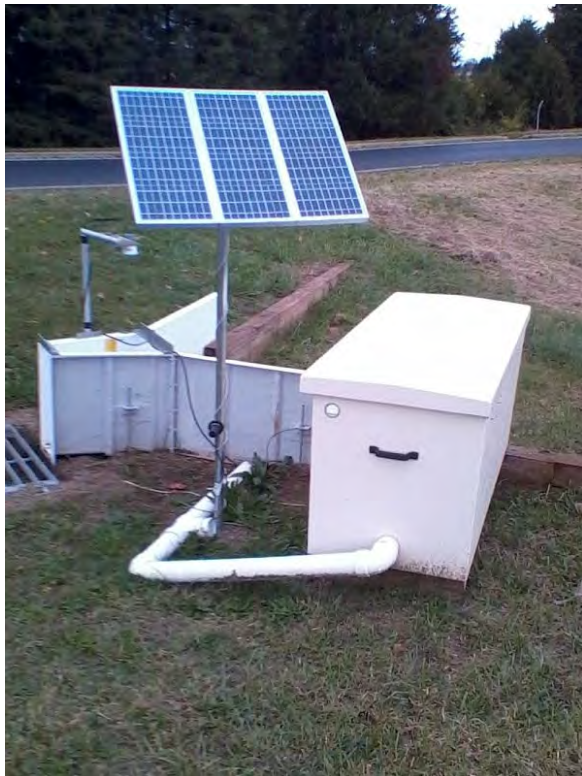
**Figure 1-40: Bioswale Monitoring Equipment**

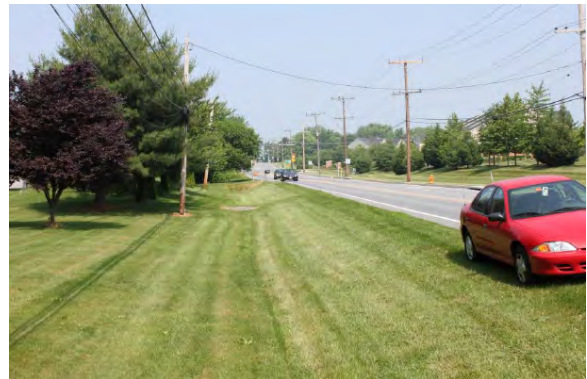
**Figure 1-41: Grass Swale Pavement Disconnection**

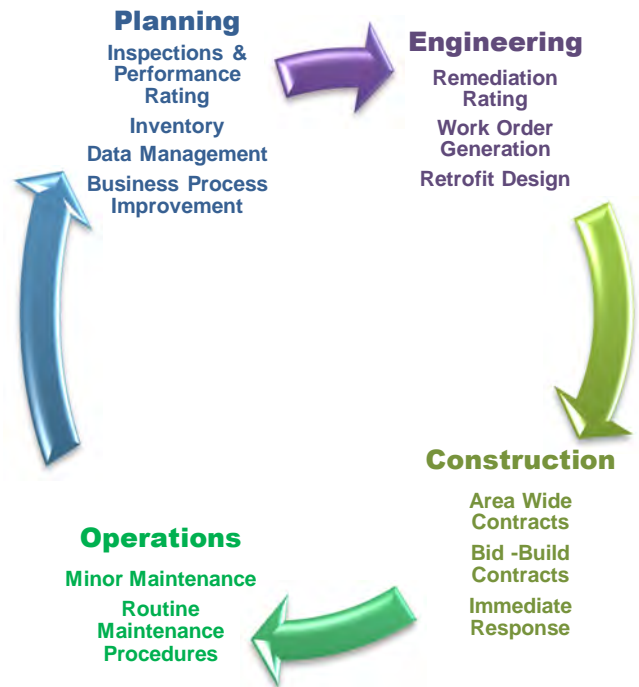
**Figure 2-1 - Stormwater Asset Management Program**

The Program, represented in Figure 2-1, is divided into four major components. These are, planning, design, construction, and operations.

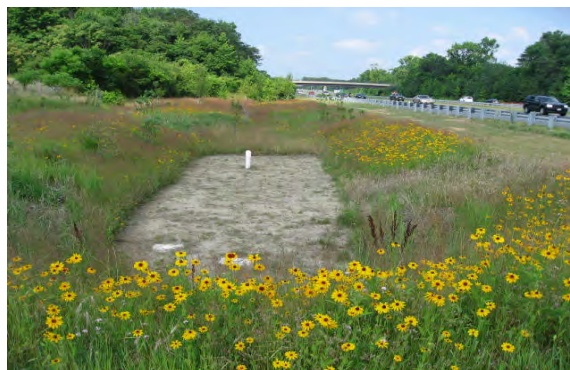
**. I No Response Required** - The asset is functioning as designed. Re-schedule for the next multi-year inspection assessment period.

Figure 2-2: Infiltration Sand Filter Rated I

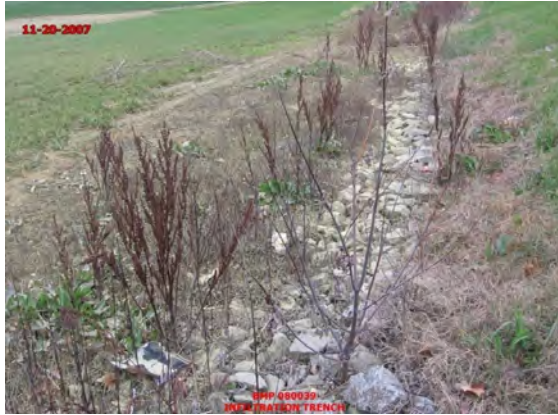
**II Minor Maintenance** - The asset is functioning as designed, but routine and preventative action should be performed to sustain effective performance.

**Figure 2-3: Infiltration Trench Rated II requiring vegetation and trash removal**

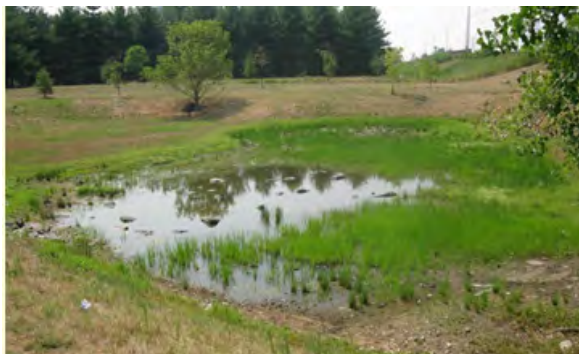
**Figure 2-4: Infiltration Basin Rated III (Infiltration is hampered and flooding beginning)**

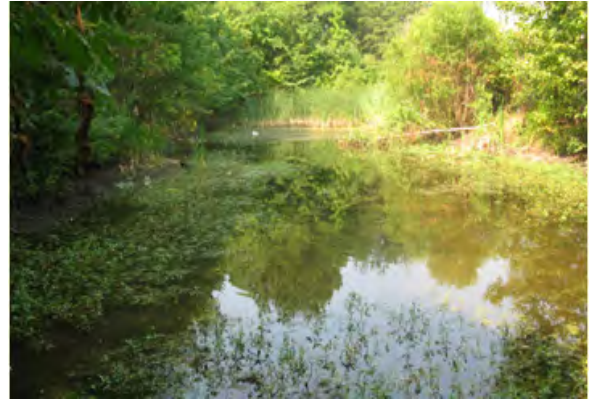
**Figure 2-5 Infiltration Basin Rated IV (significant flooding and water not able to be retained in the original footprint.)**

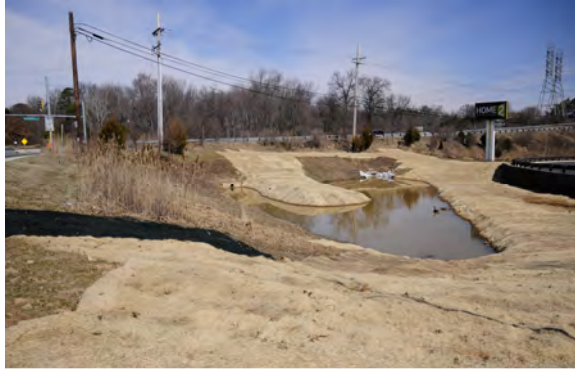
**Figure 2-6: Major maintenance performed on BMP 030181 in Baltimore County**

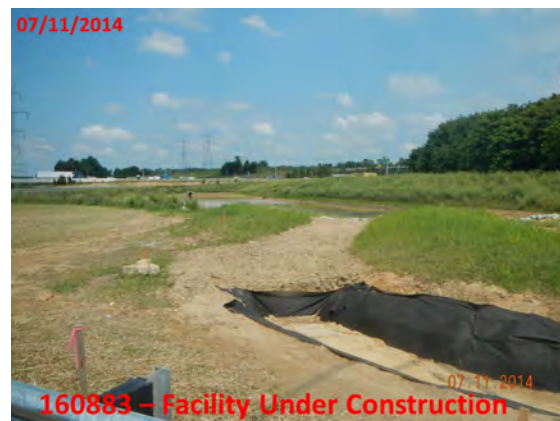
**Figure 2-7 – SWM Facility 160883 Under Retrofit Construction**

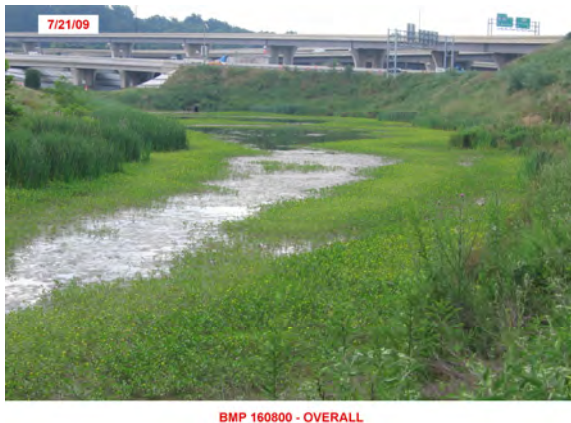
**Figure 2-8 – SWM Facility 160800 After Construction**

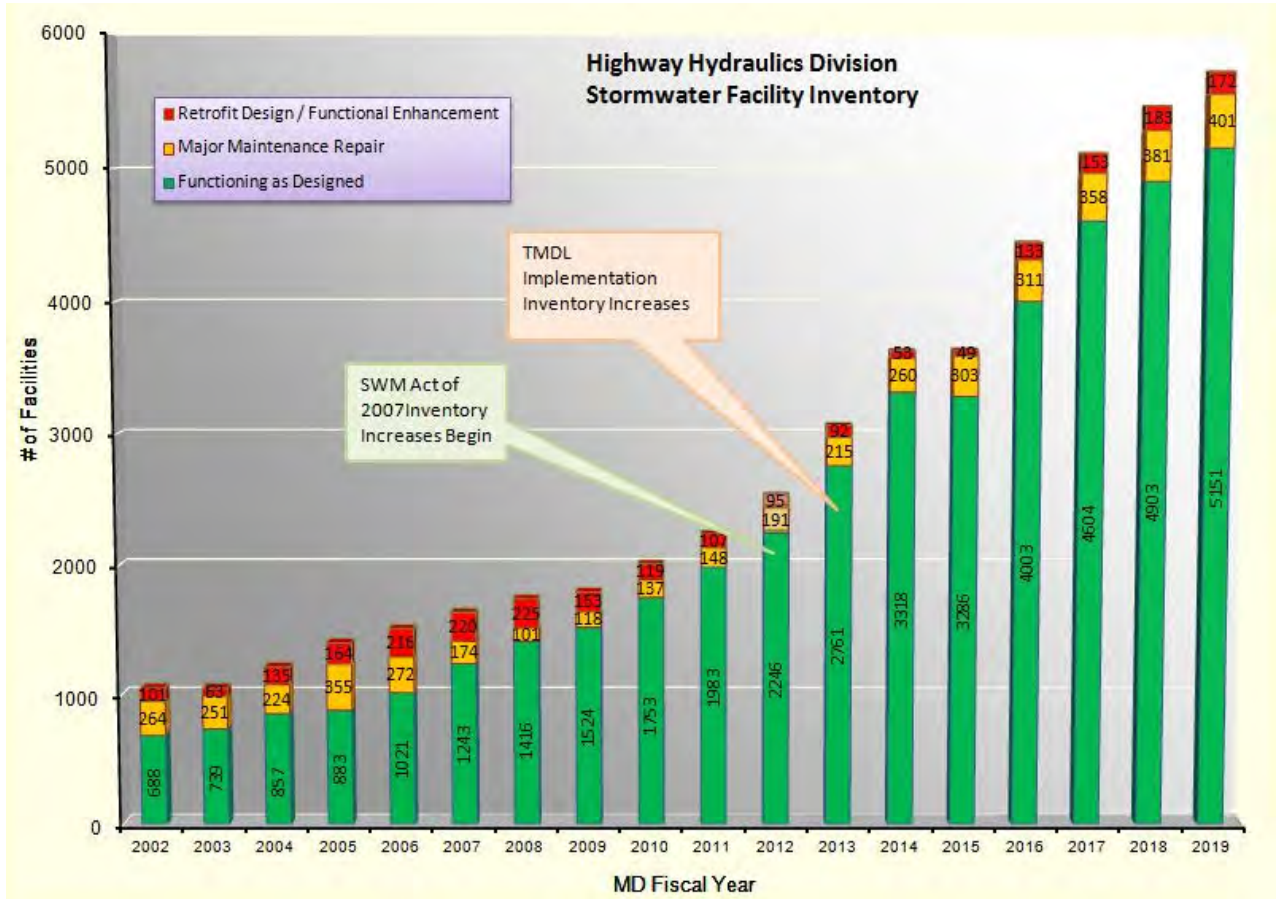
**Figure 2-9: SWM Inventory Functional Rating and Projected Trend**

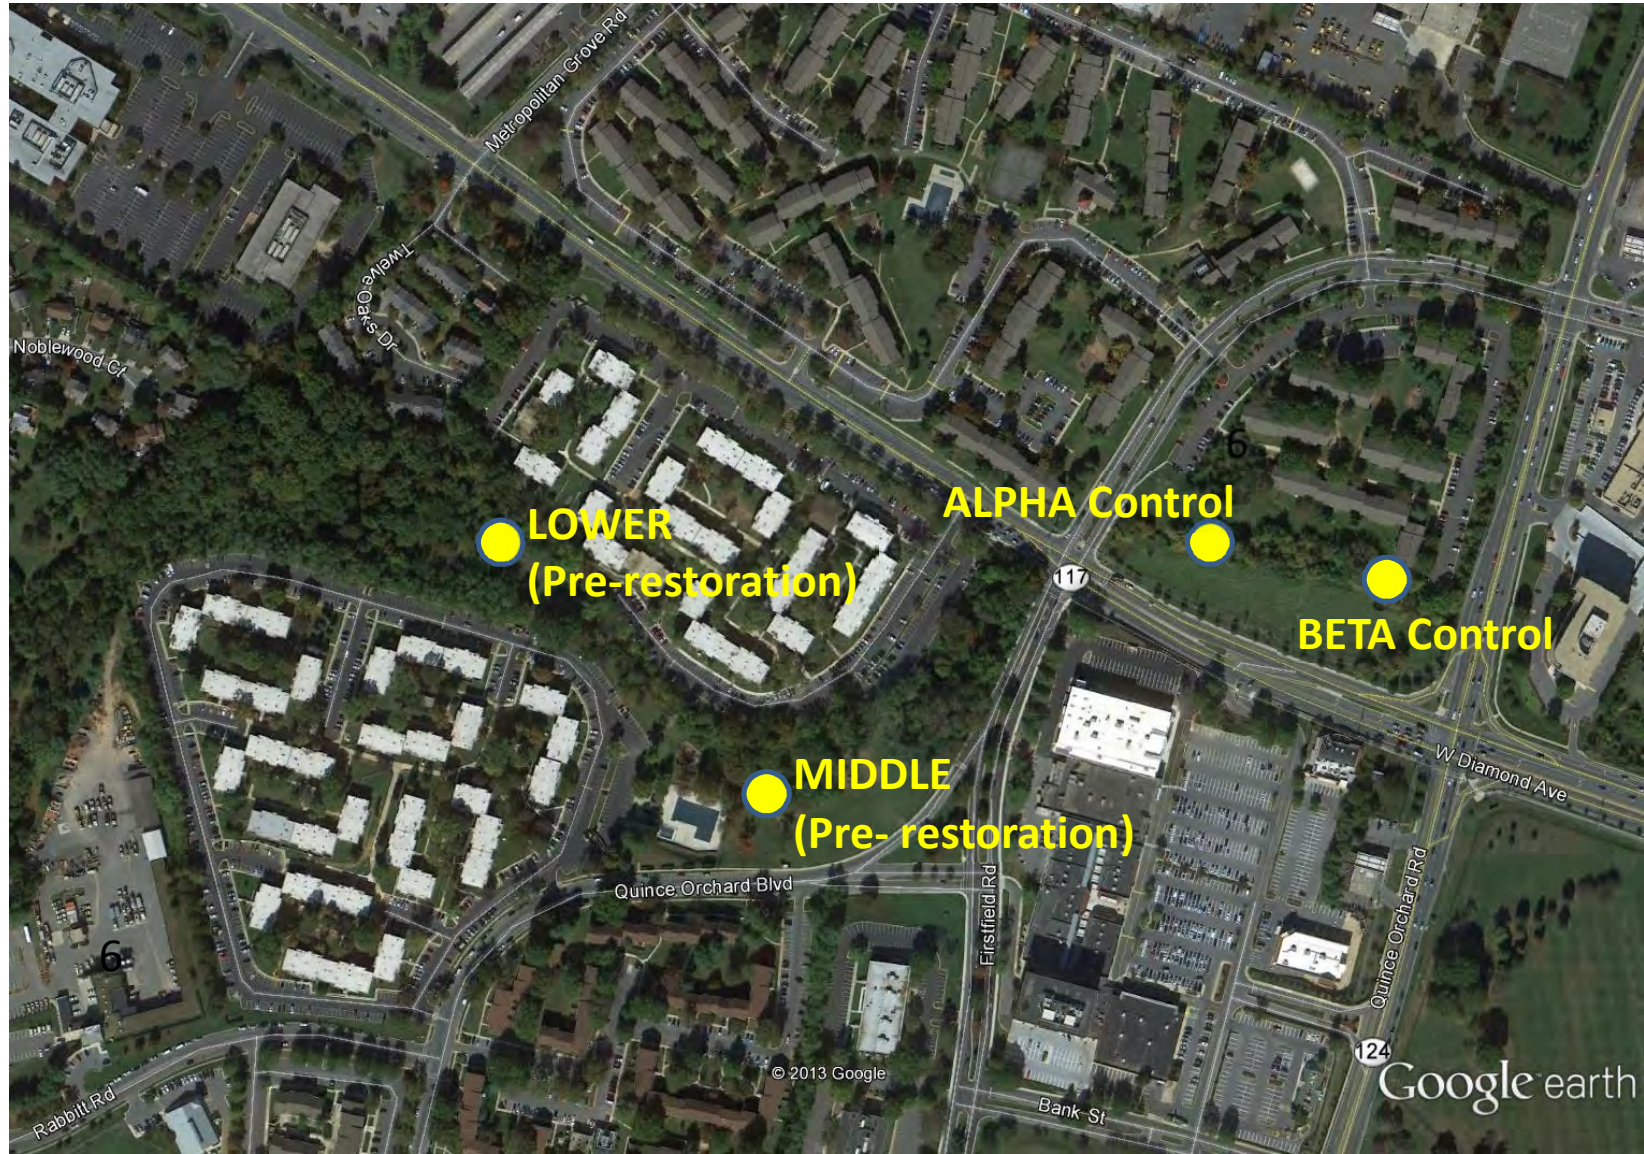
Figure LDB 1. Site locations for sampling of Long Draught Branch (LDB) in Montgomery County.

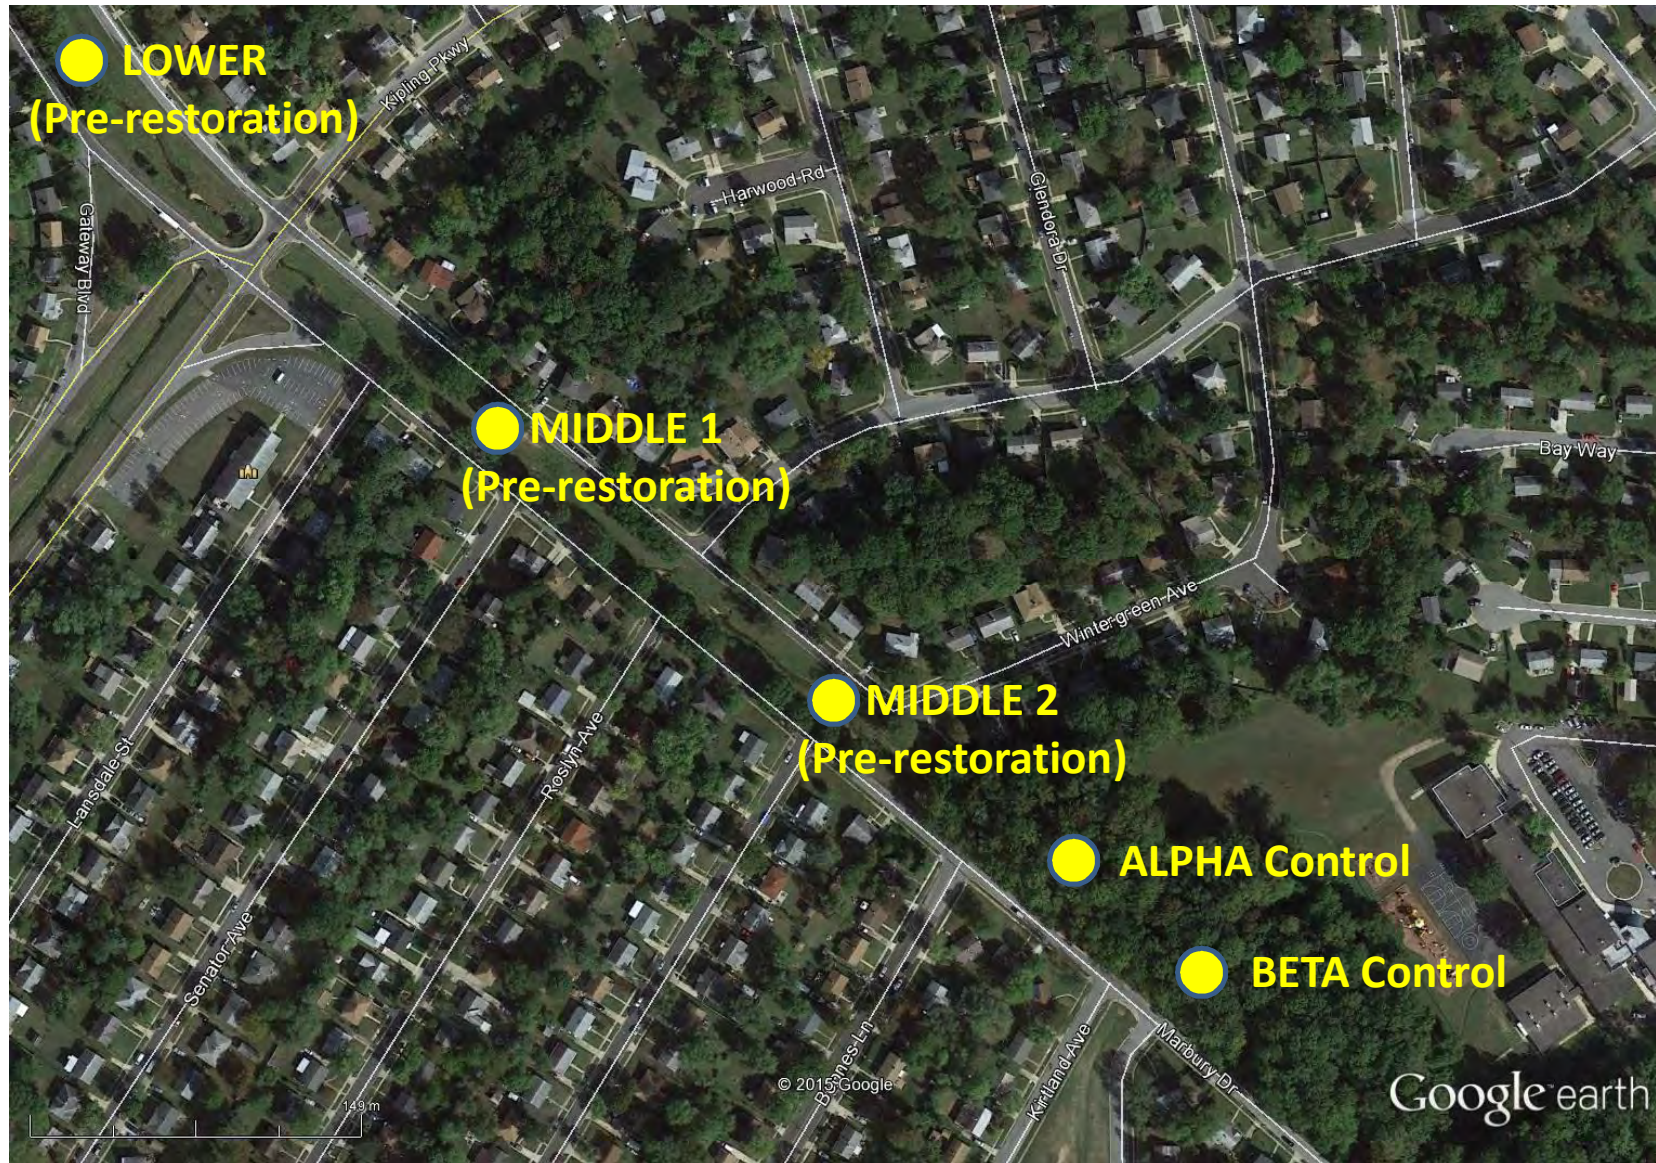
Figure MAR 1. Site locations for sampling of Marbury Drive (MAR) - UTRB (Prince Georges County).  
MIDDLE 2 was only sampled in Fall 2014.

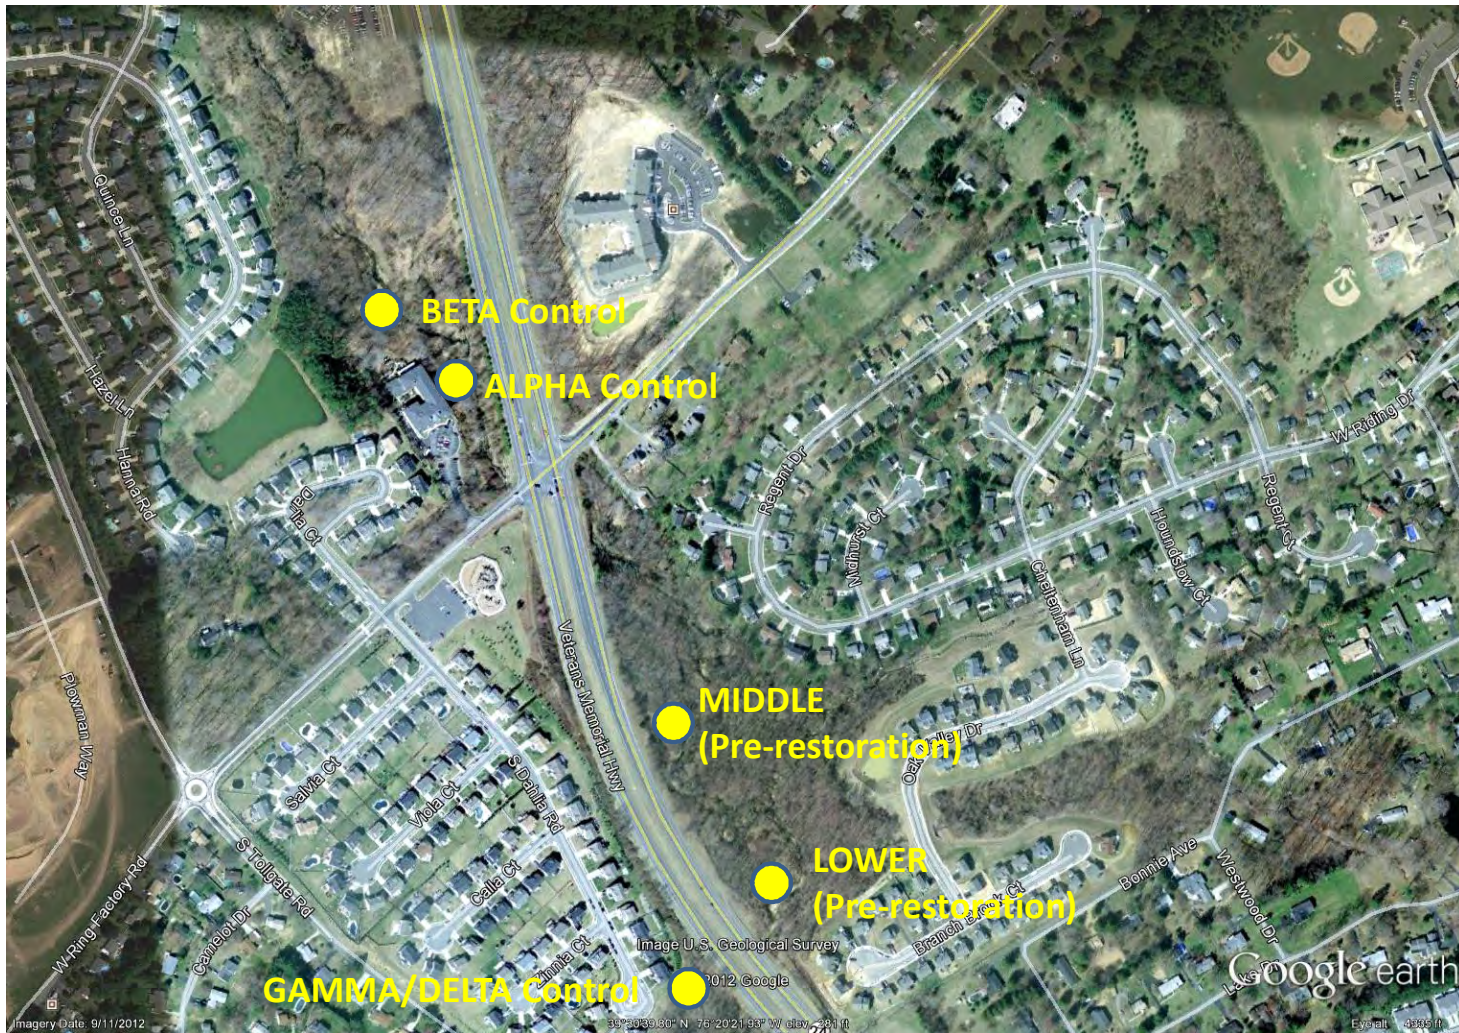
Figure PTR 1. Site locations for sampling on Plumtree Run (Harford County).

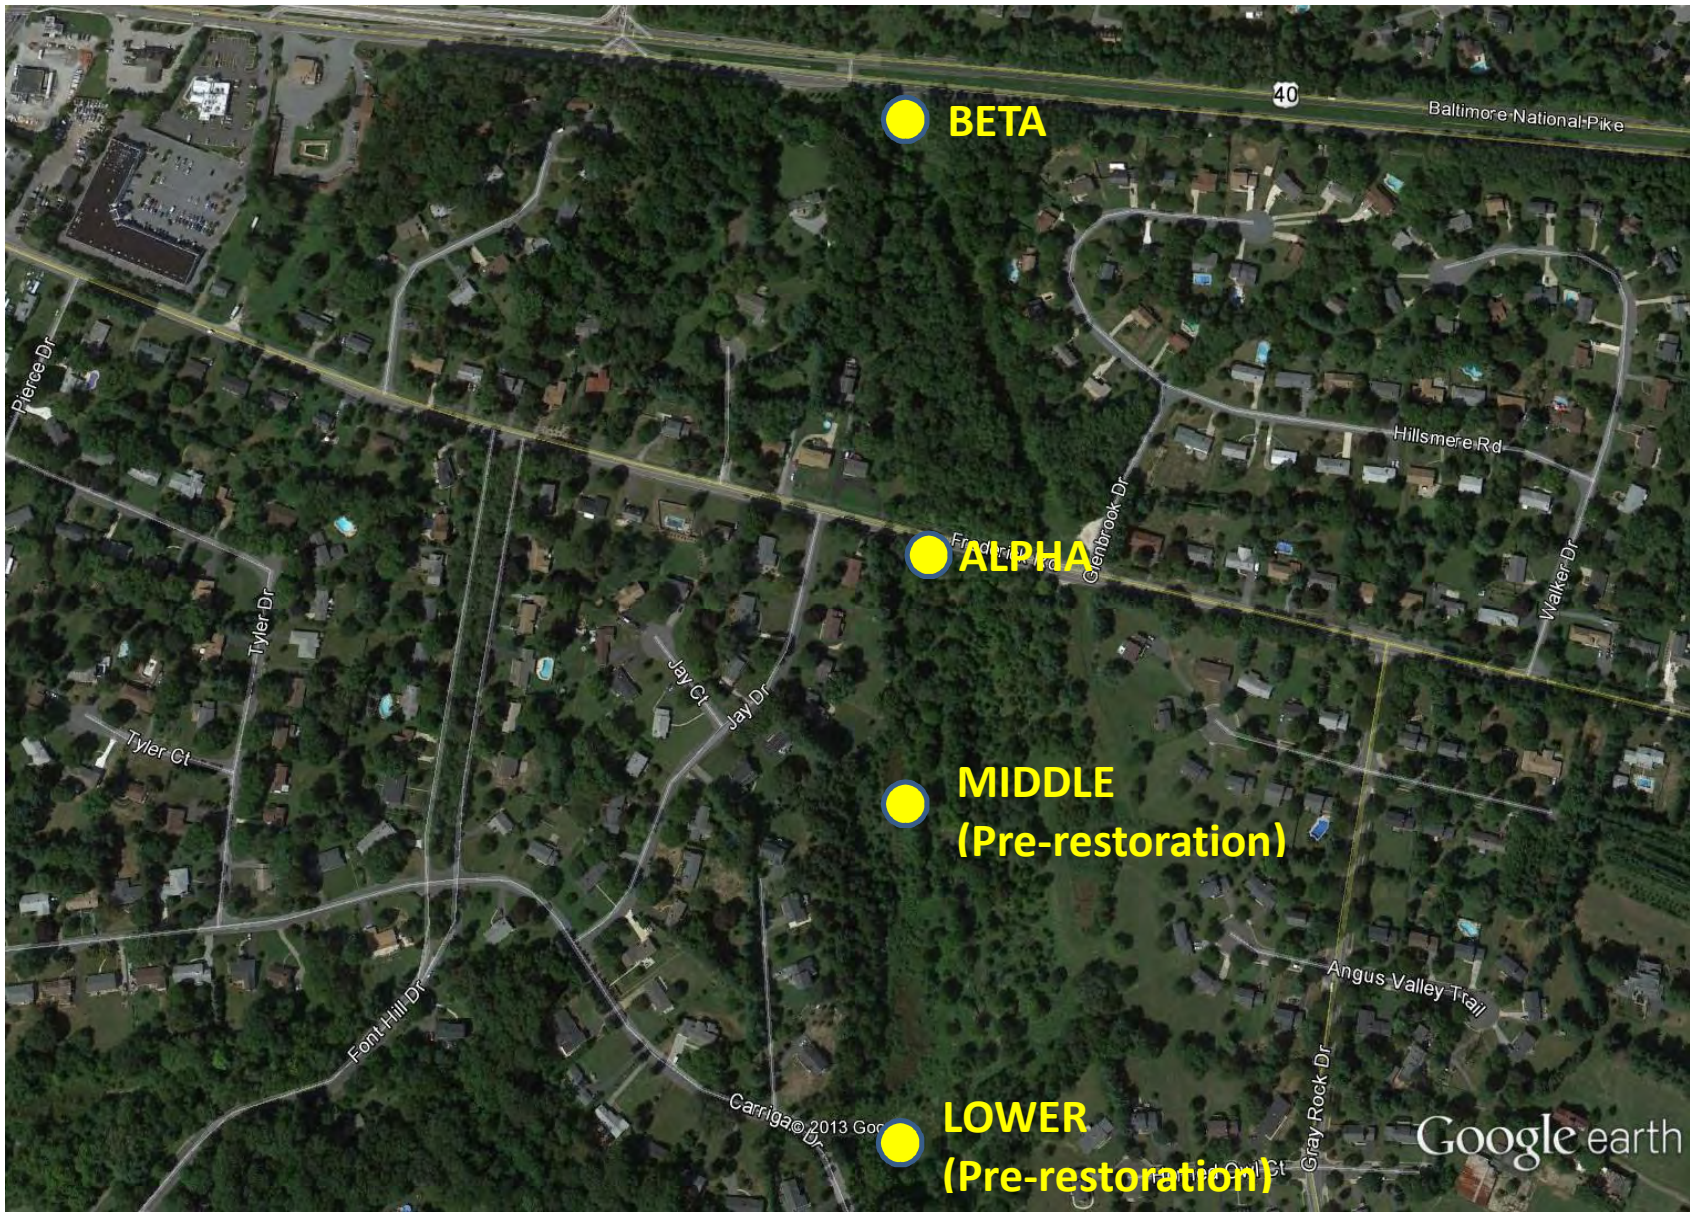
Figure ULPR 1. Site locations for sampling of Upper Little Patuxent River (Howard County).
