Evaluation of The FreezeFree Anti-Icing System

Final Report

April 22, 2005

Evaluation of the FreezeFree Anti-Icing System Final Report

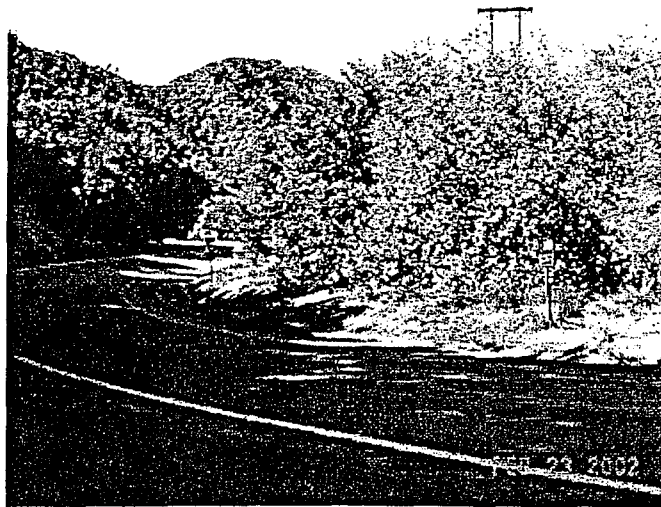
Figure 3.7: FreezeFree Automated System Installation Site, Los Angeles, CA

The installation site is located on State Route 2 in the East-West segment outside of Los Angeles, California. The length of the test section is 1,200 feet, with a width of 24 feet for travel. The nearest maintenance station is located at about 15 miles from the test site. This section of the highway has an annual average daily traffic (AADT) of 1,300 vehicles per day (VPD). The California Highway Patrol (CHP) is the agency responsible for processing collision reports for this location.
