RESEARCH REPORT

LONG-TERM BED DEGRADATION IN MARYLAND STREAMS (PHASE 2): BLUE RIDGE AND WESTERN PIEDMONT PROVINCES

Project Number SP109B4K
FINAL REPORT

March 2012

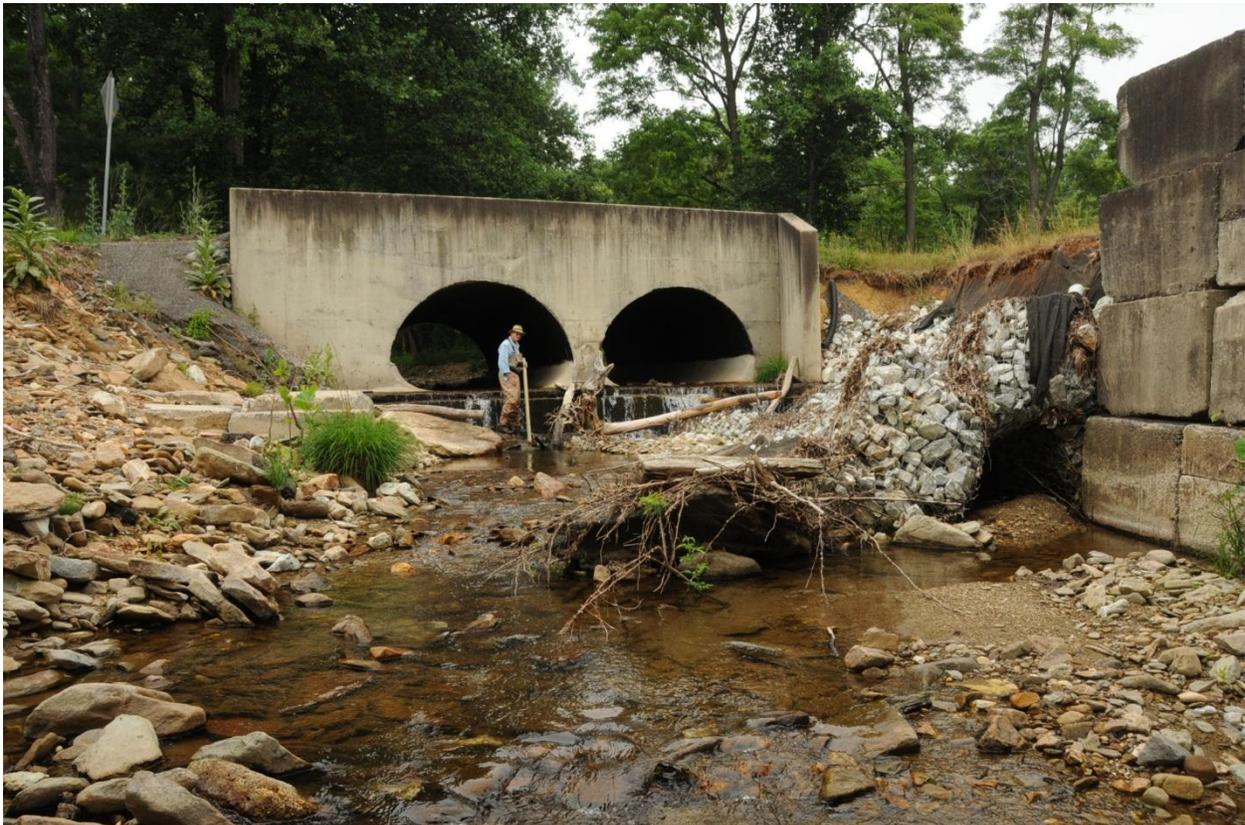
Photo 4.1. LTBD measured at the culvert outlet of Site 45.

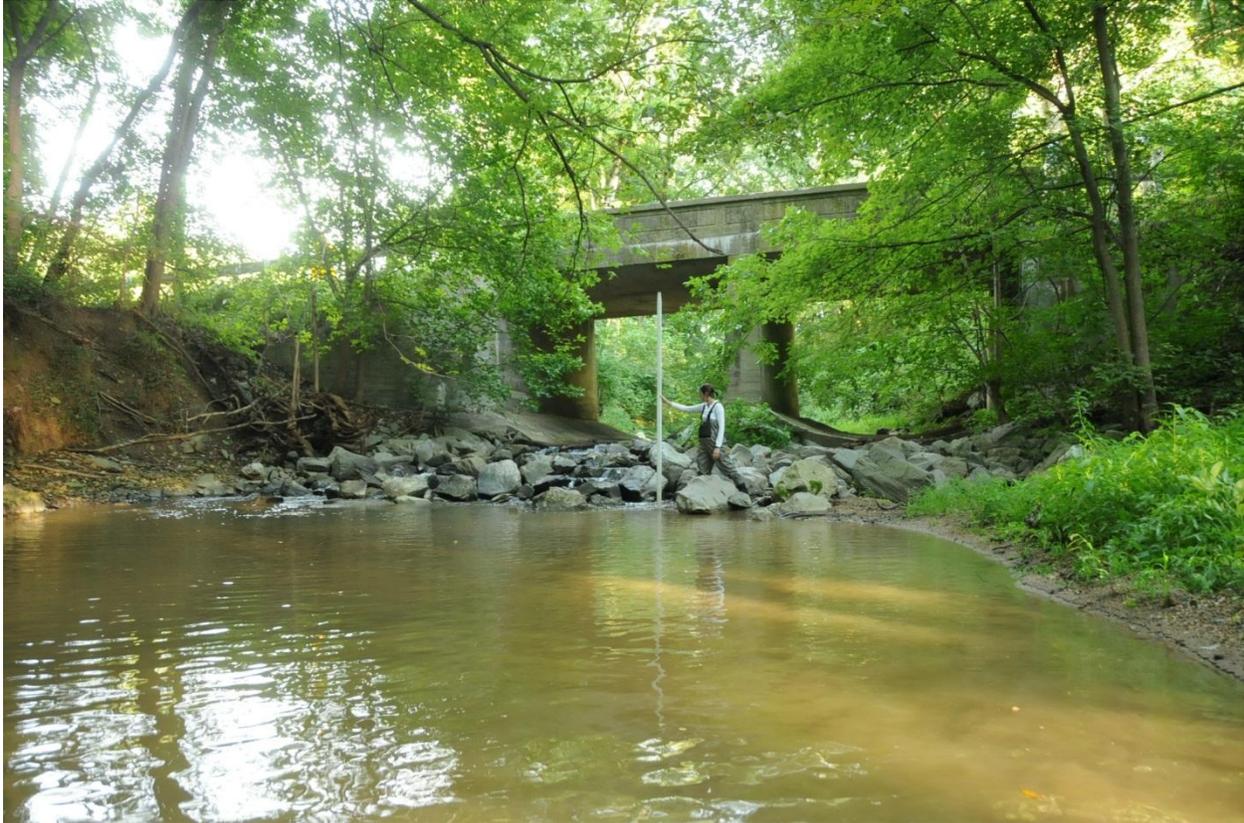
Photo 4.2. LTBD measured downstream of bridge at Site 50.

Eq. 11 and 12 that describe a conservative upper limit curve for the western Maryland data provide an upper bound for all of the Phase 2 Piedmont data except for Site 50 (Photo 4.2). This site is

different than other sites because the bridge at this location was founded on the sediment deposit of a milldam that is now breached. The breached dam is located approximately 570 ft downstream of the bridge where LTBD was measured. The dam height was estimated to be approximately 8 ft over the current water level. This sample site illustrates that Eq. 11 does not provide a conservative upper limit curve for sites located on sediment deposits formed in the backwater of dams or other structures that previously caused aggradation of the valley with fine sediment. Removal of these structures may cause LTBD to be significantly larger than at other sites in the same region.

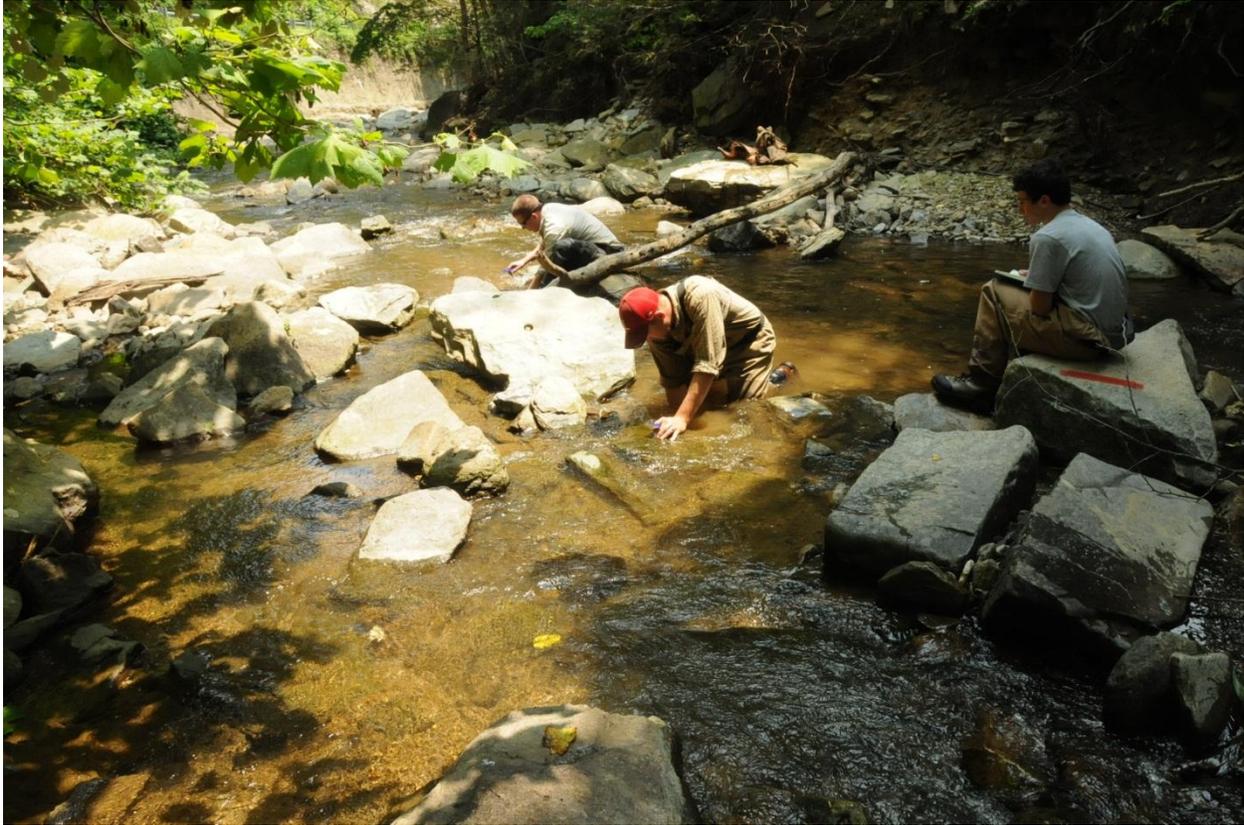
Photo 4.3. Boulder armor at Site 29.

Data from the Blue Ridge and Piedmont indicate that BMI is not a good index to predict the observed LTBD (Figure 4.5). One reason for the lack of correlation of LTBD with BMI is the dependence of BMI on the measured D_{50} at each site. As channels degrade vertically, they tend to erode into larger bed material; therefore at some sites, the measured bed material may be larger than it would have been prior to channel degradation. At several sites, the bed was armored with material that was substantially larger than the material in the channel banks that may represent the characteristics of the bed prior to channel degradation (Photo 4.3).

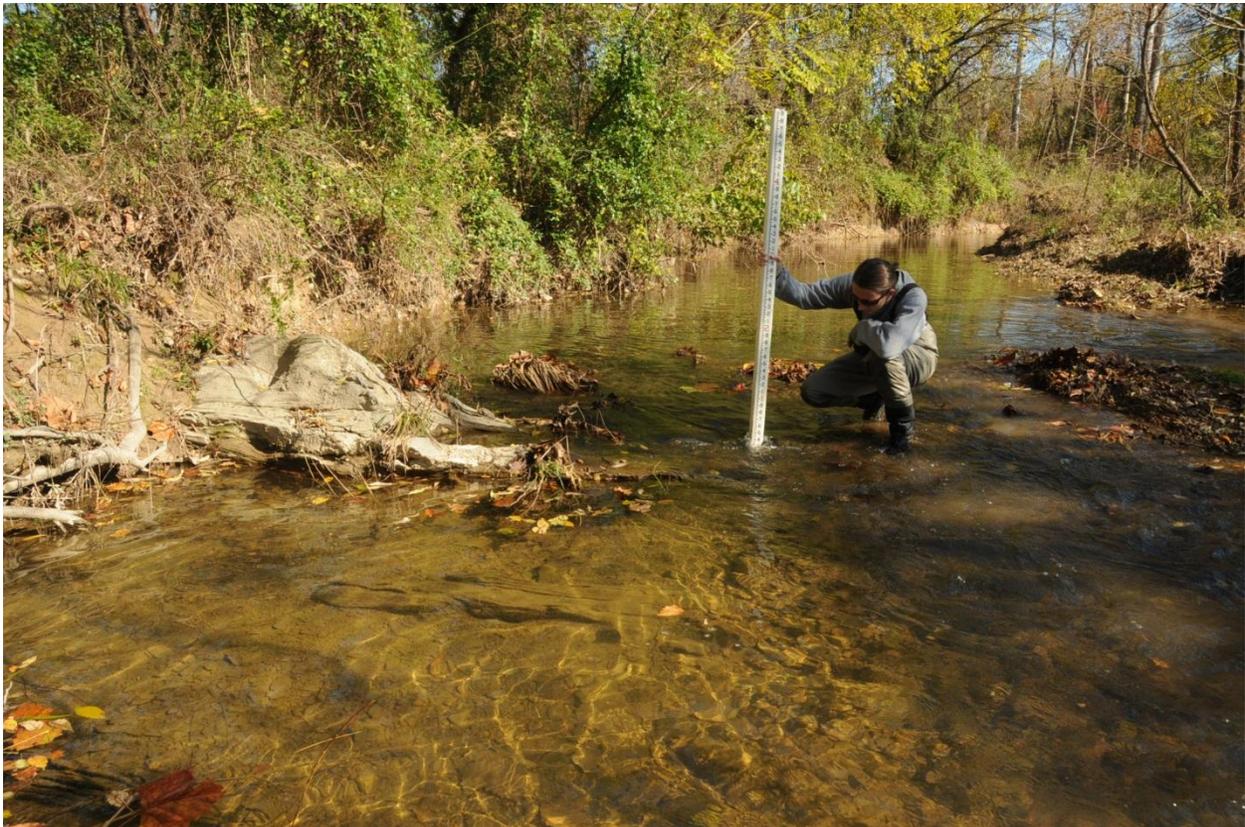
Photo 4.4. Bedrock exposed in streambed downstream of Site 49.

- The most frequent apparent form of bed control (42 percent) in the Piedmont was bedrock exposure (Photo 4.4). **Bedrock exposure** was typically but not always observed in stream reaches along the edge of valleys near the base of hillsides. Unlike bedrock steps that formed bed controls in highly resistant bedrock observed in western Maryland, fractured and weathered bedrock was most commonly observed in pools, shallow runs, or riffles with drops as small as 0.1 ft. The low-flow water surface slope was rarely controlled by exposed bedrock. Instead, it was controlled by cobble or gravel riffles. Because the fractured and weathered bedrock does not form the highest points in the channel profile during low flow, it may or may not be controlling the stream grade.

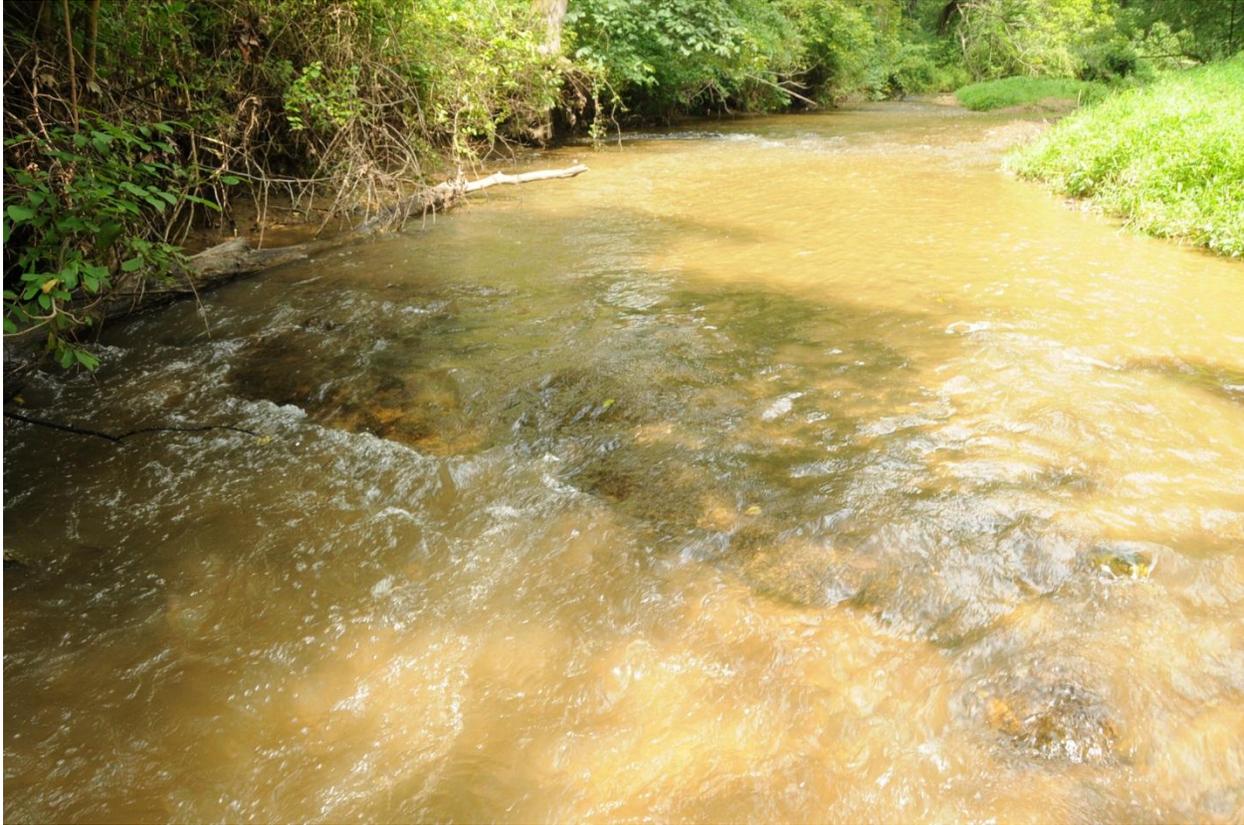
Photo 4.5. Step in channel profile composed of weakly cemented gravel downstream of Site 36.

- **Cobble-armored reaches** that provided bed control were observed at 8 percent (2 sites) of Piedmont sites.
- **Weakly cemented gravel layers** (Photo 4.5) form bed control at 13 percent (3 sites) of Piedmont sites. Small steps formed by the erosion of the gravel layers migrate upstream as headcuts, and they represent a gradual upstream progression of bed degradation.
- **A thick deposit of clay** was observed at Site 55 in a small tributary to the Potomac River. No bed control features were observed within 1000 ft downstream of the site.
- **Two dams, a culvert invert, and a ford** were identified as downstream controls at the remaining four sites in the Piedmont.
