STATE HIGHWAY ADMINISTRATION RESEARCH REPORT

IDENTIFICATION OF TECHNIQUES TO MEET PH STANDARD DURING IN-STREAM CONSTRUCTION

**Project Number SP109B4D
FINAL REPORT**

March 2014

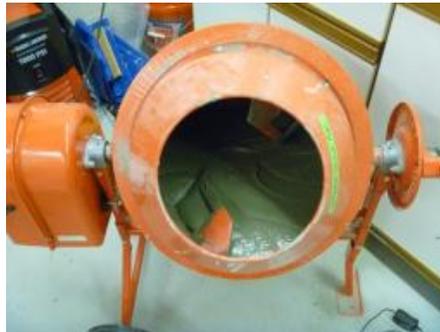
The tilting drum mixer (Scaffolding Factory Co., Hong Kong) used for all grout mixings has a container with a cross section (Figure 2.1). The blades are attached to the inside of the movable drum. The blades' main purpose is to lift the material as the drum rotates. The angle of the rotation axis is the only controlled parameter. The mixing speed was kept at the same speed for all mixings. Type I/II Portland Cement (Saylor's, Essroc Cement Corp., Nazareth, PA), sand, and tap water were added into the drum mixer and mixed until a workable consistency was obtained. Mixed grout was used for further experiments.

Figure 2.1: Grout mixing by tilting drum mixer.

The mixing ratio was adopted from the concrete mix design tested by the Concrete Technology Division in SHA's Office of Materials Technology. The proportion of mixed grout was 1 of cement to 1 of sand to .492 of water. The mixed grout was placed into cube molds for leaching experiments or PVC section bottom for flow-through experiments, and cured for two days or four days prior to the each experiment. All mixings and curing processes were performed at room temperature 20 to 23°C (68 to 73.4°F).

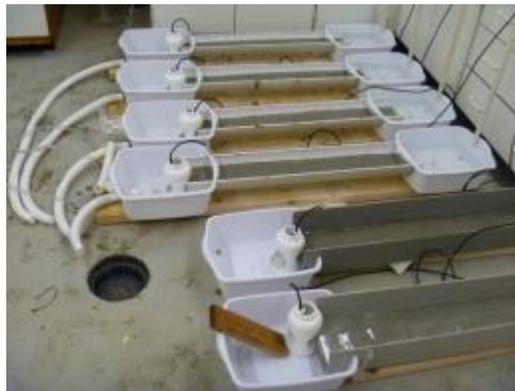
Pipe shape's effect was evaluated with two shapes of pipe. The first shape was semicircular. The second shape was rectangular. The grout surface was 12 cm wide and 91.4 cm long for the semicircular pipe, and 15 cm wide and 91.4 cm long for the rectangular pipe. The surface washing procedure (1.6 ml/cm^2) was applied after the two-day curing process finished. A basic flow rate ($930 \pm 20 \text{ ml/min}$) was adopted after the washing process (Figure 2.6).

Figure 2.6: Pipe shape effect.

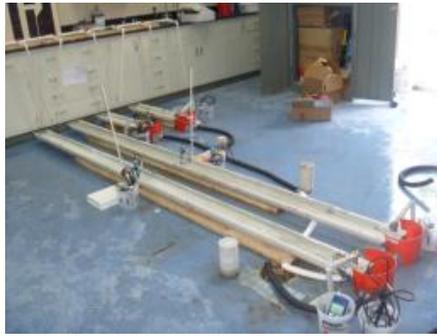
Three lengths of semicircular PVC pipe were evaluated to estimate pipe length's effect on pH change. Three flow rates were applied to evaluate pH change after the two-day grout curing process finished. Low flow rate (930 ± 20 ml/min), mid flow rate (1820 ± 20 ml/min), and high flow rate (2700 ± 20 ml/min) were assessed with tap water. All pipes of the pipes had a 15 cm diameter, and the following lengths were used: 91.4 cm, 192 cm, and 366 cm. The surface areas were 1097 cm^2 , 2194 cm^2 , 4388 cm^2 (Figure 2.8).

Figure 2.8: Pipe length effect experiment in the laboratory.

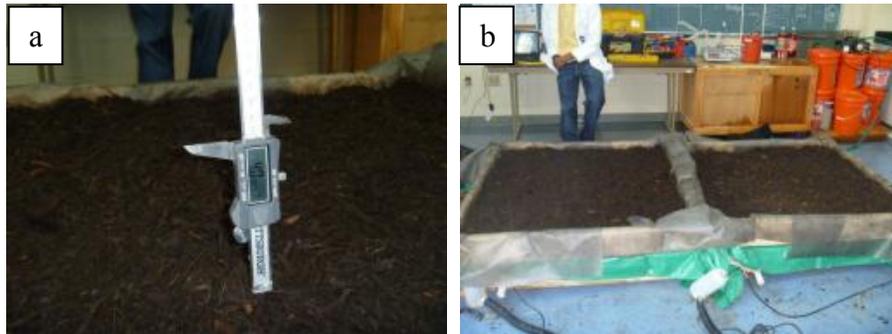
A 294-gallon galvanized sheet metal tank was filled with tap water and then 1 kg of Type I/II Portland cement was added to get approximately pH 11. A submersible sump pump (Indoor/Outdoor model # 5-MSP-18, Little Giant Pump Company, Oklahoma City, OK) delivered water into the sediment bags. Two flow rates were managed by the pump controller (Sotera Systems Model 825, Tuthill Corp, Fort Wayne, IN). The slow flow rate was 2.7 L/min, and the fast flow rate was 6.0 L/min. Organic matter such as straw, mixed mulch (Garden Pro Pine Bark Mulch and Garden Pro Shredded Hardwood Mulch, Harvest Garden Pro, LLC, Milford, DE), and peat moss (Garden Pro Sphagnum Peat Moss, Coastal Supply Company, Milford, DE) were placed on top of the filter paper and then a sediment bag was positioned on top of the organic matter. In layers, 10 cm of straw (Figure 2.10), 10 cm of mulch (Figure 2.11), 10 cm of dry peat (Figure 2.12), and 6.5 cm of wetted peat (Figure 2.13) were placed in the guide wooden frame.

Figure 2.11: Remedial experiment of sediment bag with 10 cm of mulch

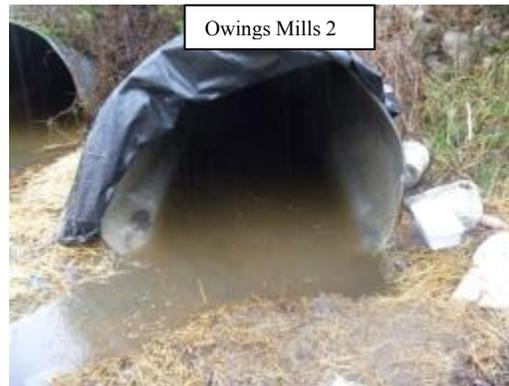
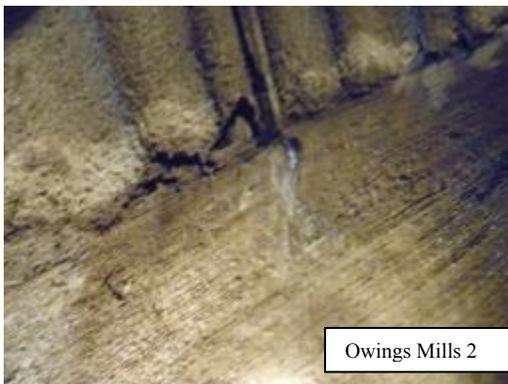
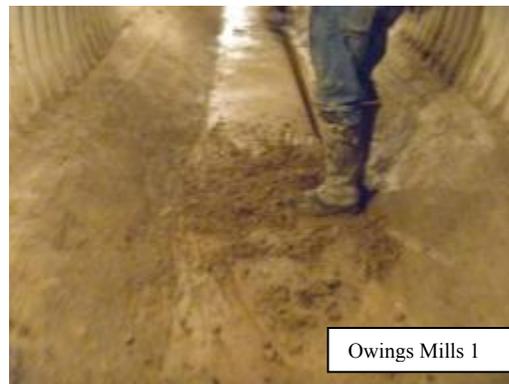
b) water filled inside culvert

c) water leaking inside culvert

d) remove grout slurry

Figure 5.2: Curing process seen at site in Owings Mills, MD.

Data logger 2 (0 meters from culvert outlet) and 3 (0.1 meters from culvert outlet) were located in the work area near the culvert outlet. At data logger 2, the pH was over 10.3 for 220 minutes. A rainfall event started after the grout paving and continued during the curing process, causing runoff and leaking groundwater (Figure 5.2c) to fill the inside of the culvert. The water leaking inside the culvert after the grout paving may have increased water content that altered the grout paving curing process. The grout paving mixture with high water content turned into a slurry (Figure 5.2 d). There was no further activity at Owings Mills 2 to remove the water that had entered the culvert (Figure 5.2 b), which is why the water pH was high for a long time.

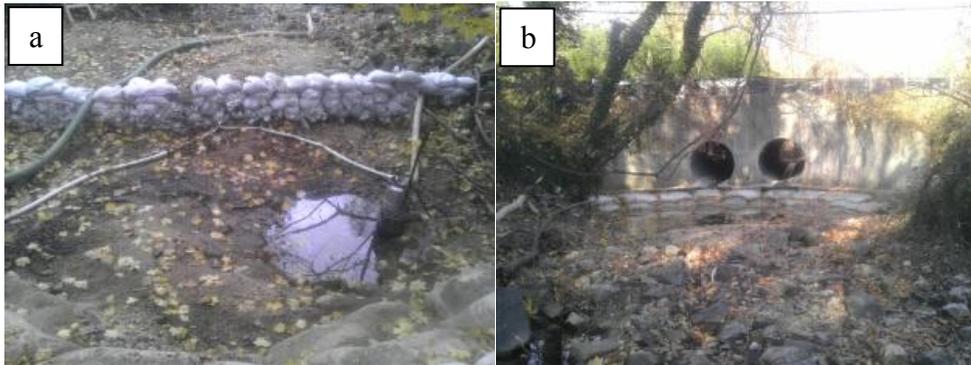
The site in Catonsville provided what could be considered an ideal setup by the contractor and resulted in ideal field result. A well-conceived catchment area provided adequate containment of any waters at the effluent end of the double culverts (Figure 5.8). Once the stream diversion was removed, a minor spike in pH was logged downstream. The peat remedial option was used at this site; however, the use of peat (shown in Figure 5.9) required additional work, and the peat was not well contained once water from the sediment bag began to drain. Peat should be wetted and mixed prior to placement. Peat would be best kept in place contained in burlap bags or unbagged

Figure 5.8: Scene at Catonsville, MD, culvert site on Rt. 144

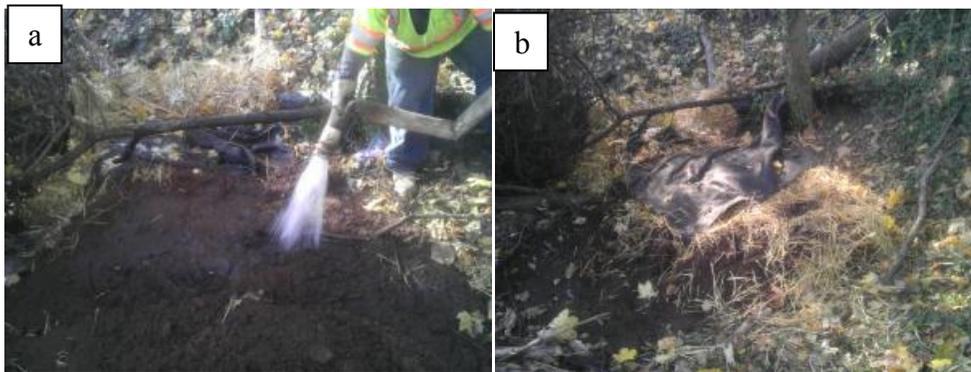
Figure 5.9: Remedial attempt at the culvert site in Catonsville, MD.
