**EFFECTIVENESS OF NEST SITE RESTORATION FOR THE  
ENDANGERED NORTHERN MAP TURTLE**

**REPORT 2: USE OF ARTIFICIAL NESTING SITES AND WILDLIFE  
EXCLUSION FENCE TO ENHANCE NESTING SUCCESS**

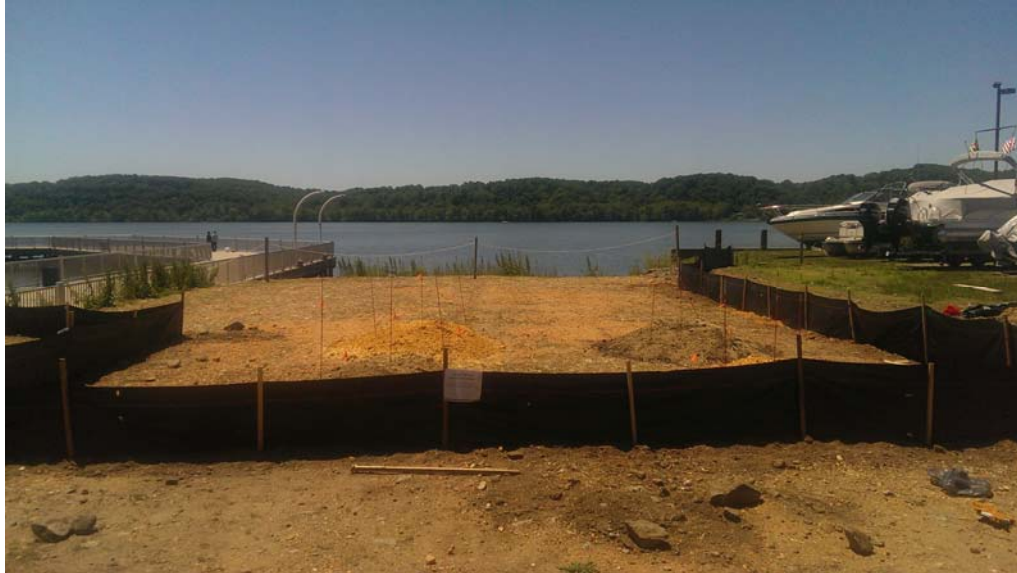
**Figure 1: Site photo showing rehabilitated nesting grounds at the Jacob Tome Gas House, along with the temporary wildlife fence.**

Data collected after the rehabilitation of the nesting grounds and the installation of the temporary drift fence in 2015 was compared with data collected from 2013-2014, specifically for (a) timing of nesting, (b) spatial distribution of nests, (c) timing of emergence of hatchlings, and (d) success of nests. Figure 1 below shows the rehabilitated nesting sites and temporary wildlife fence.
