**MARYLAND DEPARTMENT OF TRANSPORTATION
STATE HIGHWAY ADMINISTRATION**

**EFFECTIVE IMPLEMENTATION OF GPR FOR
CONDITION ASSESSMENT AND MONITORING – PHASE 2**

**PROJECT NUMBER SP509B4K
FINAL REPORT**

OCTOBER 2016

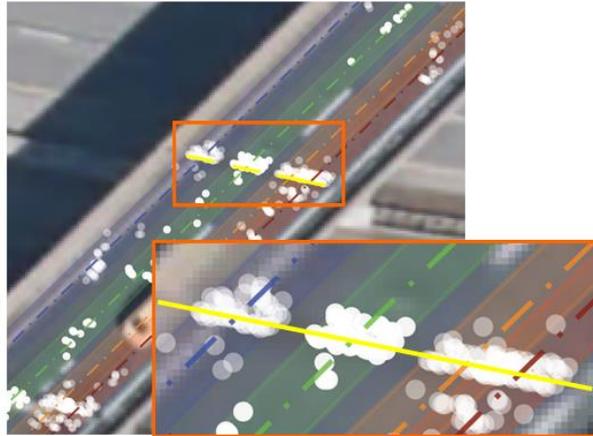
Figure 1. Visualization of Bridge Deck Boundaries: Example over a Pier.

It was important to identify potential errors and make appropriate corrections in the GPR and GPS data sets. For example, bridge deck boundaries were used to eliminate the data points that fell outside of the boundaries, as shown in Figure 1. The boundaries across the data sets were expanded when piers, abutments, or other bridge deck features are present.

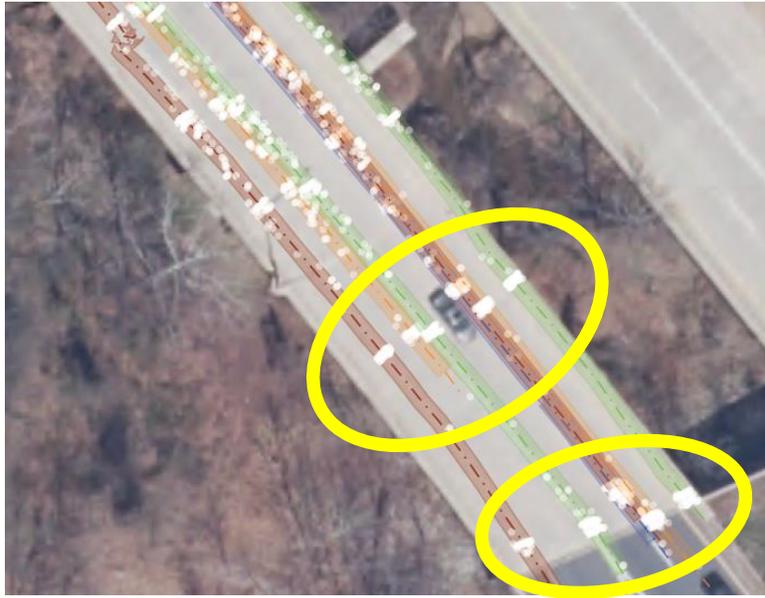
Figure 2. Temporal and Spatial Shift in GPR Data (structure 0217803)

An assessment of the spatial and temporal shift of the data collected in relation to the actual location of the bridge deck structure was conducted. As in the example of Figure 2, a temporal and lateral shift is evident. Thus, a time shift can be entered in the computations and the solution is improved. A hybrid correction method is used to estimate and apply the time shift along with corrections in the GPS records using both an internal and an external GPS, Figure 3.

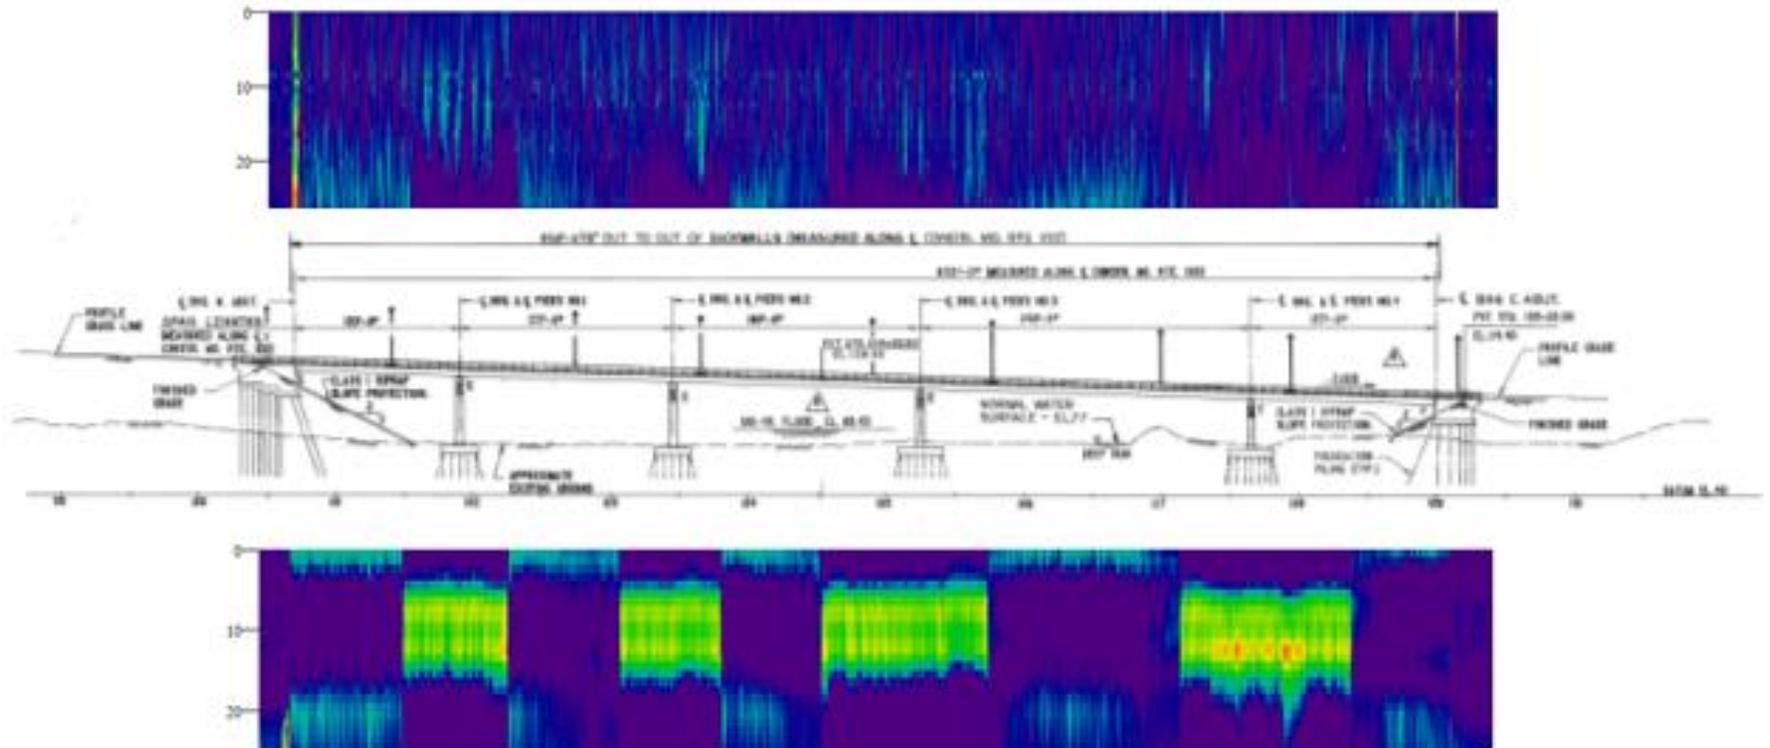
Figure 4. Bridge Boundaries Detection (Structure 0217803)

The bridge boundaries are detected in two steps: (i) matching the primary features to the structural components; and, (ii) estimating the location of the piers using dimensions listed in the bridge design plans, Figure 4.

Location of Abutments Identified

Location of Girder Splices Identified

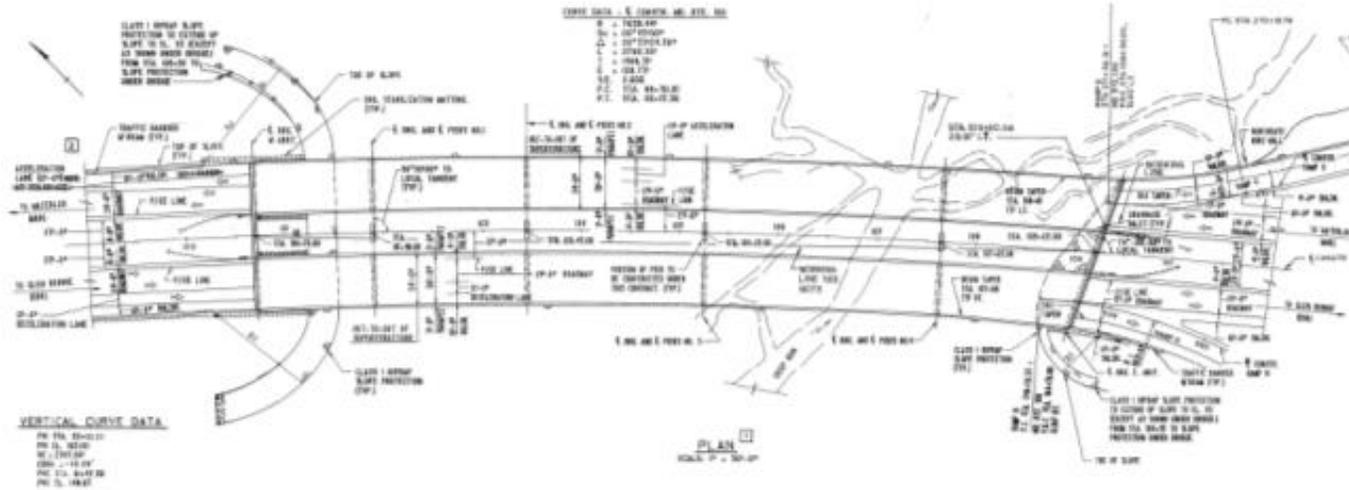
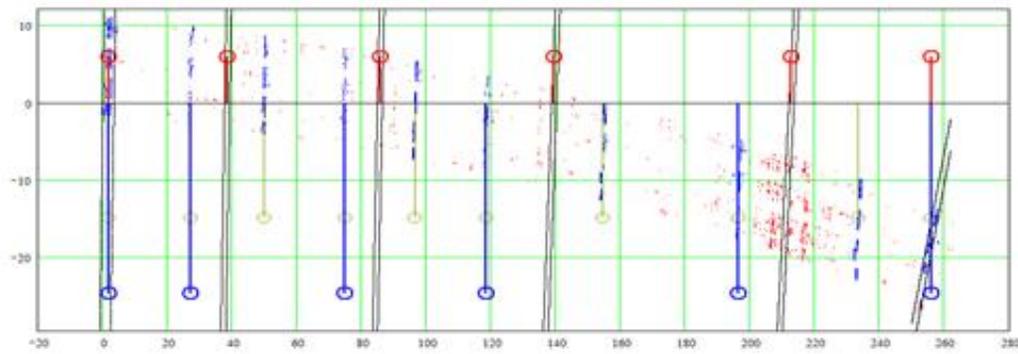
Figure 5. Bridge Deck Segmentation into Spans (Structure 0217803)

The segmentation of the bridge deck into spans using GPR data cannot be fully automated since each case requires some level of customization. In the case of structure 0217803, Figure 5, three steps were required: (i) detect clusters; (ii) extract geometry of the steel frame from design plans; (iii) estimate position of the piers. The results still needed to be reviewed visually to confirm the general position of the piers. Cluster analyses were then used on the GPR data to match the bridge deck features, Figure 6. Once the clusters were matched to features on the bridge deck, the Hough transform was used to estimate their orientation, Figure 7. These linear patterns were used to define the boundaries of each span. Additional bridge deck features were identified based on the bridge design drawings. For example: the position of the piers was established with respect to cross-members of the steel frame below the bridge deck; the distances between the splices and piers were found in tables included in the design plans. A visual check of the final span boundaries were made after the data was plotted over the tiff image.

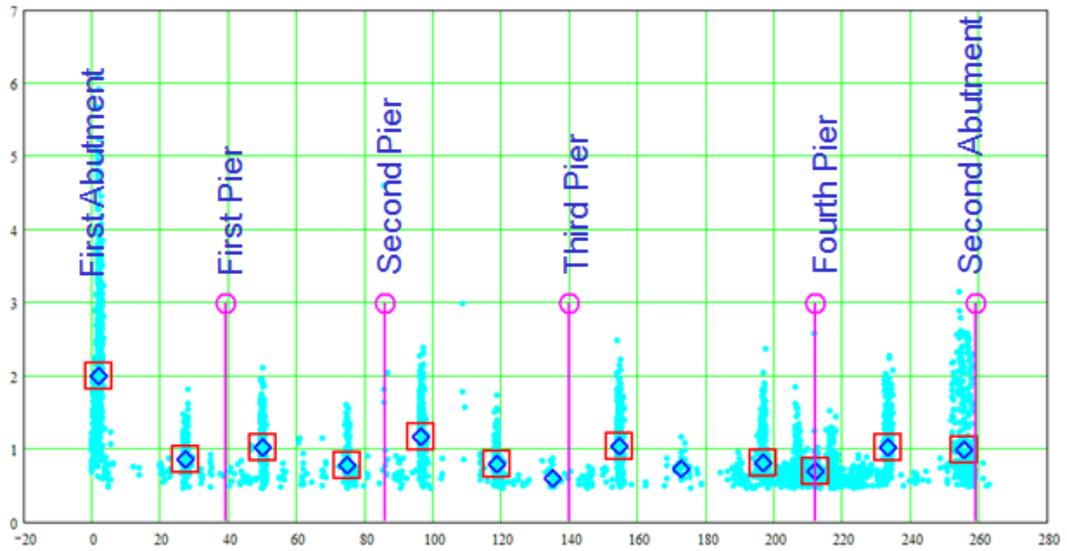
Figure 6. Cluster Analysis of GPR data (Structure 0217803)

Boundary Marker and Detection of abutment and piers

Red squares are strongest clusters

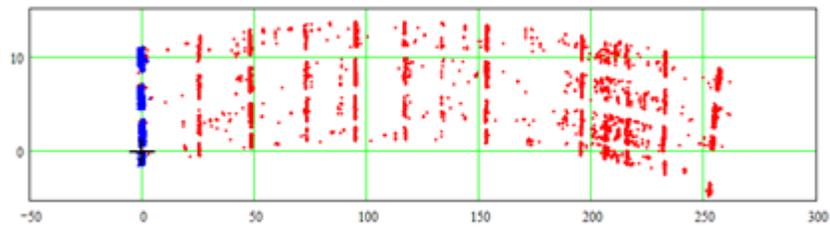
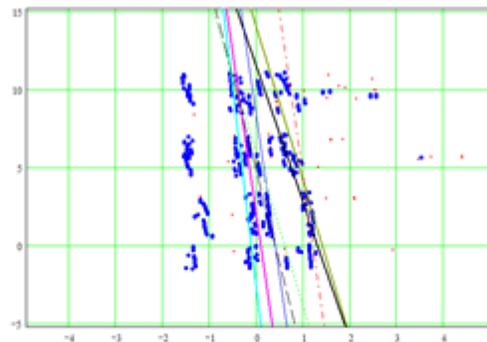
Figure 7. Hough Transform for Detection of Boundaries' Orientation (Structure 0217803)

Cluster near first abutment

Linearity in Cluster

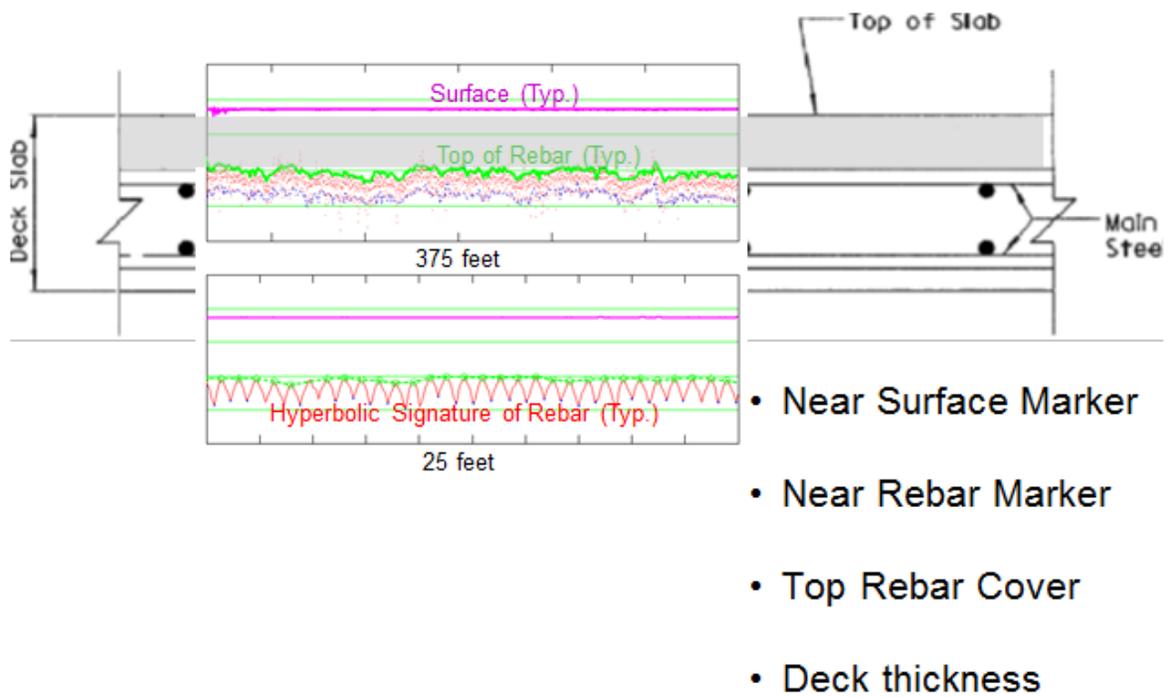
Figure 8. Example SF- GPR Computations

Once all the boundaries of a bridge deck were detected, Starodub analysis tools were used to detect the following parameters in the GPR step frequency data, Figure 8: Near Surface Marker, Near Rebar Marker, Top Rebar Cover, Deck thickness.

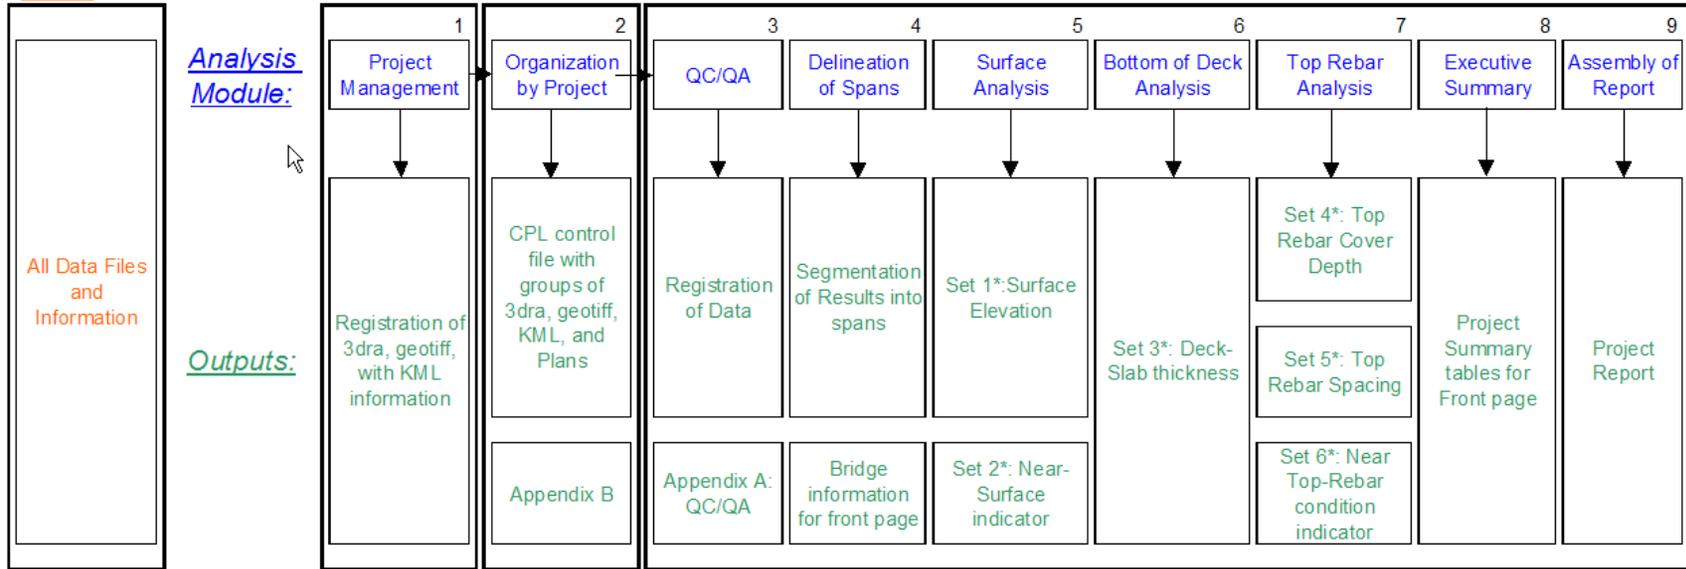
Figure 9. GPR Data Analysis Pipeline

Since 80 bridge decks were inspected and 80 GPR data sets needed to be analyzed, database automation of the analysis was necessary. For this purpose Starodub analysis tools (developed prior to this project) applicable to the GPR data collected by SHA were organized in an analysis pipeline, Figure 9. The analysis pipeline is organized in 9 modules, and each module is presented in terms of Mode, Status, Input, Description, and Output.

- iii) “Status of Coding” – For each project, it is recommended to validate the completeness of the algorithms used in the analysis, including, as shown in Figure 9, (a) bridge deck

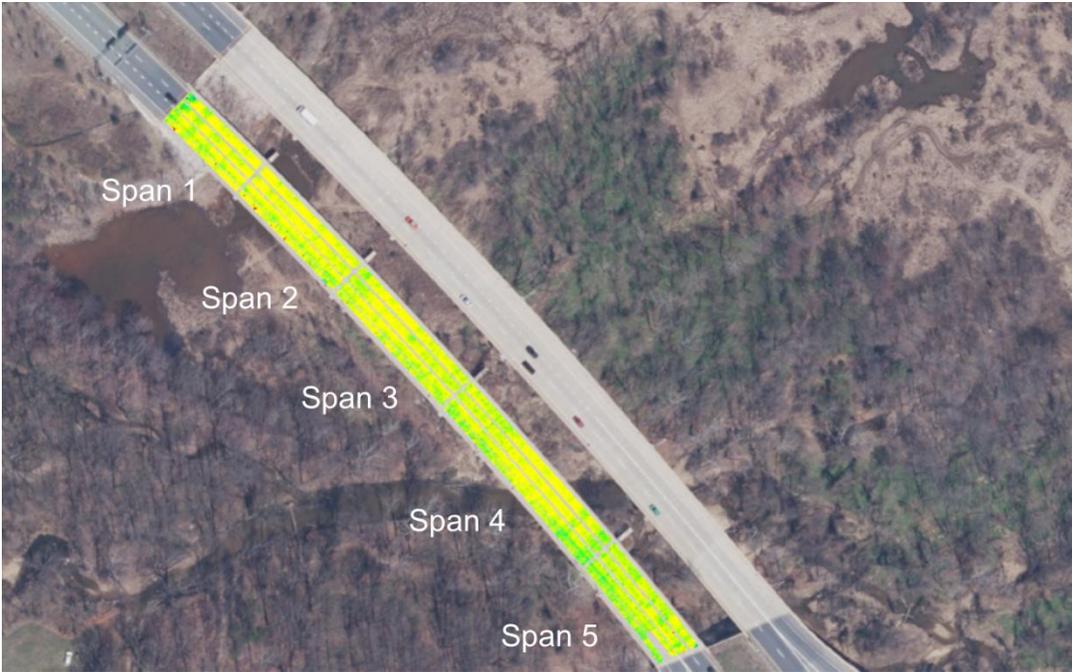
Figure 10. GPR Data and Bridge Boundaries (structure 217803)

Figure 10 shows the GPR Data collected by span on structure 217803 and the bridge deck boundaries developed following the procedures outlined in Chapter 2.

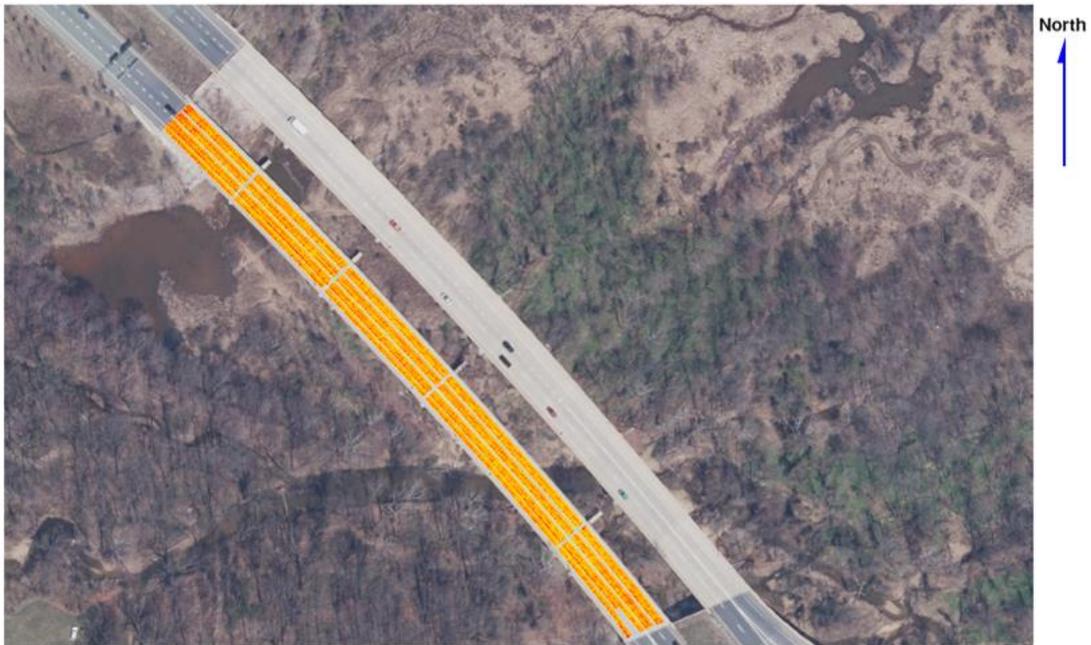
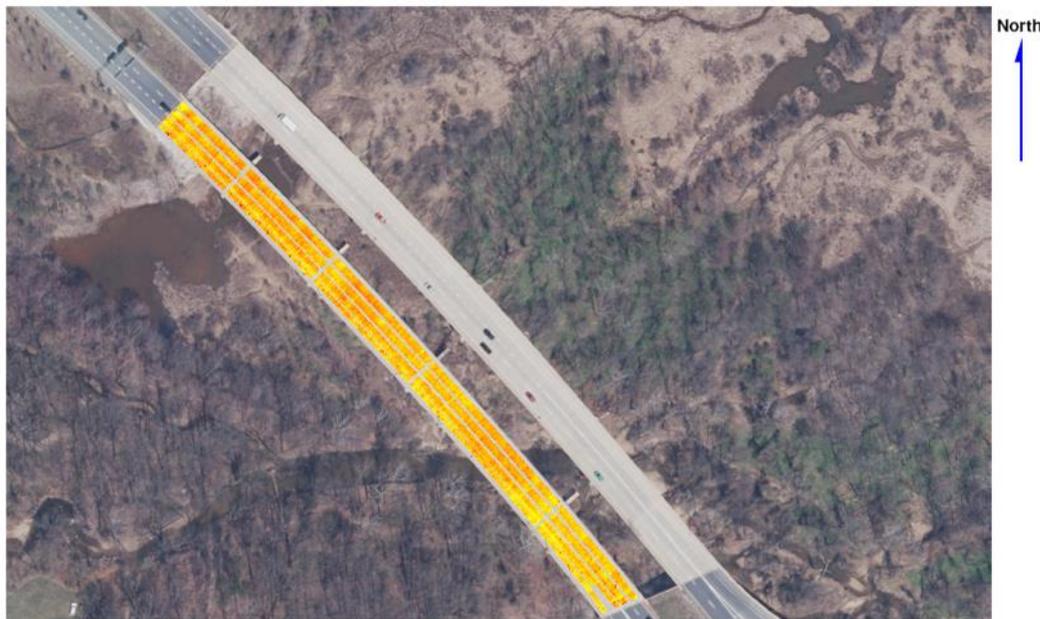
Figure 11. Surface Analysis (structure 217803)

The concrete surface condition was documented using two primary statistics: the variance in surface elevation and an estimate of the near-surface dielectric permittivity computed with the first amplitude or first reflection at the surface of the bridge deck, as shown in Figure 11. The two plots combined, Figure 12, provides information needed to detect potential surface defects. The estimate of dielectric permittivity using the amplitude of the first surface reflection was calculated using the combination of the amplitude of the first surface reflection in the GPR data and a reference amplitude of the first surface reflection over a metal plate. For this project, no reference measurements were available. A synthetic replacement was produced from measurements made by Starodub with the same antenna array in the past.

Surface height

Near-surface density indicator

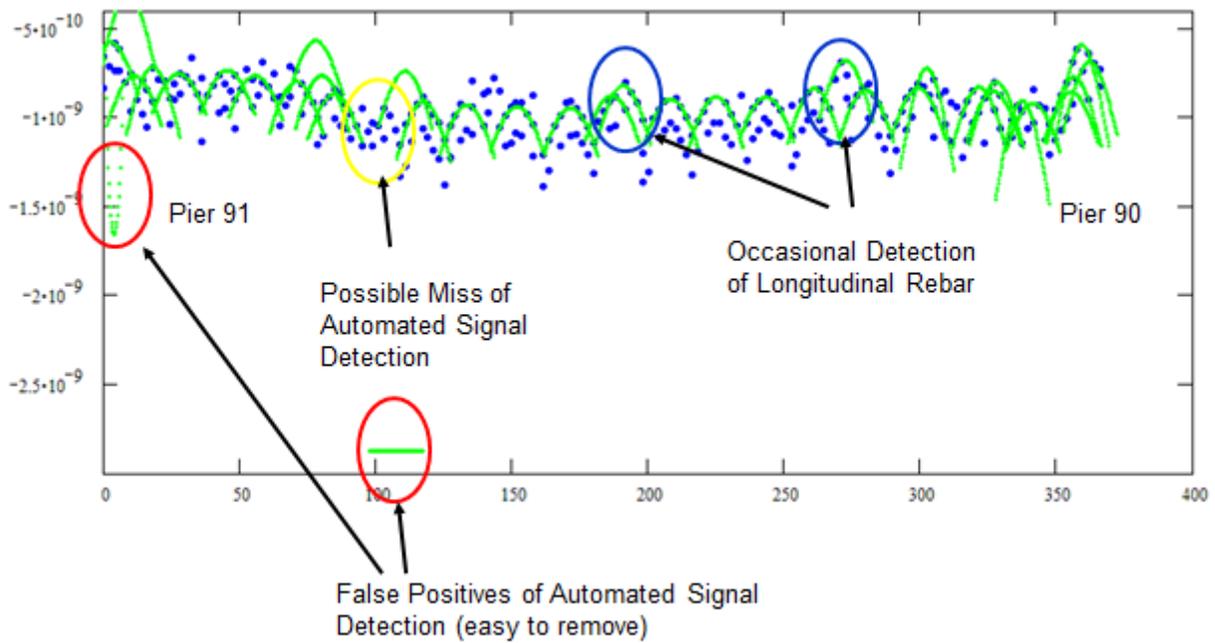
Figure 13. Top Rebar Boundary (in orange)

The depth of top rebars detected was used to estimate the thickness of the concrete cover. With the common-offset test protocols used in this project, a virtual global calibration for all antennas (i.e., all samples estimate an overall dielectric property) was used to compute an estimate of depth from the time of propagation to and from the top rebars. Figure 13 shows the boundary in orange established with the apex of the hyperbolic SAR signal of each rebar. The source/criteria for top of rebar “marker” is the top of the hyperbolas at each rebar.

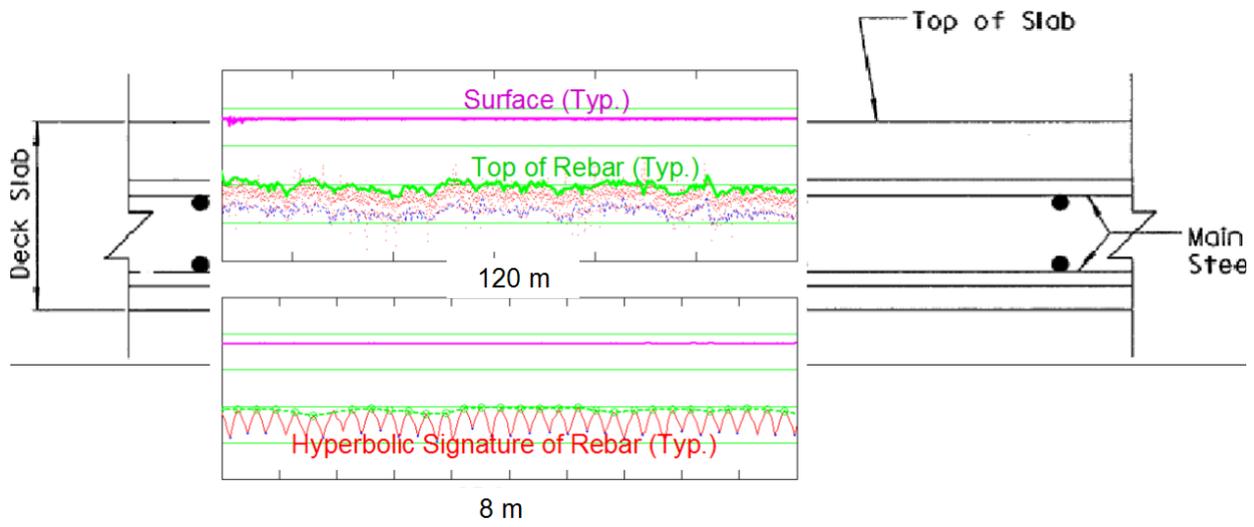
Figure 14. Top Rebar Cover

The thickness of the concrete cover was estimated as the distance between the surface and this apex-boundary Figure 14. Figure 15 provides an illustration of Starodub’s automated hyperbola detection algorithm, and indicated the hyperbola superimposed on the features of interest in the GPR data. The numbers of false positives were minimized using Starodub’s proprietary solution. The general concept/criteria for such processing is based on the analysis of each hyperbola in terms of signal strength, geometry, size of object that produces the hyperbola, and composition in terms of 3d linear continuity.

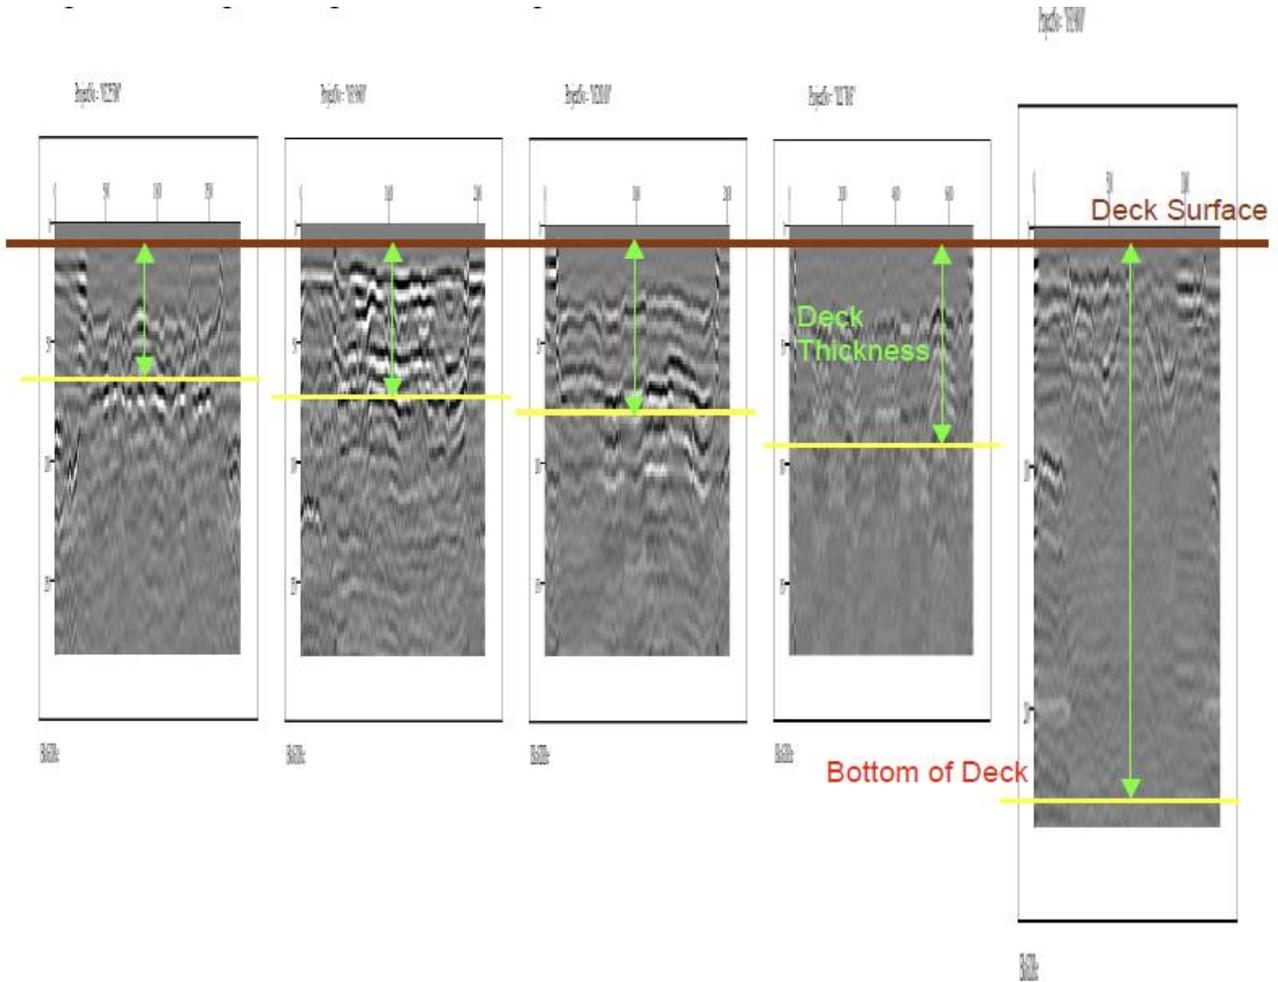
Figure 16 Signal Range for Increasing Thicknesses

The thickness of the bridge deck was estimated by detecting the bottom of the concrete slab. With the common-offset test protocols used in this project, a virtual global calibration was used establish the computation of the estimate of depth from the time of propagation to and from the bottom of the slab, Figure 16.

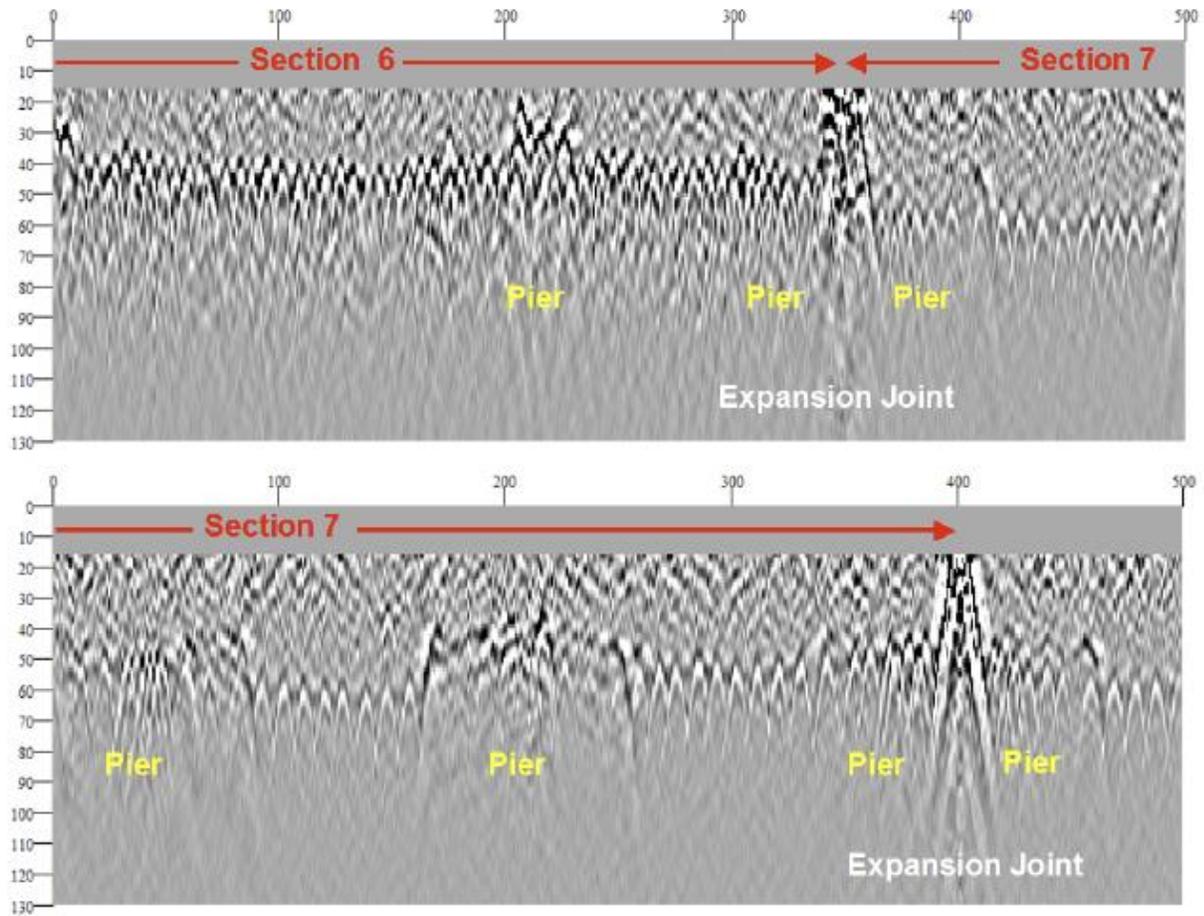
Figure 17. Radagram of Top Rebar Region

The depth and location of each rebar was estimated based on an automated signal detection algorithm developed by Starodub, Inc. The automated algorithm identified the rebar signals first and other signals next, and created a radagram as in Figure 17. False positives were removed from the analysis (using a Starodub detection algorithm), including potential points near the interference patterns below the rebar based on criterion. The hyperbolic SAR signal of steel rebars was analyzed to estimate their condition. A rebar deterioration indicator was proposed to leverage the information in the variance of the following four primary parameters:

- Location using the apex of the signal;
- Depth using the time at the apex of the signal;
- Apparent dielectric constant using the signal; and,
- Strength or amplitude of the signal at the apex of the signal.

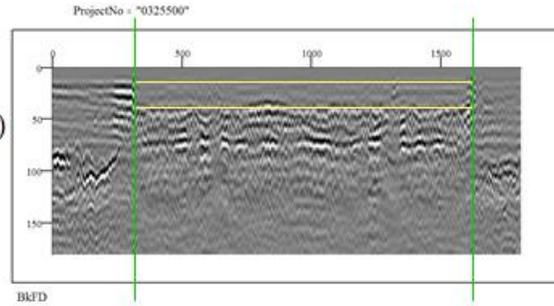
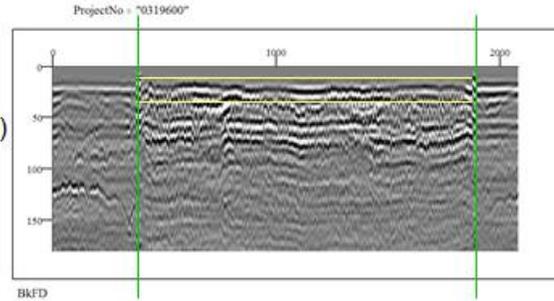
Figure 18. Detection of Signal Near Surface (structure 0325500)

- iii) Detection of signal near surface – Some signals between the surface and the top of rebar were detected during analysis, as shown in Figure 18. These could be the interface between concrete and HMA layer, or deterioration of the concrete. These analyses require project-specific verification in order to classify the patterns;

Typical Results –
 Abutments (green lines)
 Rebar Layer (below lower yellow line)

Variant –
 Signal Above Rebar Layer
 Rebar Layer (between two yellow lines)

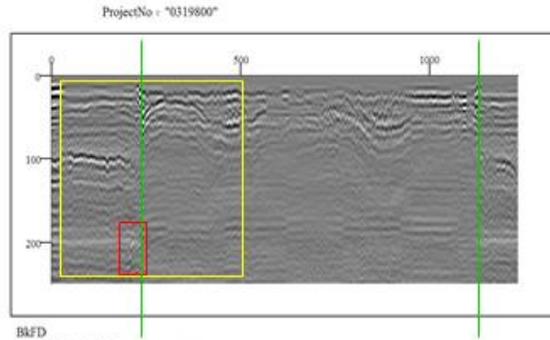
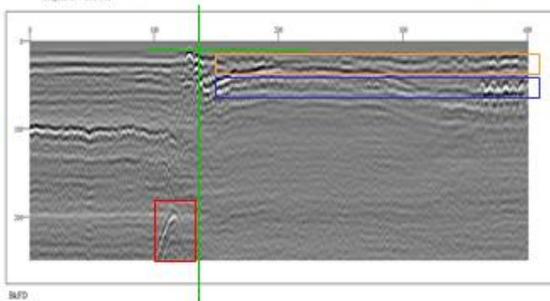
Figure 19. Detection of Buried Objects Near Abutment (structure 0319800)

Detecting Buried Object under the
 approach slab near the abutments
 (in red box)
 Expansion joints at abutments are
 indicated with vertical green line

In Close-up box (shown in yellow in top
 radargram), the signature of buried
 object is clear
 Transverse rebar in top mat is also clear
 (in blue box) – Above is another
 occurrence of an additional signal (in
 orange box)

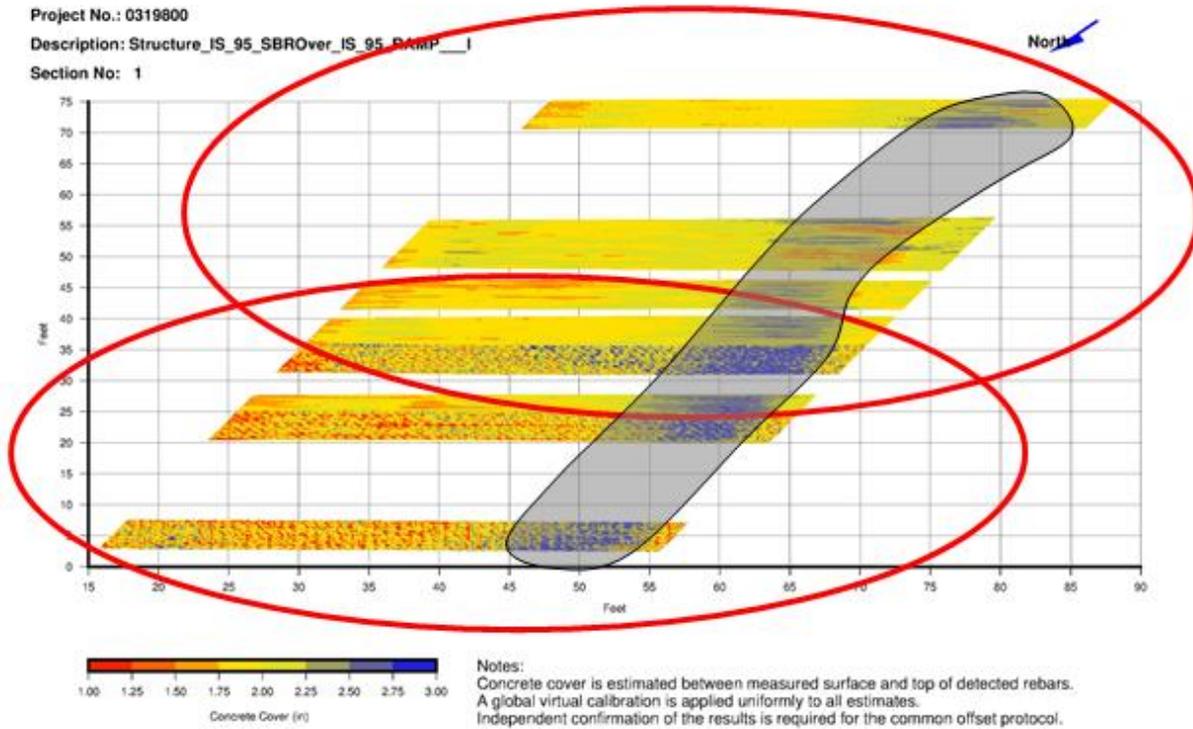
Figure 20. Documenting Patterns Across Data sets on a Bridge Deck (structure 0319800)

- v) Documenting Patterns – Continuity in patterns across data sets on the same structure can be detected, as shown in Figure 20, and documented, and may include differences in texture due to weather conditions or data collection settings. Location and occurrence of patterns in each thematic map parameter may provide additional insights on the condition of a bridge deck, as shown in Figure 21. For example alternating low and high magnitudes in surface condition may indicate an area where moisture levels are higher in red and may be causing damage/ deterioration, as shown in Figure 22;

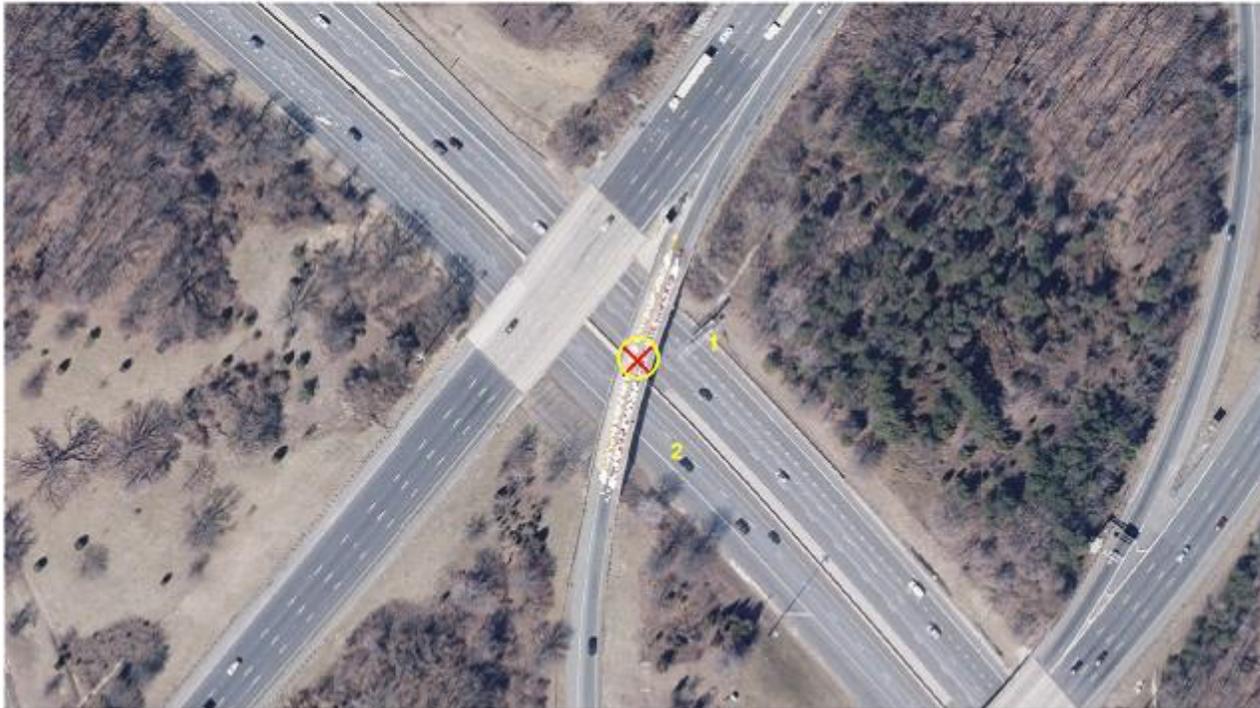
BOUNDARIES – Bridge/Section/Span

Notes:
Boundary Markers in white detected in GPR data.
Sections are numbered per inventory.
Data coverage outline shown.

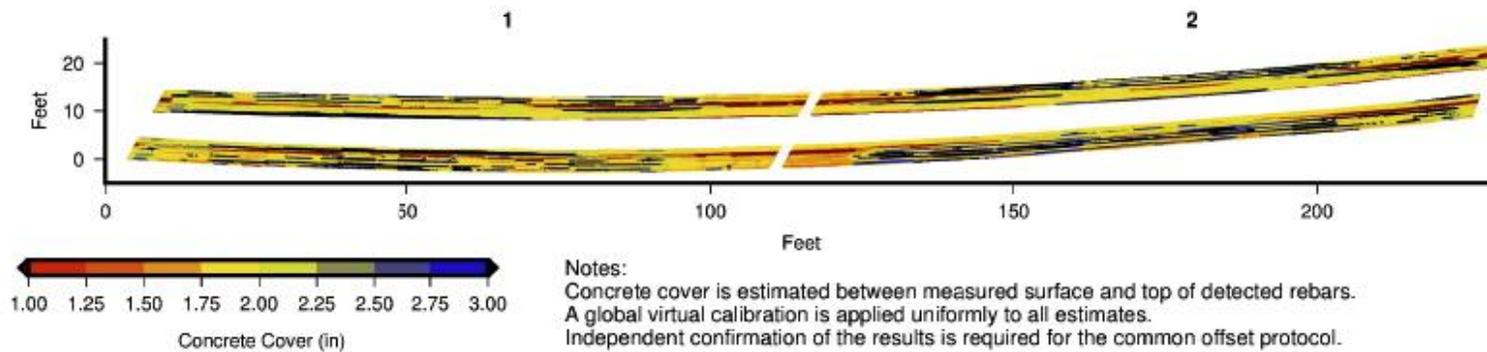
Concrete Cover (in)	1	2	Project
Average	2.1	2.1	2.1
Minimum	0.4	0.4	0.4
Maximum	3.8	3.8	3.8

Concrete cover is estimated between measured surface and top of detected rebars.
 A global virtual calibration is applied uniformly to all estimates.
 Independent confirmation of the results is required for the common offset protocol.

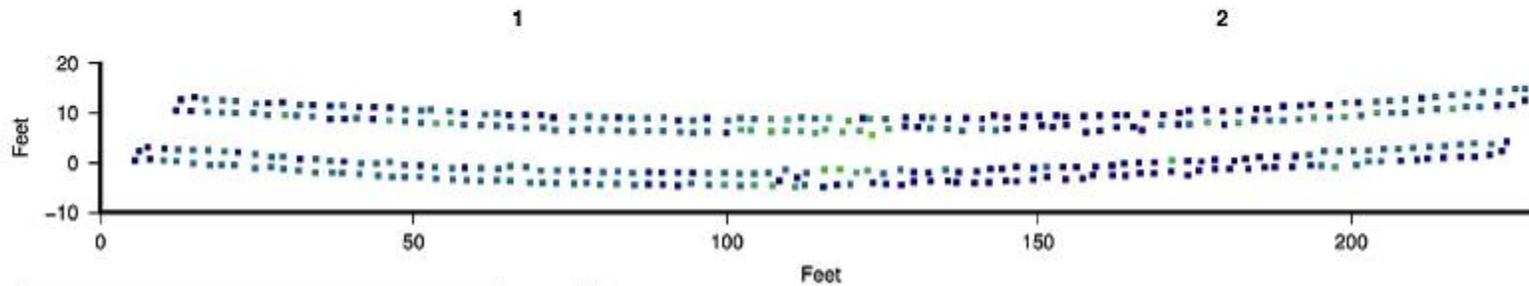
Top Rebar Condition	1	2	Project
Average Rebar Spacing	6.8	5.5	6.2
Median Rebar Spacing	6.5	5.7	6.1
Minimum Rebar Spacing	3.8	3.8	3.8
Maximum Rebar Spacing	9.2	7.5	9.2
Higher Potential of Deterioration	2.9	3.0	2.9

Notes:
 The average spacing is calculated between detected individual rebars.
 The detection rate of individual rebars is above 95%.
 The condition index is estimated using strength of signal and dielectric properties.
 The condition index requires verification and validation.
