National Pollutant Discharge Elimination System
Municipal Separate Storm Sewer System
Permit No. 11-DP-3313 MD0068276
Permit Term October 9, 2015 to October 8, 2020

Sixth Annual Report October 21, 2021

Maryland Department of Transportation
State Highway Administration
Office of Environmental Design
707 North Calvert Street, C-303
Baltimore, MD 21202

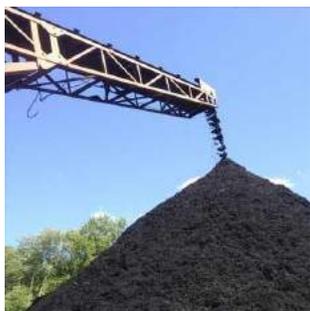
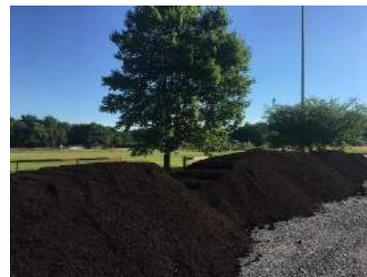
Pictures of compost processing from tree trimmings and yard waste collected by MDOT and sent to the WeCare Woodbine, Maryland site.
