National Pollutant Discharge Elimination System
Municipal Separate Storm Sewer System
Permit No. 11-DP-3313 MD0068276
Permit Term October 9, 2015 to October 8, 2020

Seventh Annual Report

October 28, 2022

Appendix F: Little Catoctin Creek Watershed Monitoring Implementation Document

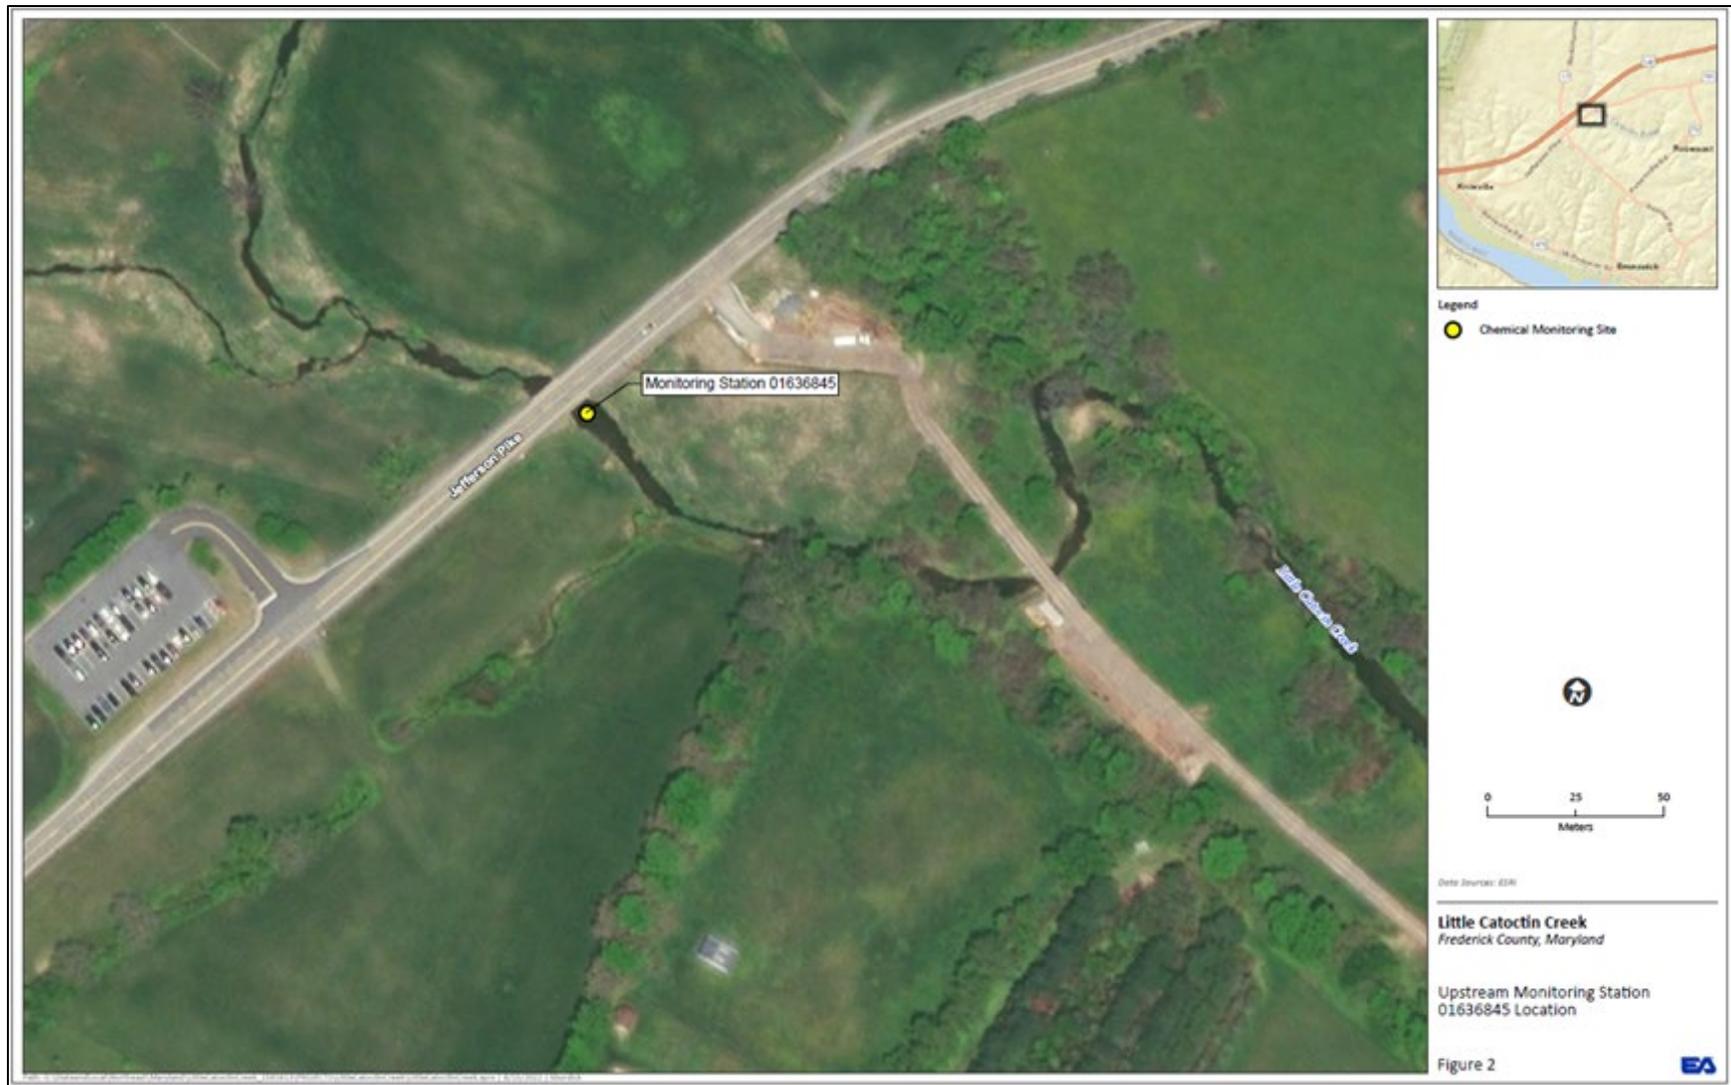
Figure 2. Upstream chemical monitoring station (01636845)

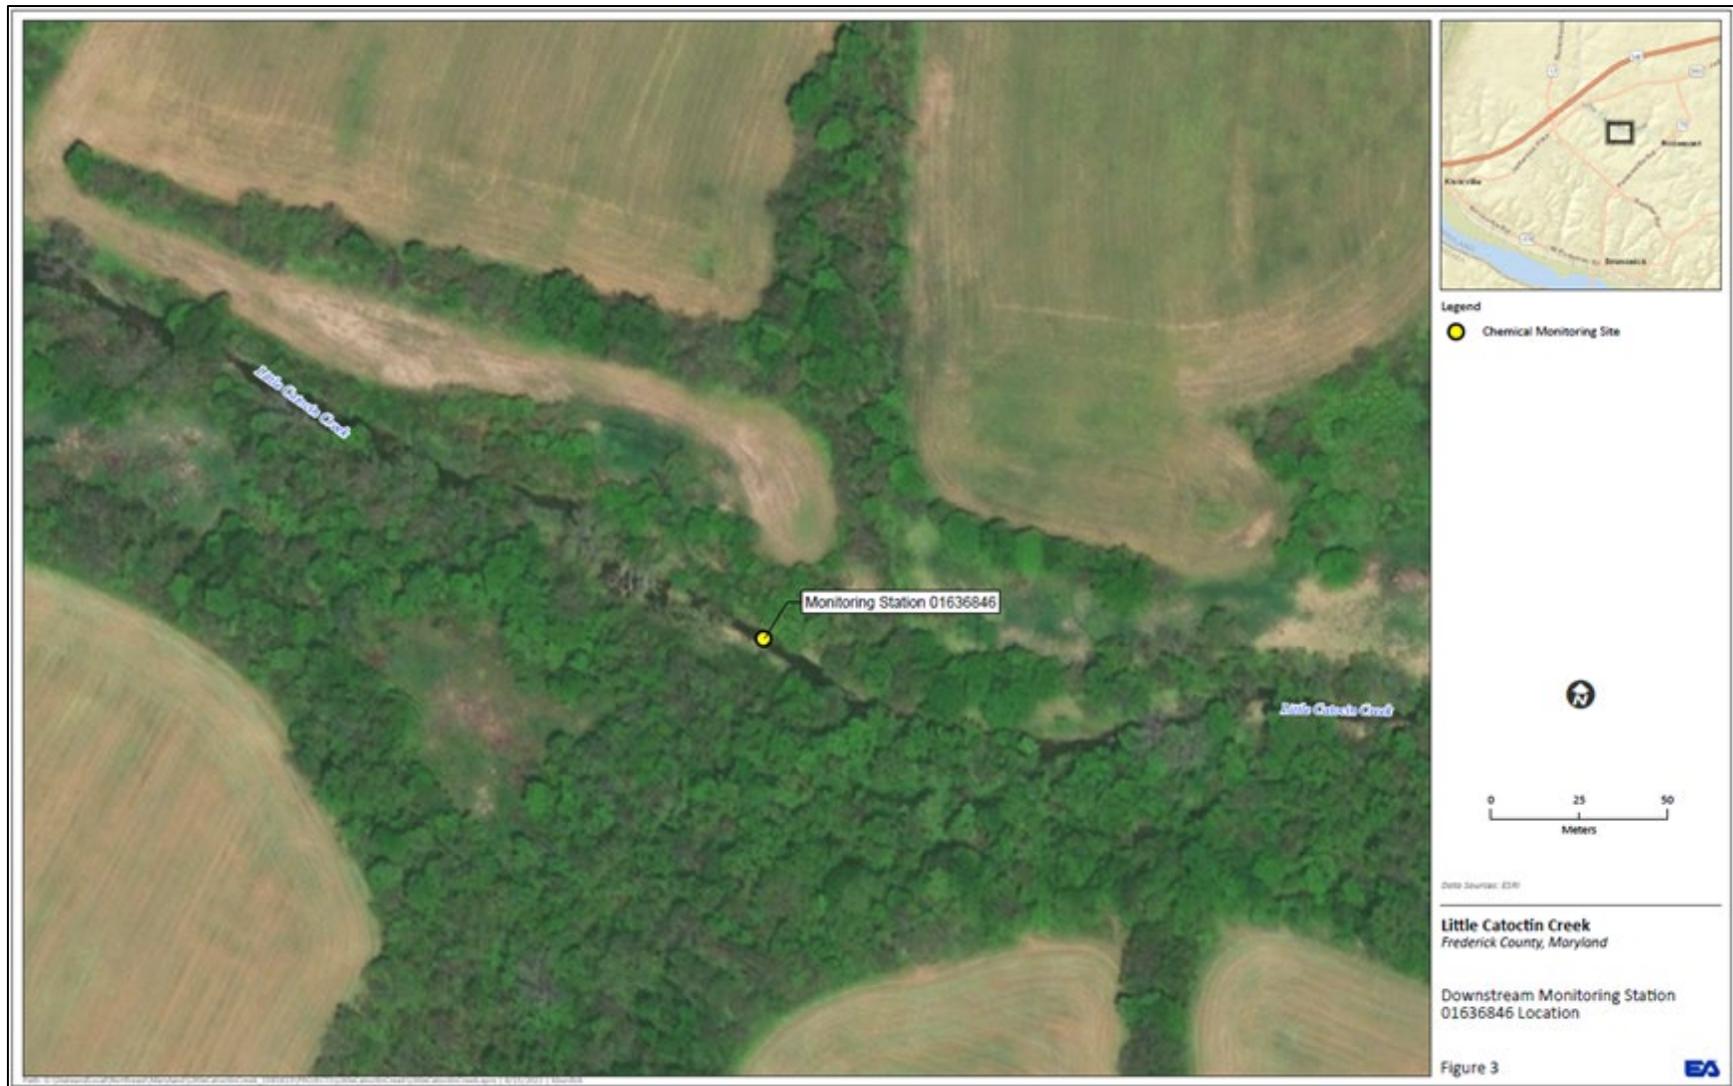
Figure 3. Re-located downstream monitoring station (01636846)

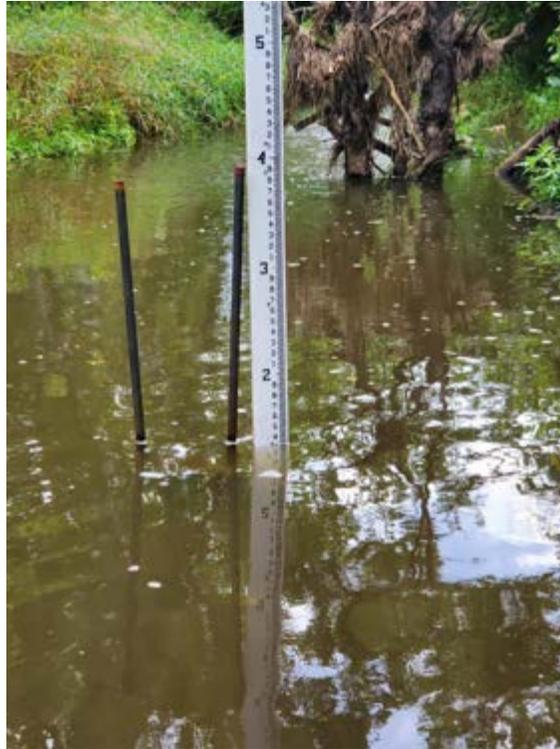
Figure 4. FY22 relocated downstream station (Site ID 01636846) on Little Catocin Creek near Rosemont, MD. The photo shows the HOBOT logger and stream gage.

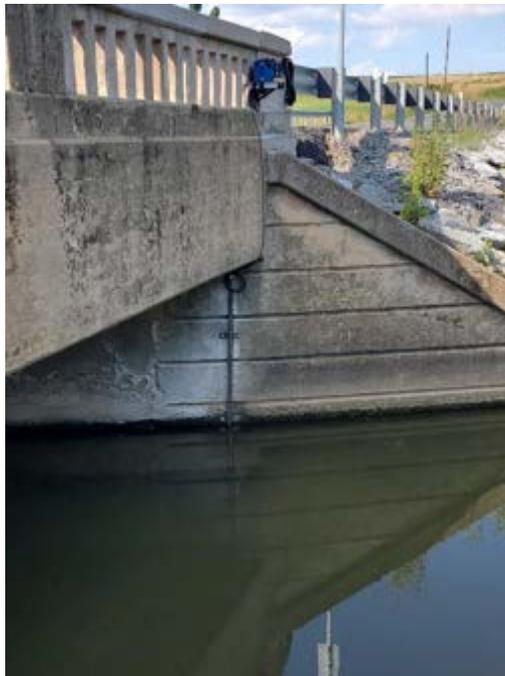
Figure 5. FY22 upstream station (Site ID 01636845) on Little Catocin Creek near Rosemont, MD. The photo shows the ISCO velocity and area flow module.
