## STATE HIGHWAY ADMINISTRATION

# EVALUATION OF INTELLIGENT TRANSPORTATION SYSTEM DEPLOYMENTS FOR WORK ZONE OPERATIONS

MD-05-SP208B4H  
FINAL REPORT

AUGUST 2005

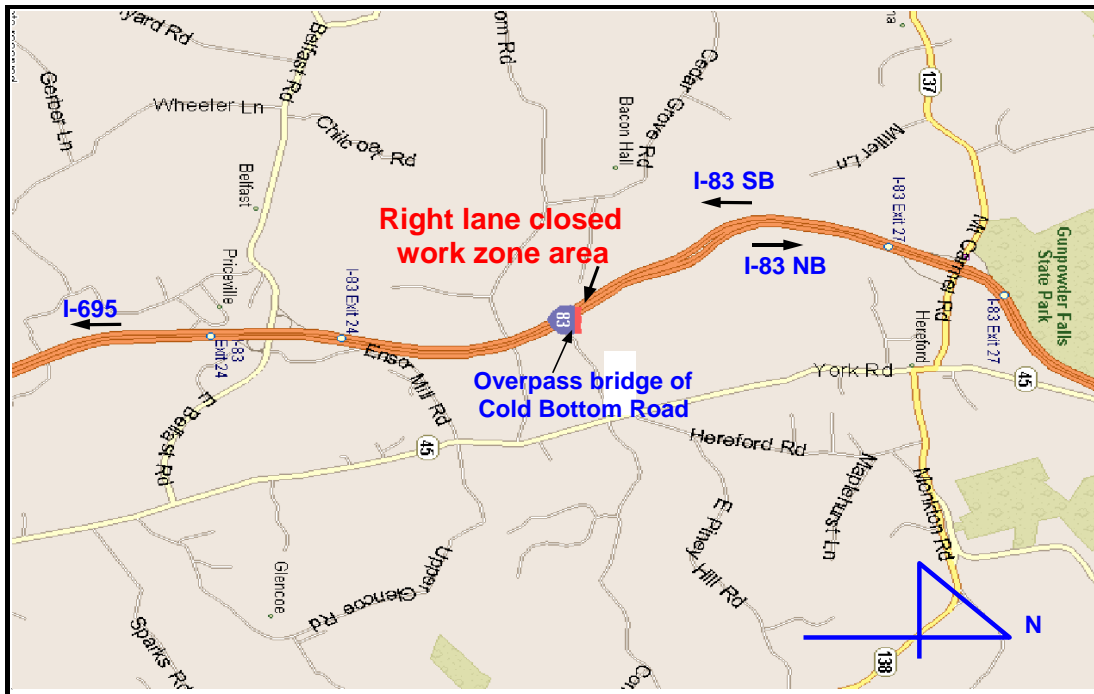
The proposed DLM system was deployed prior to a right-lane closure in a work zone area near the overpass bridge of Cold Bottom Road on I-83 SB (see Figure 1-2).

**Figure 0-2:** Location of the work zone on I-83 SB, near Cold Bottom Road

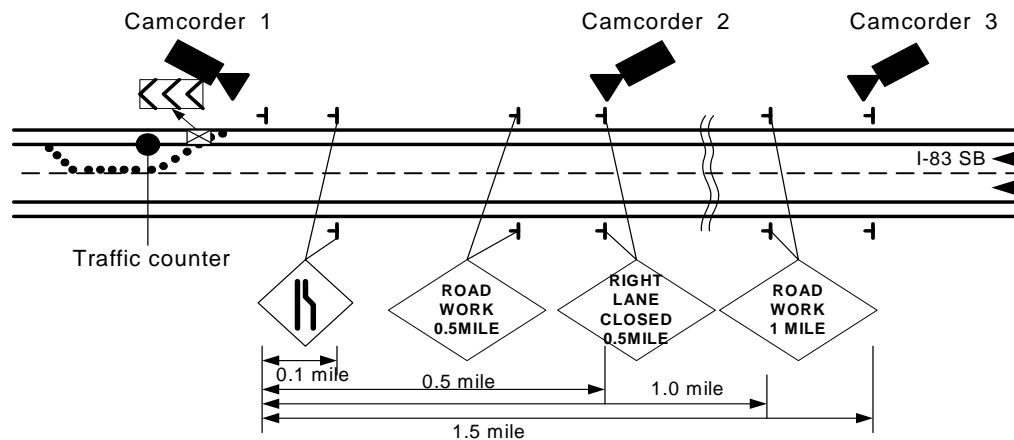
Field data for evaluation was gathered with three camcorders (see Figure 2-1 for camcorder locations) and focused on capturing volume data, merge behavior, traffic conflicts, and queue lengths. In addition, two speed guns were used to measure the distribution of spot speeds. The camcorders were installed at the merge point (i.e., Camcorder 1 and PCMS 1) close to the beginning of the taper, at the middle point (i.e., Camcorder 2 and PCMS 3) about 0.5 mile before the taper, and at the upstream point (i.e., Camcorder 3 and PCMS 4) about 1.5 miles away from the lane closure location (also see Figure 1-1). Speed samples were collected at the merge and middle points. The data collection plan is summarized in Table 2-1. Traffic flow data such as volume, speed, and occupancy were also available from RTMS for system performance evaluation under the DLM control.

**Figure 0-1:** Locations of the camcorders

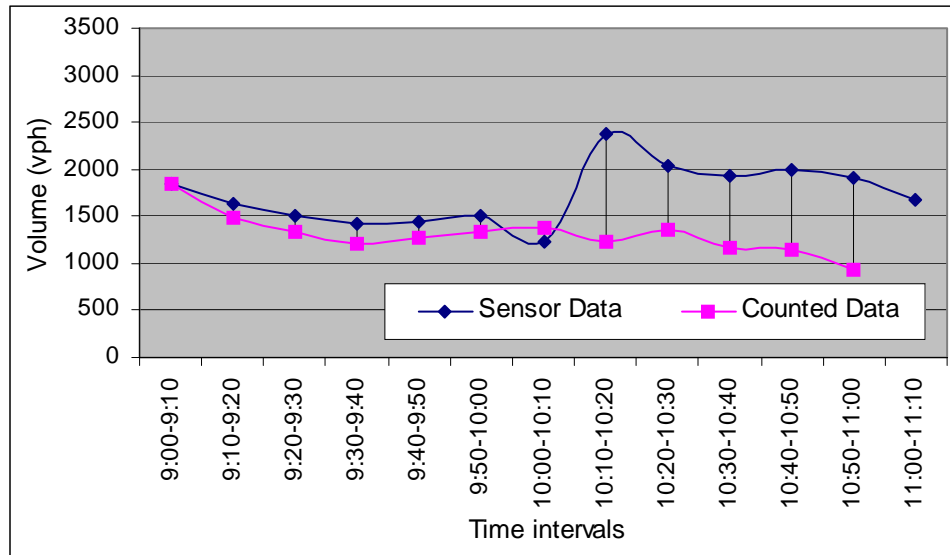
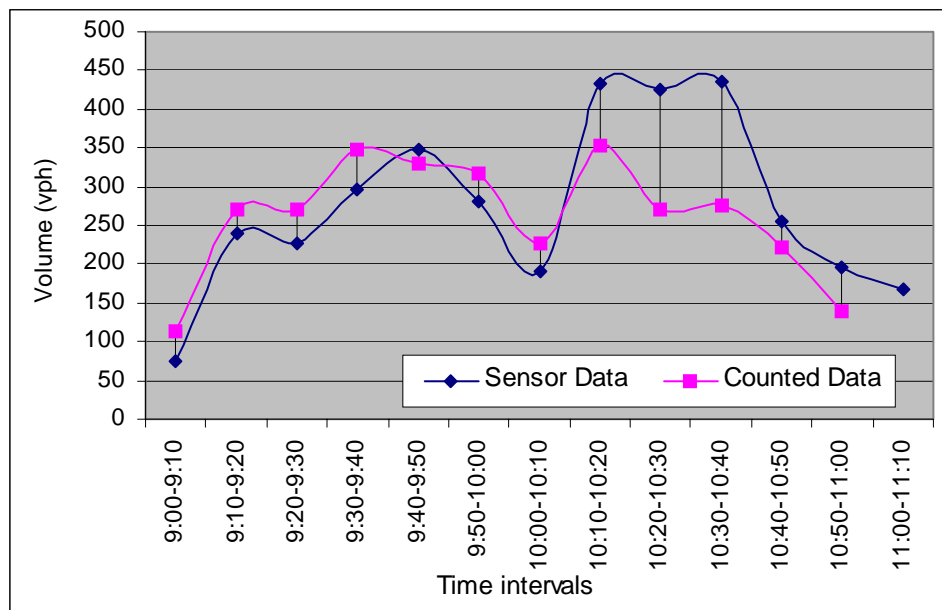
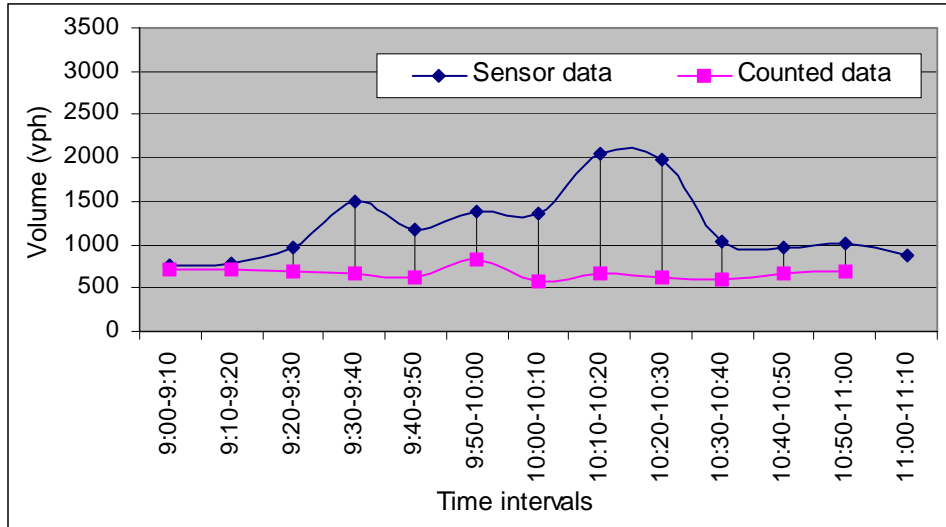
Figures 3-1 to 3-4 compare the sensor detected data and manually counted volumes for the open and closed lanes at the merge and middle points, respectively. The results clearly indicate that the volumes detected by sensors for both the open and closed lanes differ significantly from those counted directly from video tapes.

**Figure 0-1:** Comparison of volume data on the open lane (Merge point, 10/22/2003)

**Figure 0-2:** Comparison of volume data on the closed lane (Merge point, 10/22/2003)

**Figure 0-3:** Comparison of volume data on the closed lane (Middle point, 10/22/2003)

**Figure 0-4:** Comparison of volume data on the open lane (Middle point, 10/22/2003)

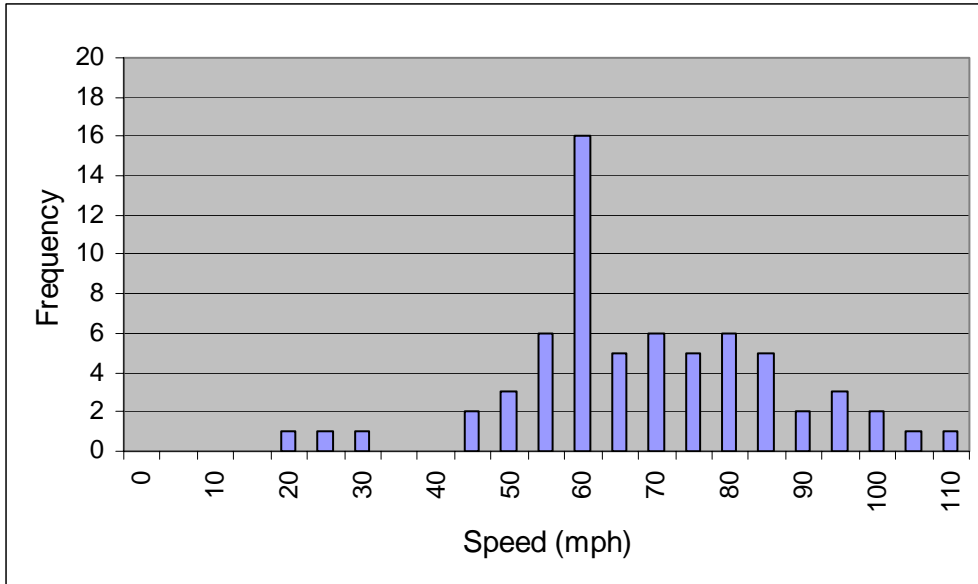
Based on the speed distributions measured under No-control (i.e., Figures 3-5 to 3-8) and field observations, it is apparent that the RTMS sensors under DLM control did not provide accurate speed measurements (Figures 3-9 to 3-12). For example, it is unlikely that some speeds have exceeded 100 mph on the open lane at the merge point (see Figure 3-10), during the DLM control period.

**Figure 0-9:** Speed distribution on the closed lane (Merge point, 10/23/2003)

**Figure 0-10:** Speed distribution on the open lane (Merge point, 10/23/2003)

**Figure 0-11:** Speed distribution on the closed lane (Middle point, 10/23/2003)

**Figure 0-12:** Speed distribution on the open lane (Middle point, 10/23/2003)

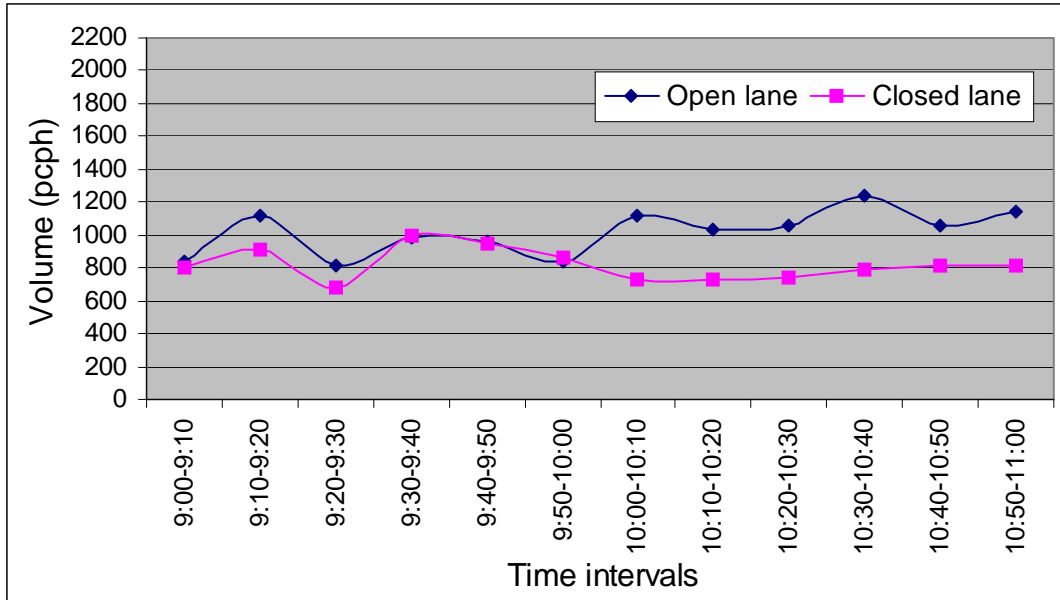
Figures 4-1 to 4-3 display the lane volume distributions at the merge, middle, and upstream points, respectively, under the No-control operation. Note that although volumes were nearly equal between both lanes at the upstream point (see Figure 4-3), many drivers began to use the open lane when they reached the middle point (see Figure 4-2). Also note that a large number of vehicles were observed on the open lane at the merge point (see Figure 4-1).

**Figure 0-1:** Lane volume distribution at the merge point (No-control, 10/10/2004)

**Figure 0-2:** Lane volume distribution at the middle point (No-control, 10/10/2004)

**Figure 0-3:** Lane volume distribution at the upstream point (No-control, 10/10/2004)

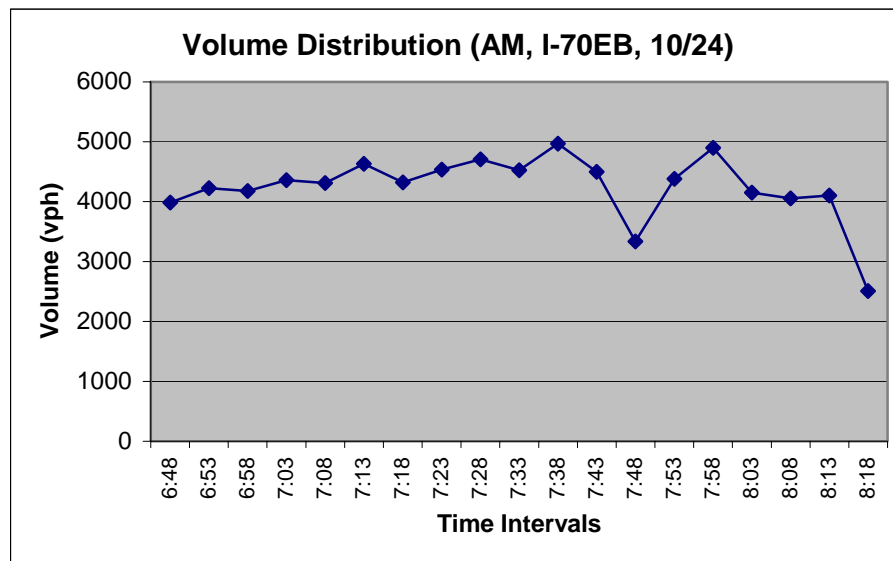
**Figure 0-1:** Volume distribution during the morning peak period

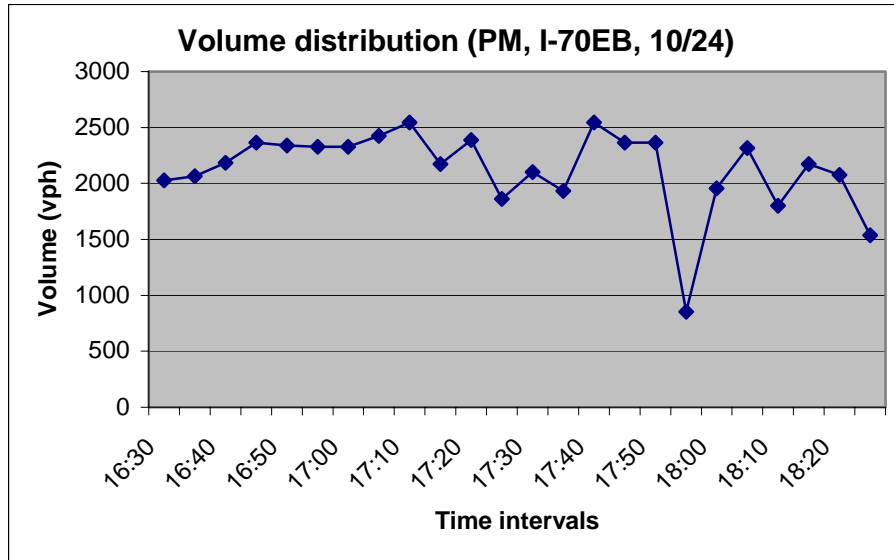
**Figure 0-2:** Volume distribution during the evening peak period

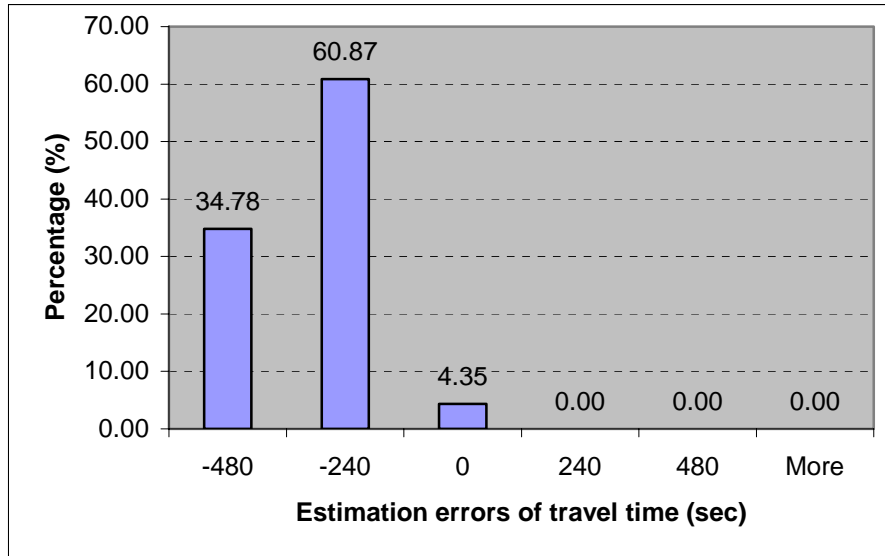
Figure 4-1 further displays the distribution of prediction errors for PCMS #1. It appears that TIPS significantly overestimated the travel times at PCMS #1. The results in Figure 4-2 further show that most of the unacceptable travel times displayed on PCMS #1 were predicted by TIPS during the end of a congested period.

**Figure 0-1:** Distribution of predicted travel time errors at PCMS #1 (AM, 11/14/2003)

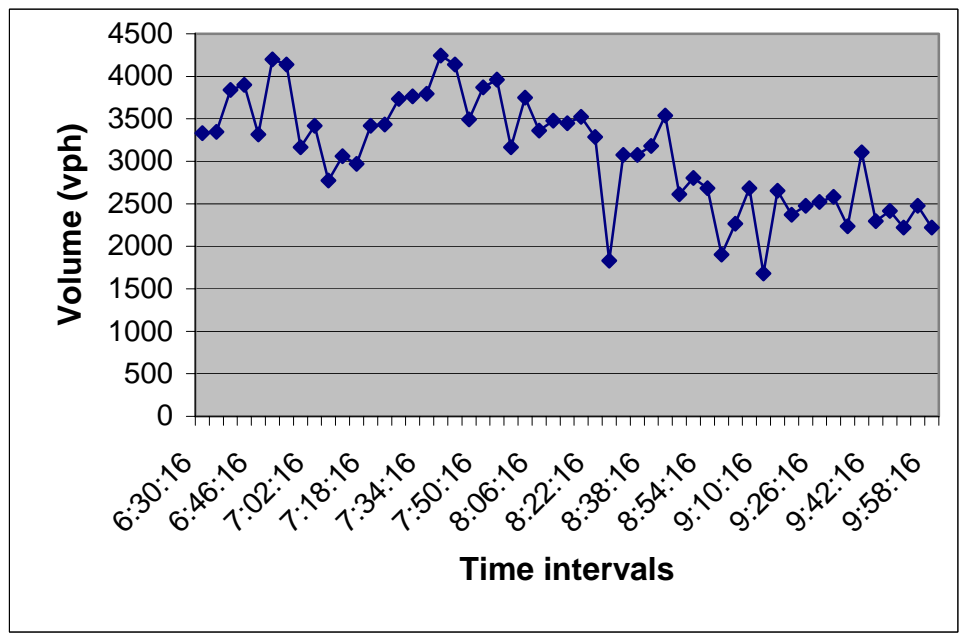
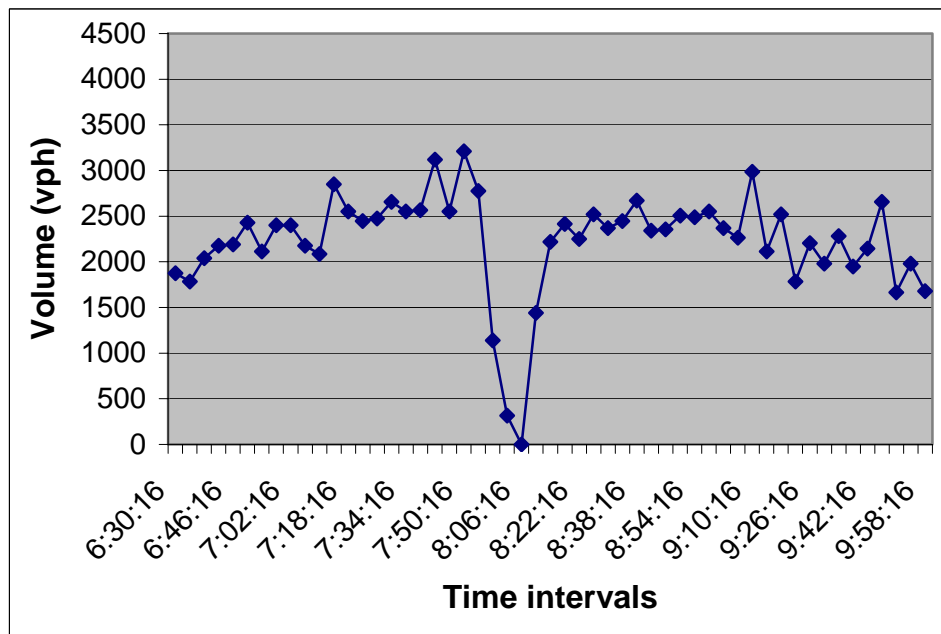
Figures 4-3 to 4-7 present the traffic flow data obtained from the four sensors (i.e., RTMS) in TIPS. It is clear that the first sensor, associated with PCMS #1, did not appear to function properly as evidenced in many of the “zero-flow” intervals.

**Figure 0-3:** Volume distribution from Sensor #1 at PCMS #1 (AM, 11/14/2003)

**Figure 0-4:** Volume distribution from Sensor #2 at PCMS #2 (AM, 11/14/2003)

**Figure 0-5:** Volume distribution from Sensor #3 at PCMS #3 (AM, 11/14/2003)

**Figure 0-6:** Volume distribution from Sensor #4 at Sensor Trailer (AM, 11/14/2003)

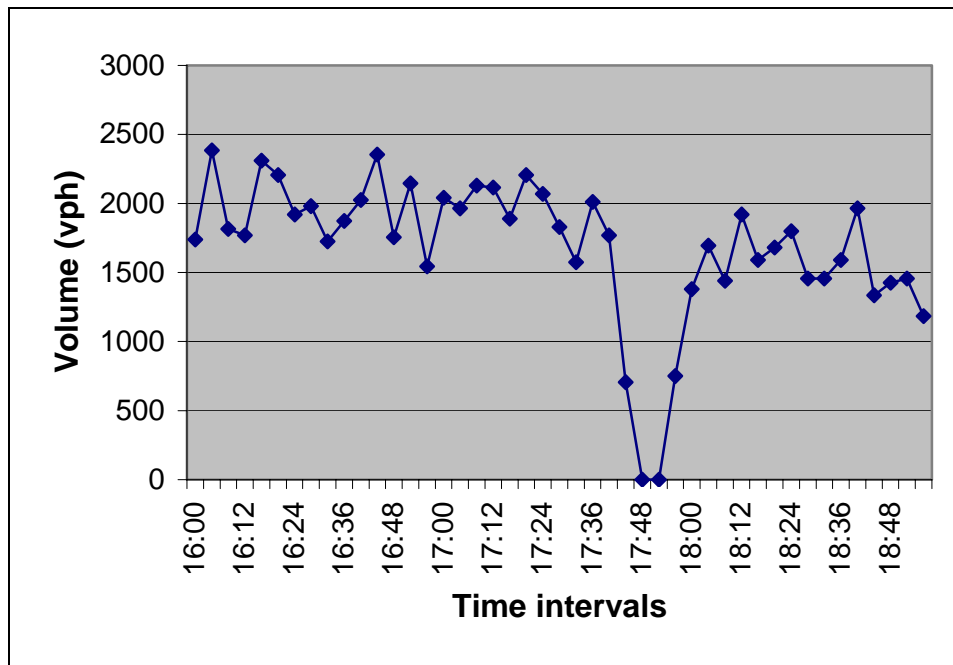
Based on the data obtained from all four sensors, Figures 4-13 to 4-16 present traffic flow patterns during the field survey period (4:00 p.m. ~ 7:00 p.m.). It should be noted that except at the location of the sensor trailer, traffic conditions were quite smooth on the targeted freeway segment. The predicted travel times by TIPS appear to mostly lie within an acceptable range under such traffic conditions.

**Figure 0-13:** Volume distribution from Sensor #1 at PCMS #1 (PM, 11/24/2003)

**Figure 0-14:** Volume distribution from Sensor #2 at PCMS #2 (PM, 11/24/2003)

**Figure 0-15:** Volume distribution from Sensor #3 at PCMS #3 (PM, 11/24/2003)

**Figure 0-16:** Volume distribution from Sensor #4 at Sensor Trailer (PM, 11/24/2003)

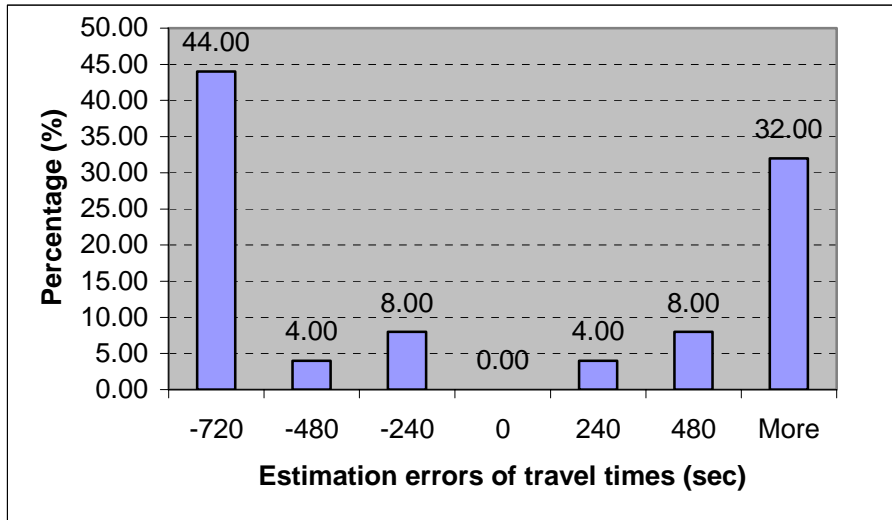
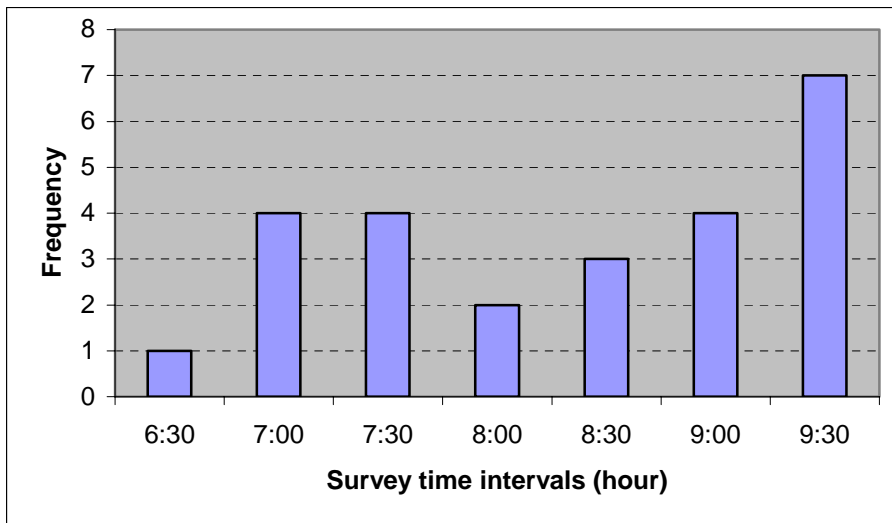
Figure 4-17 further shows the distribution of deviations from actual travel times displayed on PCMS #1. It should be noted that most of the incorrect travel times were displayed during the duration of Accident 2 and uncongested periods (Figure 4-18).

**Figure 0-17:** Distribution of predicted travel time errors at PCMS #1 (AM, 11/25/2003)

**Figure 0-18:** Distribution of incorrect travel times predicted at PCMS #1 (AM, 11/25/2003)

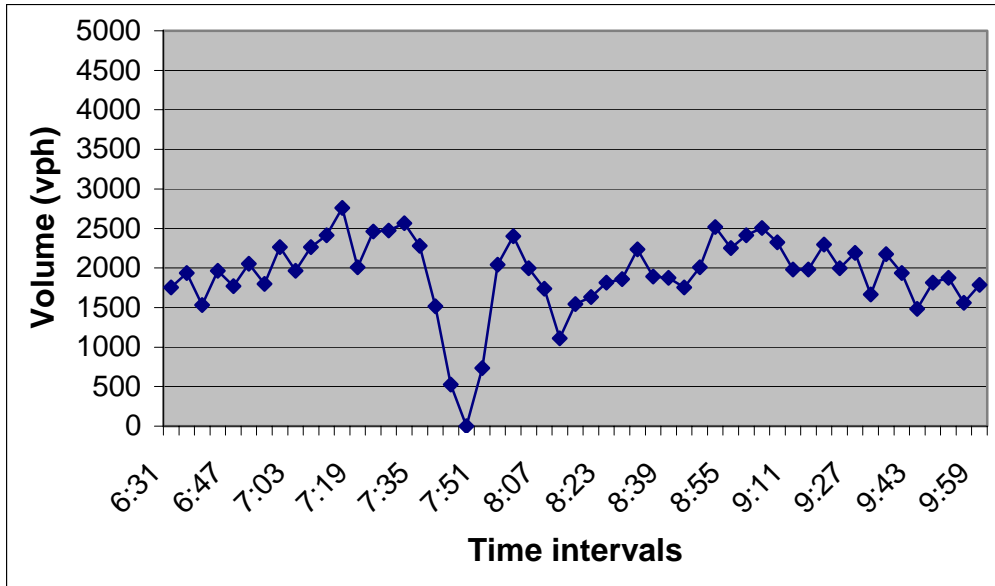
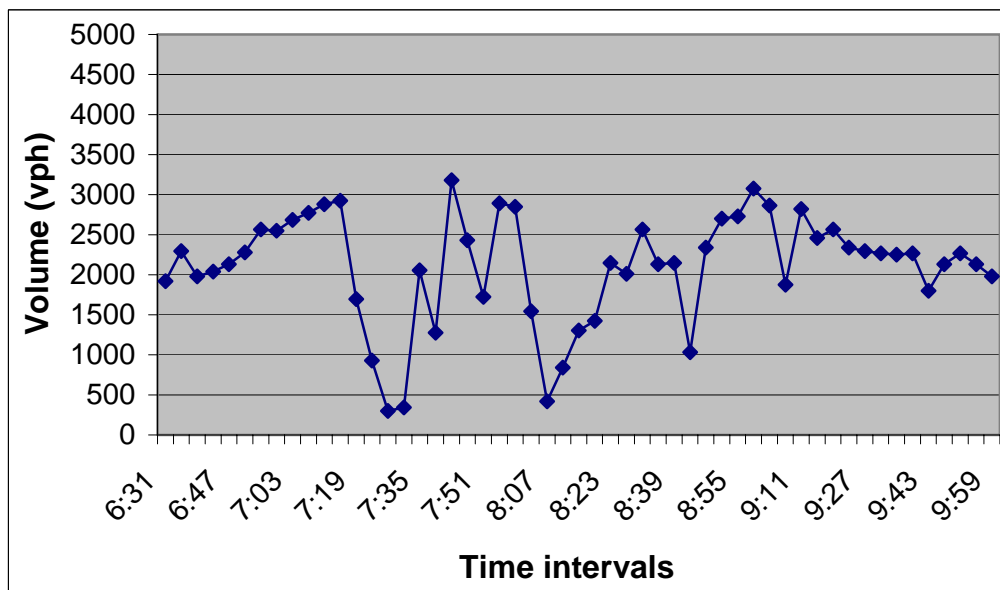
As shown in Table 4-7, traffic volume at the locations of PCMS #1 and #2 fluctuated significantly during the survey period, reflecting the existence of unstable traffic conditions (see Figure 4-21 and 4-22, respectively).

**Figure 0-21:** Volume distribution from Sensor #1 at PCMS #1 (AM, 11/25/2003)

**Figure 0-22:** Volume distribution from Sensor #2 at PCMS #2 (AM, 11/25/2003)

**Figure 0-23:** Volume distribution from Sensor #3 at PCMS #3 (AM, 11/25/2003)

**Figure 0-24:** Volume distribution from Sensor #4 at Sensor Trailer (AM, 11/25/2003)

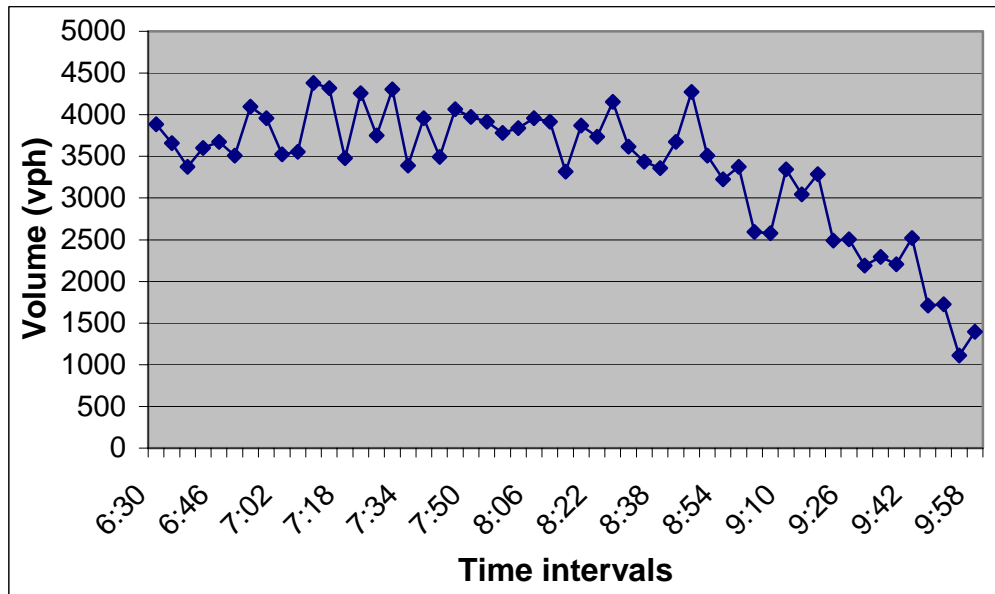
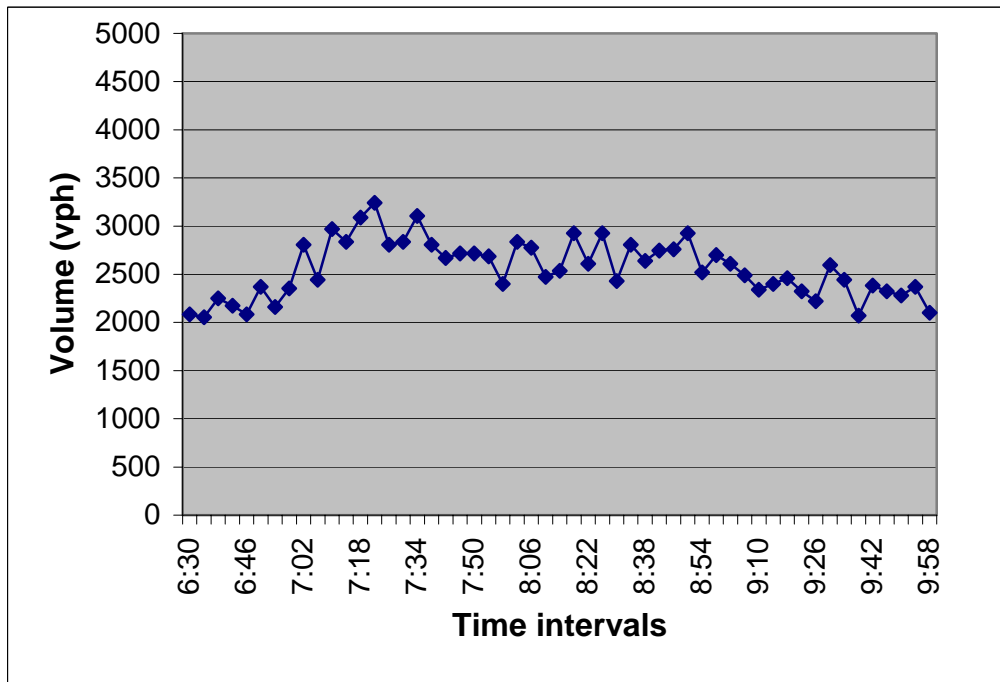
Note that the sensor at PCMS #1 did not function properly (see Figure 4-25). The volume distribution at PCMS #3 (see Figure 4-27) reflected stable and uncongested traffic conditions.

**Figure 0-25:** Volume distribution from Sensor #1 at PCMS #1 (AM, 12/04/2003)

**Figure 0-26:** Volume distribution from Sensor #2 at PCMS #2 (AM, 12/04/2003)

**Figure 0-27:** Volume distribution from Sensor #3 at PCMS #3 (AM, 12/04/2003)

**Figure 0-28:** Volume distribution from Sensor #4 at Sensor Trailer (AM, 12/04/2003)

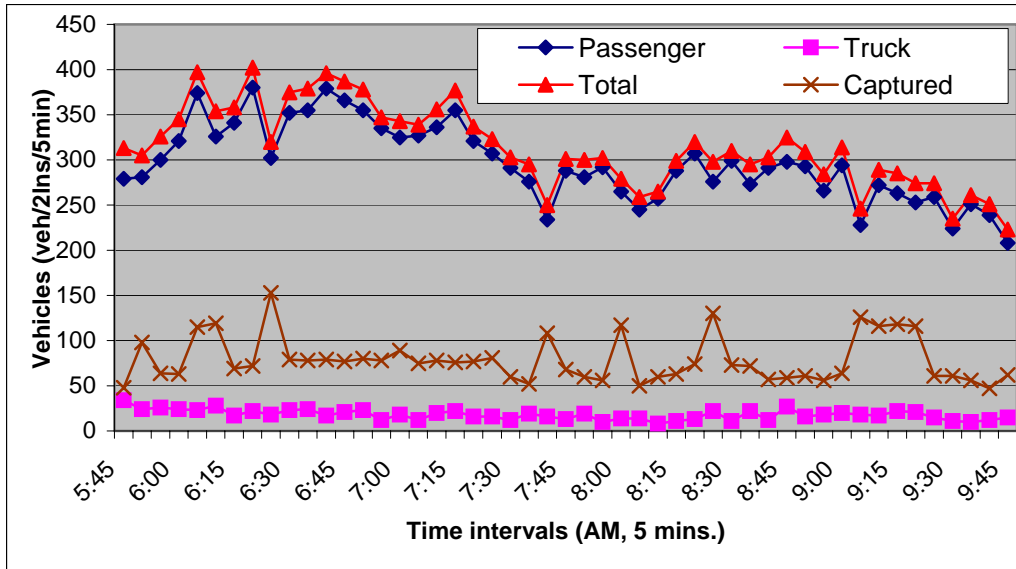
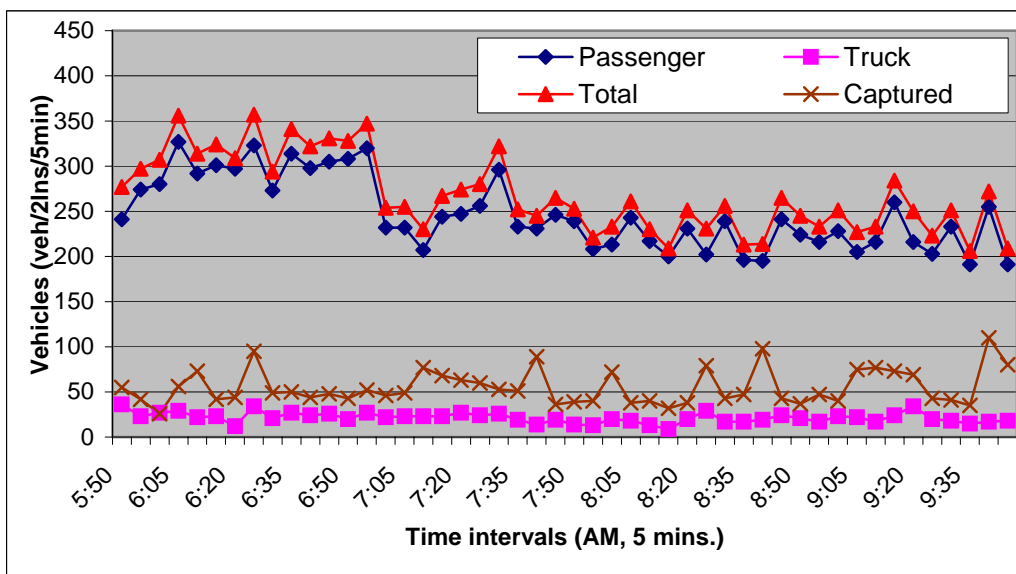
- Note that capture-ability at Site 2 on 11/19/04 (21.1 %) is lower than that on 11/18/04 (33.2 %) because no congestion occurred during the observation period at Site 2 on 11/19/04.

Figure 0-2(a): Comparison of actual volume and LPR captured images at Site 1 (11/19/04)

Figure 4-2(b): Comparison of actual volume and LPR captured images at Site 2 (11/19/04)

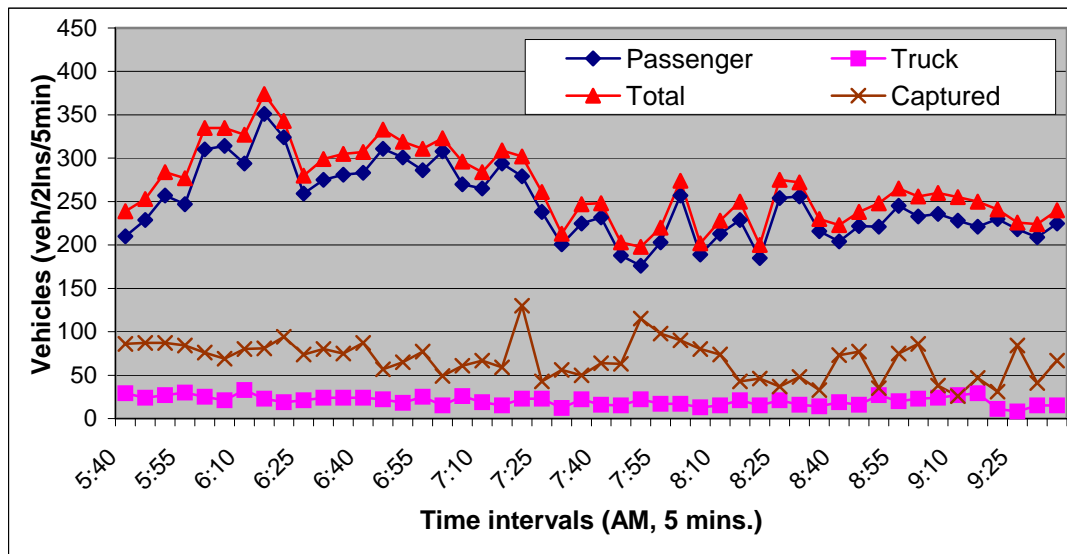
**Figure 0-4: Comparison of actual volume and LPR captured images at Site 2 (11/30/04)**

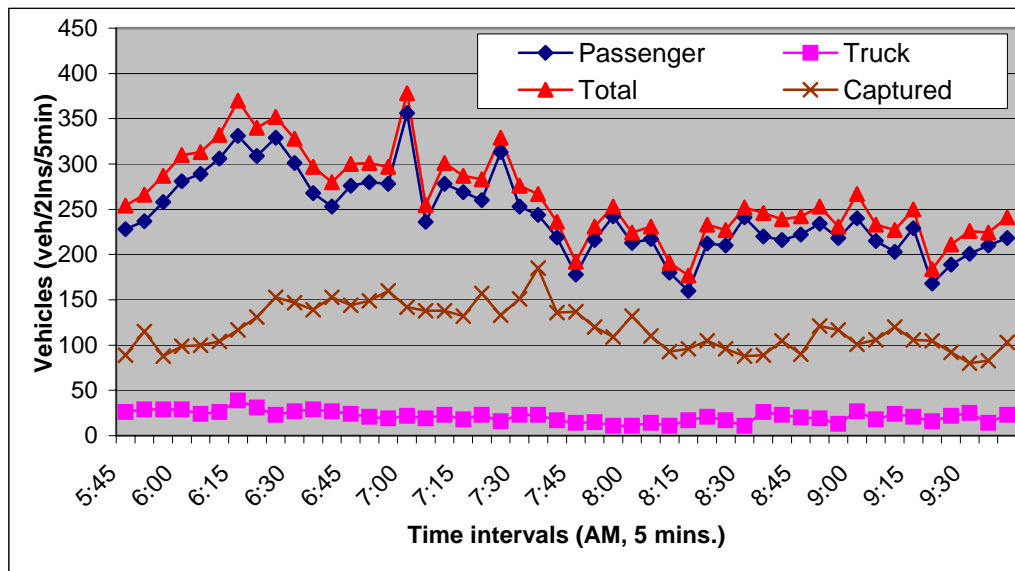
**Figure 0-5: Comparison of actual volume and LPR captured images at Site 2 (12/02/04)**

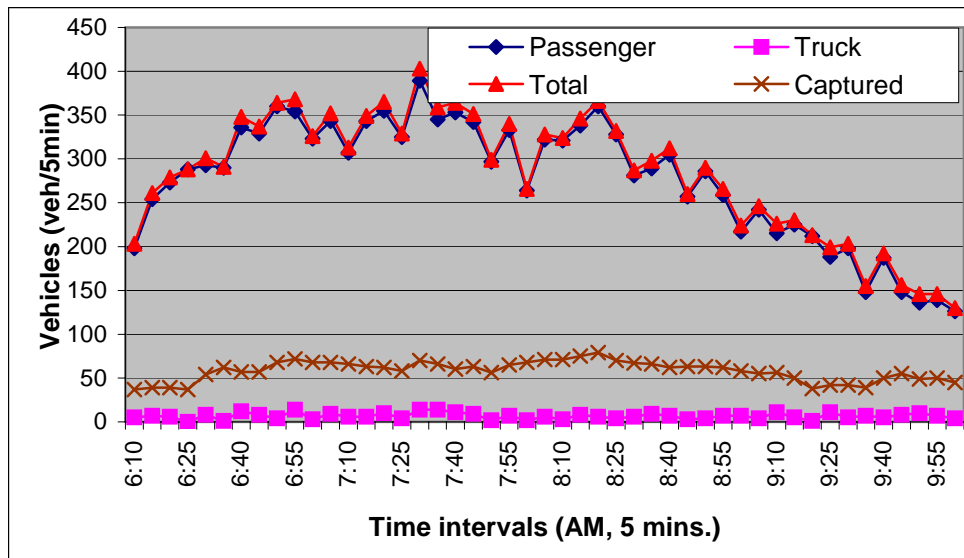
- It should be noted that the roadway around Site 1 is near a segment of the freeway. Therefore, its average flow speed is higher than the posted speed limit (55mph).

**Figure 0-6: Comparison of actual volume and LPR captured images at Site 1 (12/13/04)**

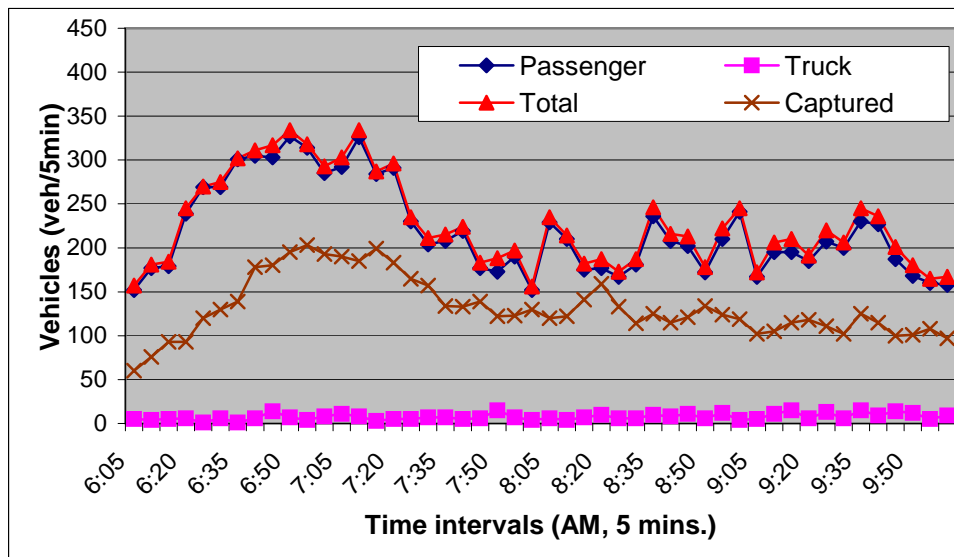
**Figure 0-7: Comparison of actual volume and LPR captured images at Site 2 (12/14/04)**

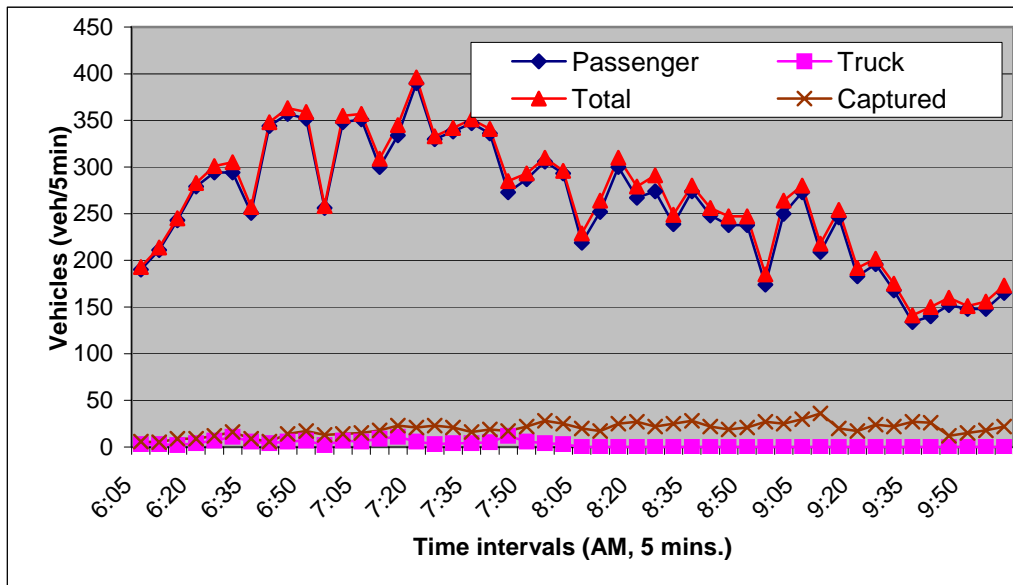
**Figure 0-8: Comparison of actual volume and LPR captured images at Site 1 (12/15/04)**

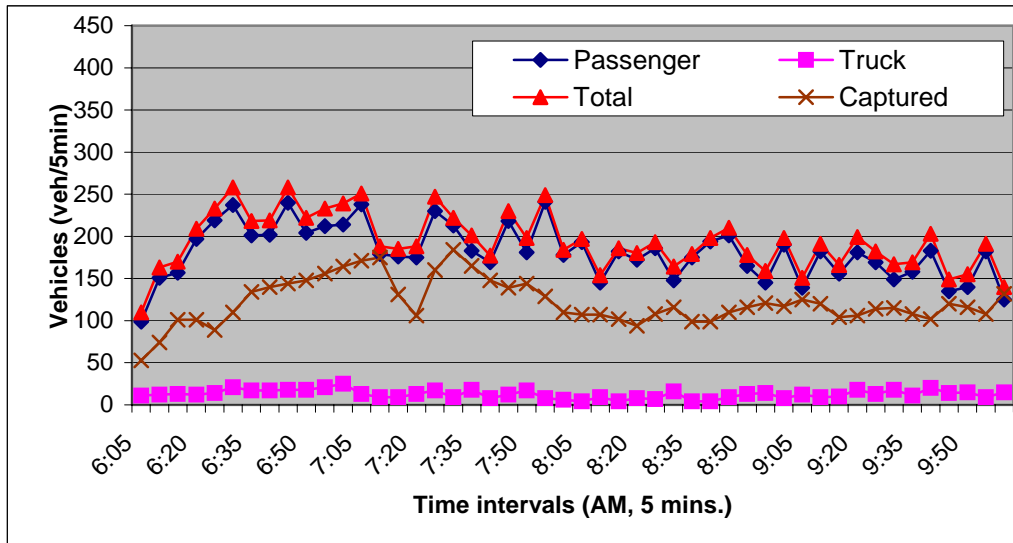
**Figure 0-9: Comparison of actual volume and LPR captured images at Site 2 (12/16/04)**

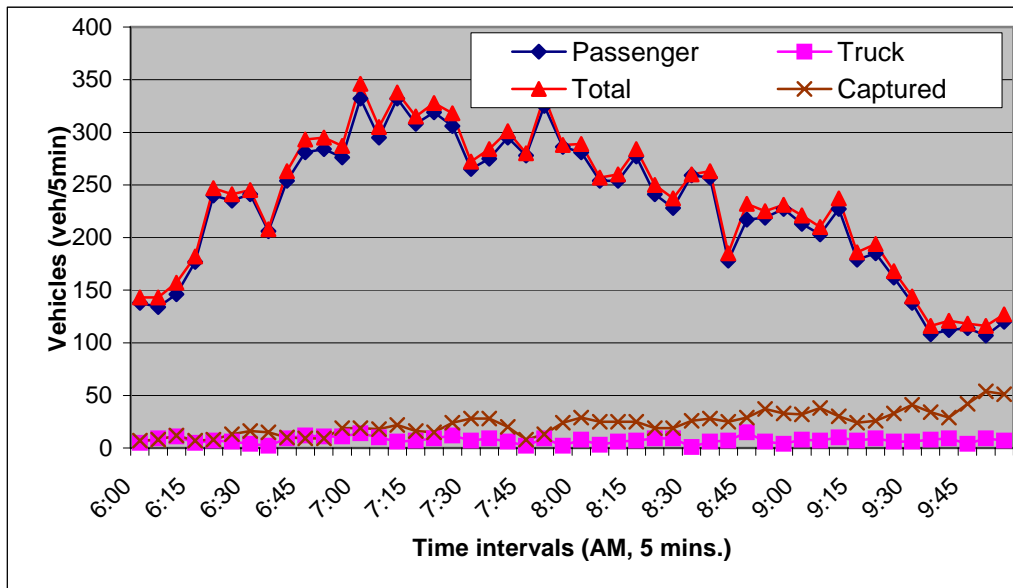
**Figure 0-10: Comparison of actual volume and LPR captured images at Site 1 (12/17/04)**

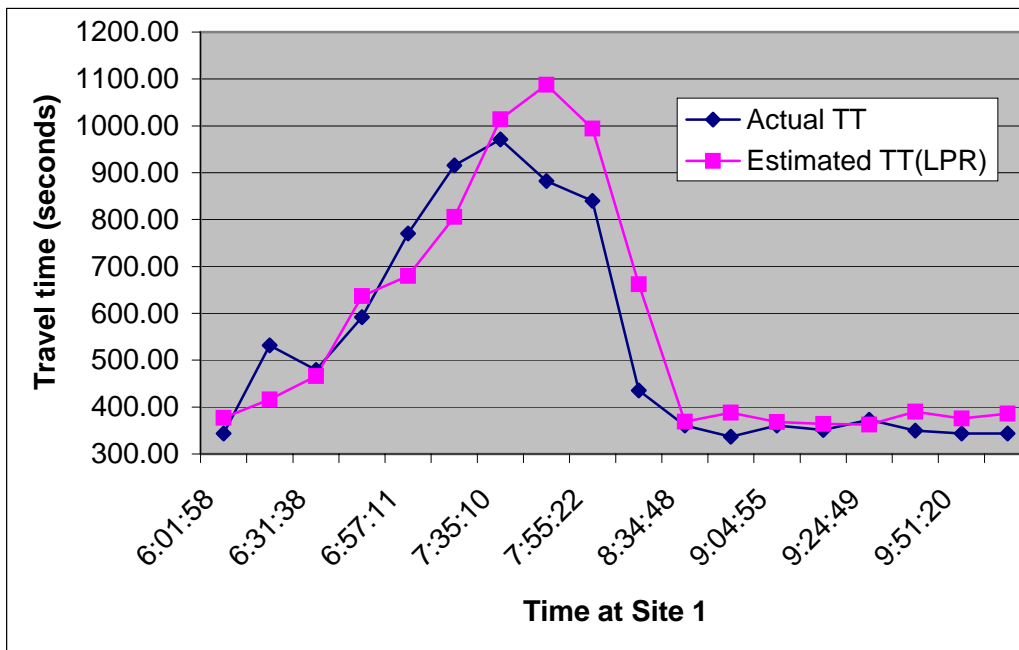
**Figure 0-1: Comparison of actual and LPR estimated travel times (11/18/04)**

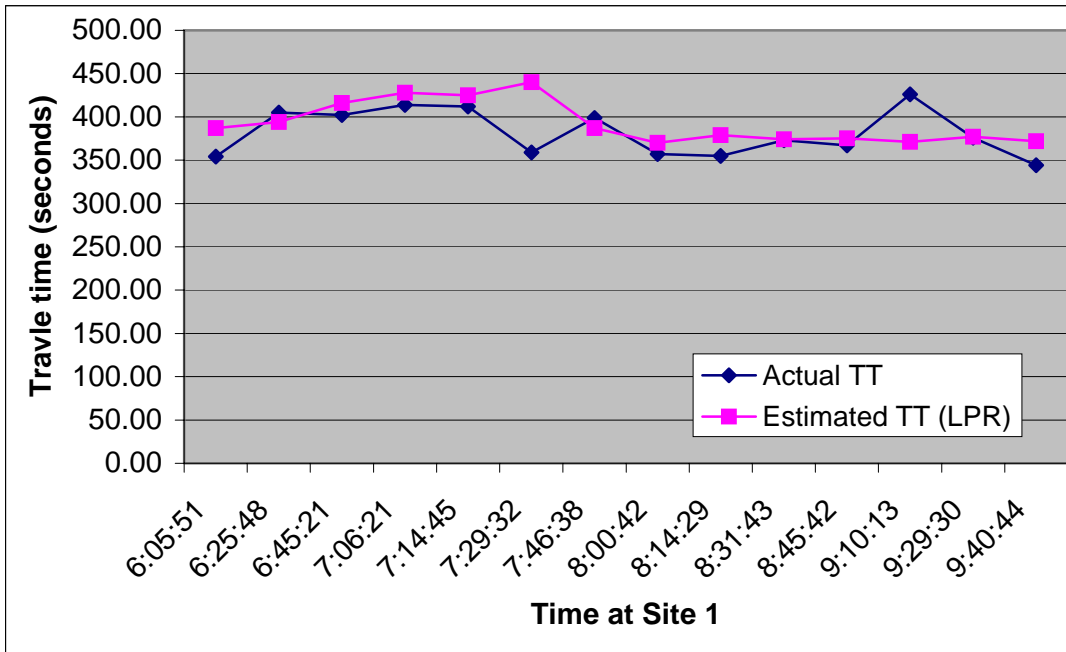
Figure 0-2: Comparison of actual and LPR estimated travel times (11/19/04)

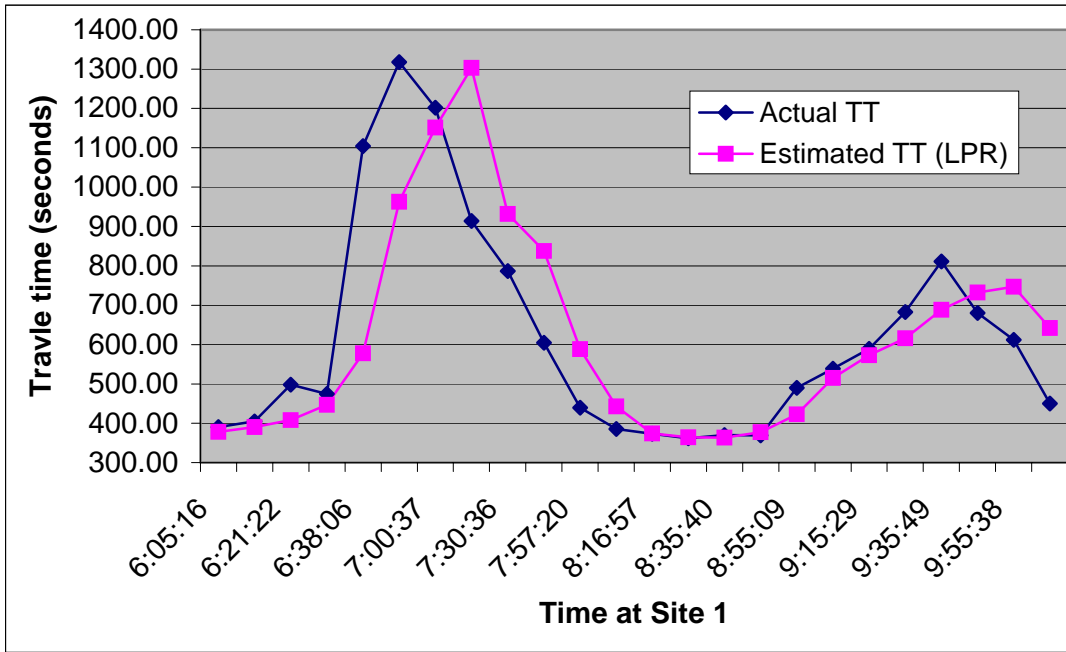
Figure 0-3: Comparison of actual and LPR estimated travel times (11/23/04)

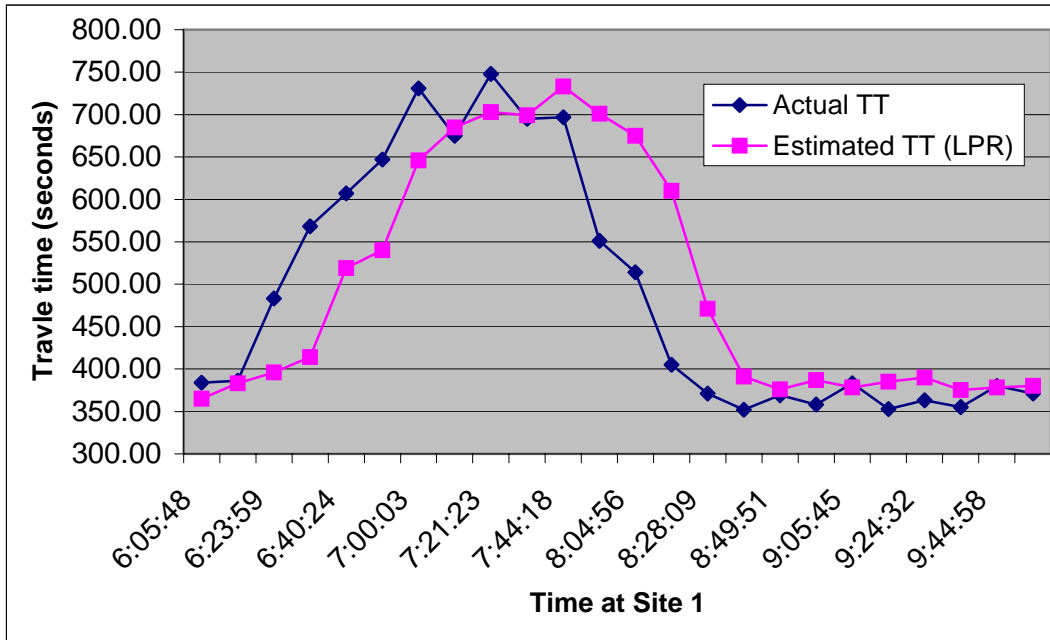
Figure 0-4: Comparison of actual and LPR estimated travel times (11/30/04)

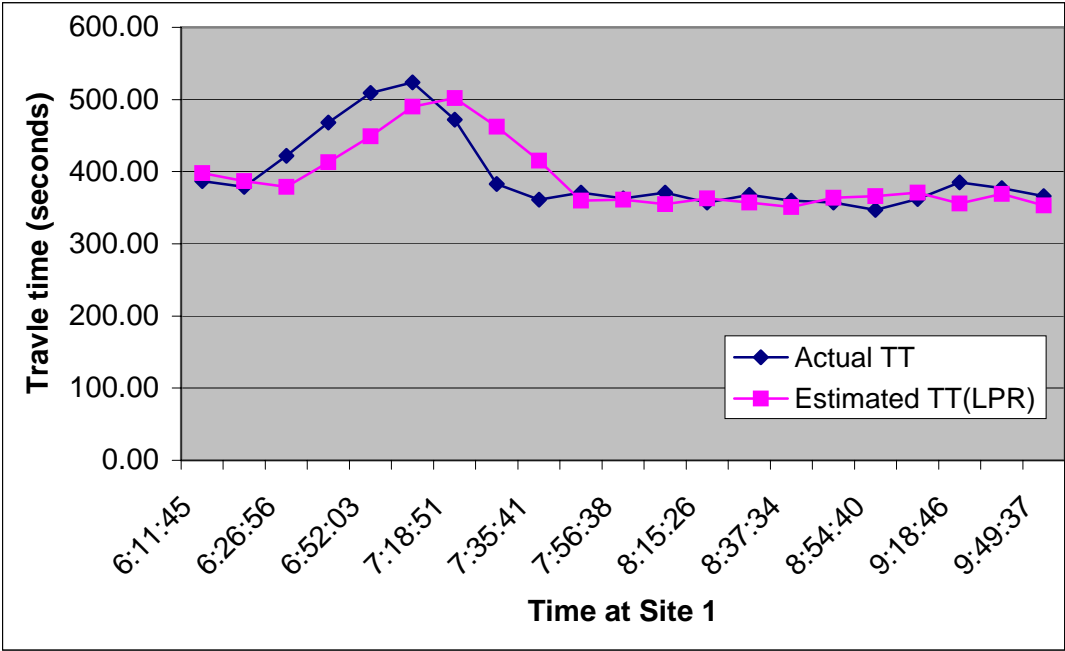
Figure 0-5: Comparison of actual and LPR estimated travel times (12/02/04)
