# EVALUATION OF INTELLIGENT TRANSPORTATION SYSTEM DEPLOYMENTS FOR WORK ZONE OPERATIONS

UNIVERSITY OF MARYLAND, COLLEGE PARK

MD-05-SP208B4H  
FINAL REPORT

AUGUST 2005

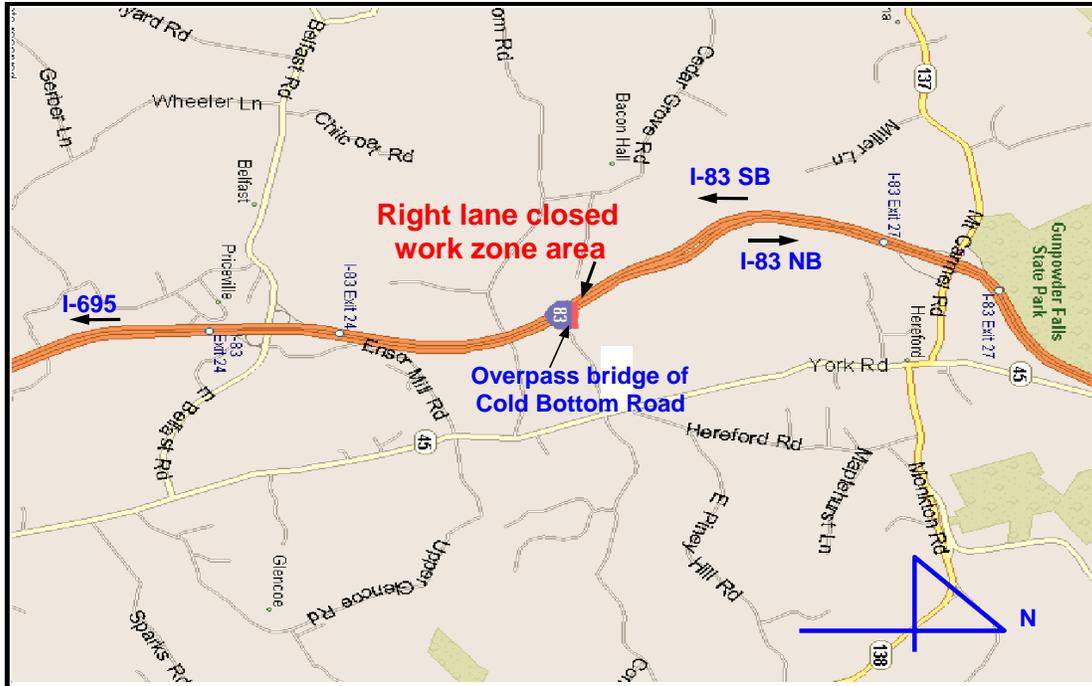
**Figure 0-2:** Location of the work zone on I-83 SB, near Cold Bottom Road

The proposed DLM system was deployed prior to a right-lane closure in a work zone area near the overpass bridge of Cold Bottom Road on I-83 SB (see Figure 1-2).
