RESEARCH REPORT

**Effectiveness of Nest Site Restoration for the Endangered
Northern Map Turtle**

**Report 2: Use of Artificial Nesting Sites and Wildlife
Exclusion Fence to Enhance Nesting Success**

**FINAL REPORT
October 2016**

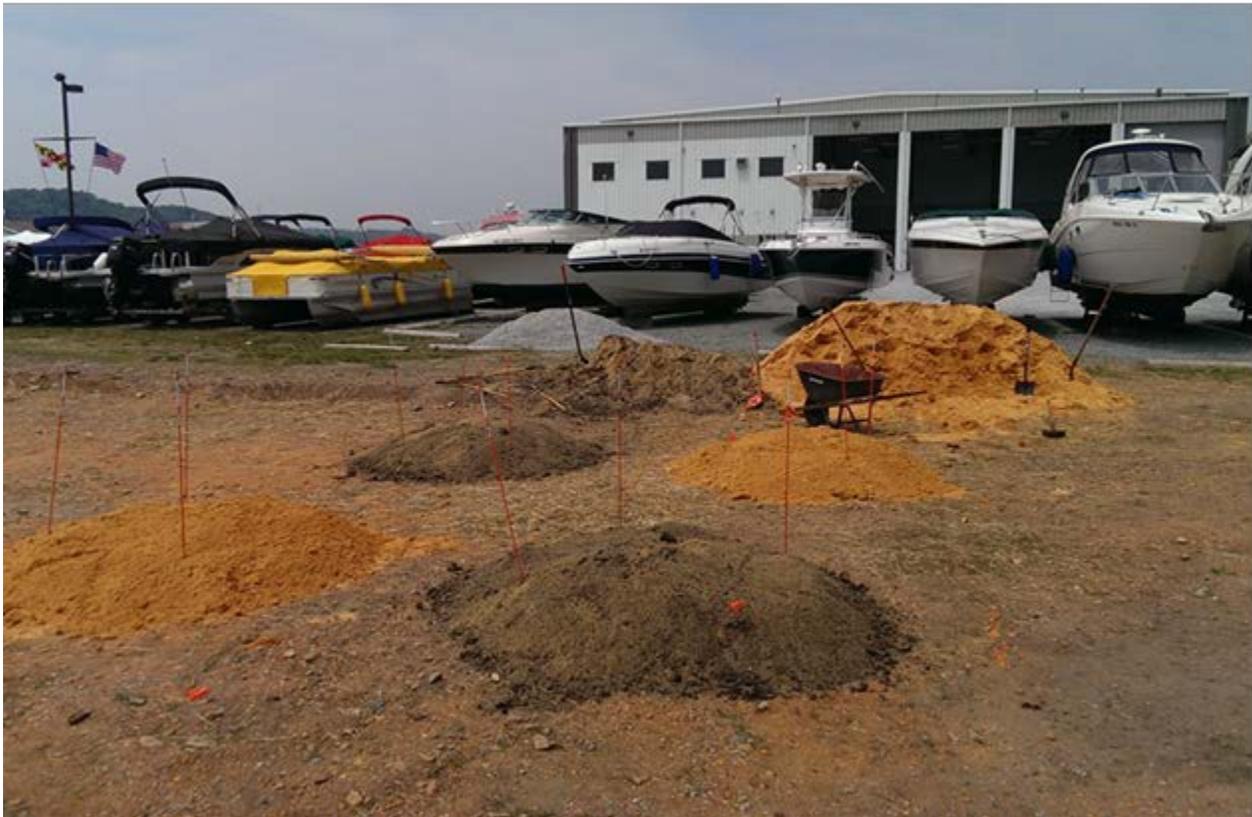
Figure 2.1. Close-up photograph of nesting mounds

The design for the environmental education center calls for (a) rehabilitation of the highly compacted soils available for nesting and (b) a permanent wildlife exclusion fence established along the perimeter of the Tome Gas House that will preclude nesting Map Turtles from leaving the primary nesting grounds. How turtles will react to this barrier and modified soil types is not known. By installing a temporary exclusion fence and a series of nesting “mounds”, the researchers were able to collect data on the behaviors of nesting female Map Turtles relative to this modified nesting environment and made predications on how Map Turtles will react to the permanent modifications in 2017. To begin the process of installing the temporary exclusion fence and creating improved the nesting area, the research team first created a series of discrete mounds (each 4’ high x 4’ diameter [30 cm x 150 cm]) within the area that will eventually be inside the permanent wildlife fence. The concept for using raised areas is based on observations of Map Turtles elsewhere which suggest that elevated areas are preferred for nesting (unpublished observations). Two of the mounds were made of sand and two of organic-rich soil (see Fig. 2-1). This allowed us to both compare nesting effort between the mounds and other sites within the enclosed nesting grounds and between soil types.

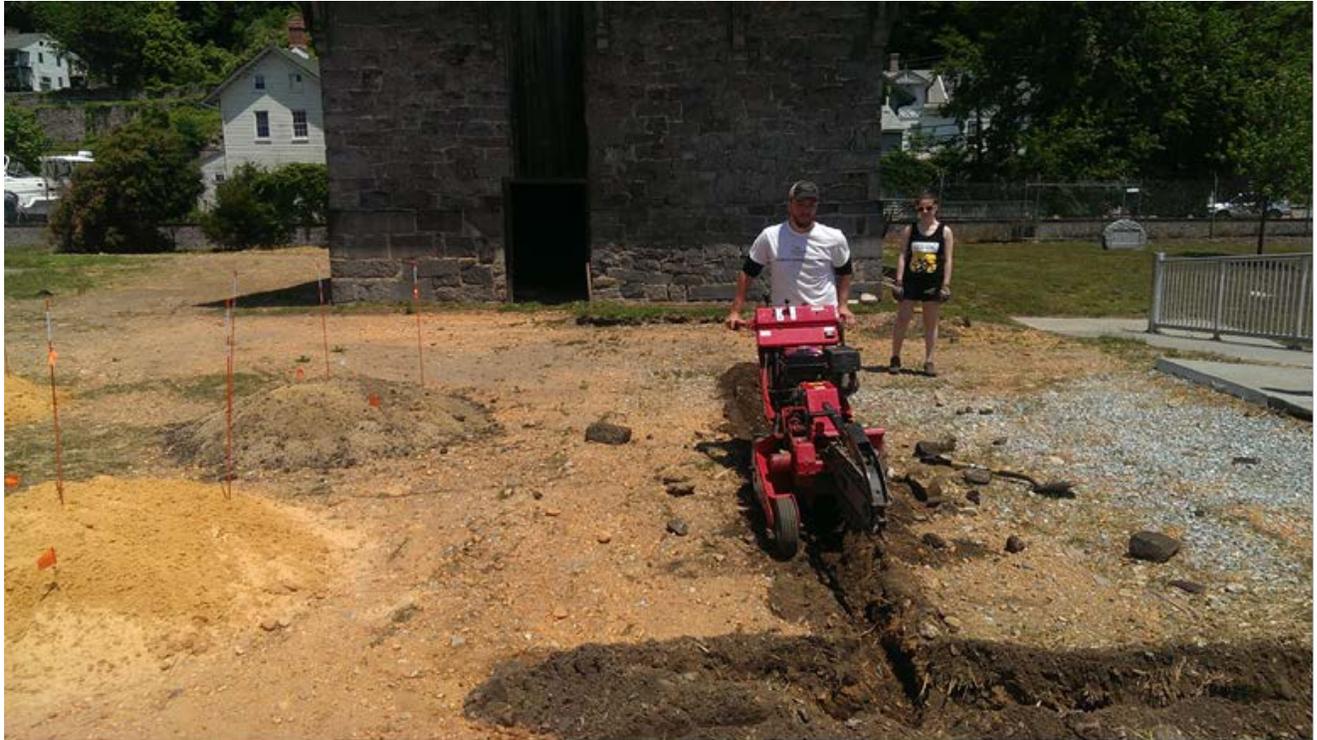
Instead of a permanent wildlife fence, the research team installed a temporary fence made of highway-grade “silt” fencing. A powered trencher was used to dig a 6” deep trench and the research team then laid 36” high silt fencing into the trench, with wooden stakes at 5’ intervals (see Fig. 2-2).

Figure 2.2. Photograph of installation for trench for wildlife exclusion fence

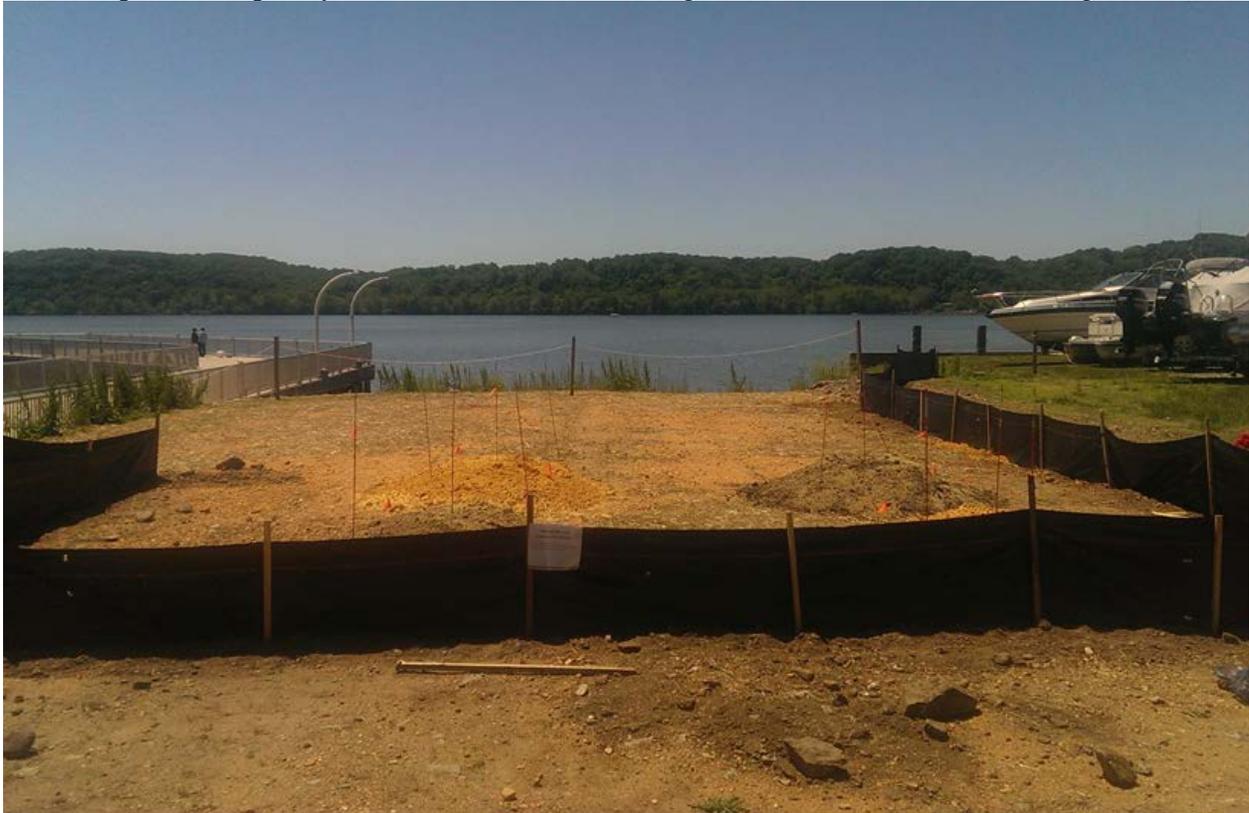
The completed temporary fence with enclosed nesting mounds is shown below in Figure 2-3.

Figure 2.3. Photograph of nesting beach at Port Deposit following establishment of nesting mounds and wildlife exclusion fence

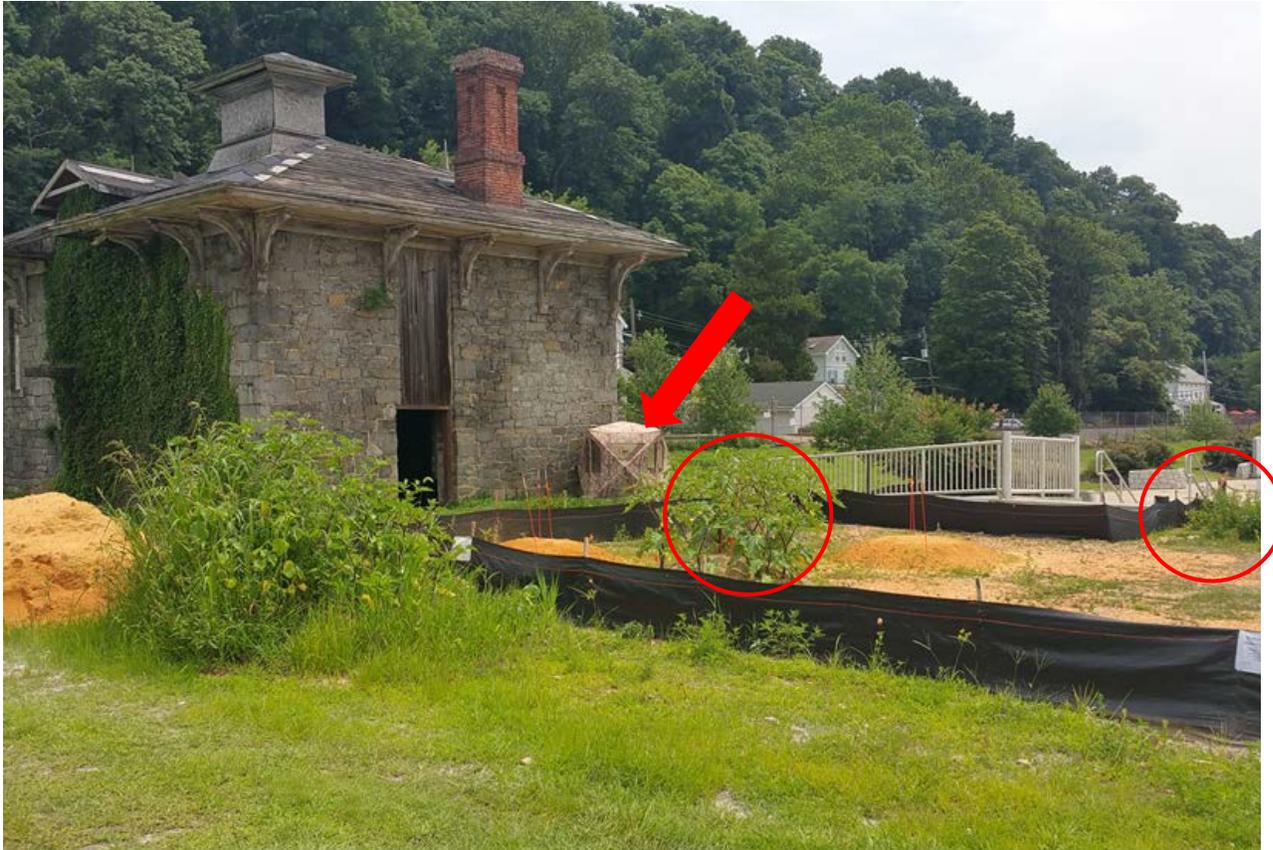
Figure 2.4. Photograph of wildlife blind (at red arrow) used to collect data on nesting Map Turtles in 2015. The blind can be seen in the front right corner of the Gas House. Vegetative growth on the nesting grounds can also be seen (inside red circles) in this photo.

In 2015, the research team made observations on timing and behaviors during nesting at the newly-enclosed nesting grounds via direct observation from a wildlife blind established at the downstream corner of the Gas House perimeter (see Fig. 2-4). Time of day, duration of the nesting foray, exact nest location, and environmental conditions (air temperature, relative humidity, cloud cover, wind speed and direction) were recorded for all turtles seen nesting. If a female was disturbed while nesting, the source and timing of the disturbance was recorded. Once nesting was completed, the female was captured, processed as indicated below, and released at the site of capture.

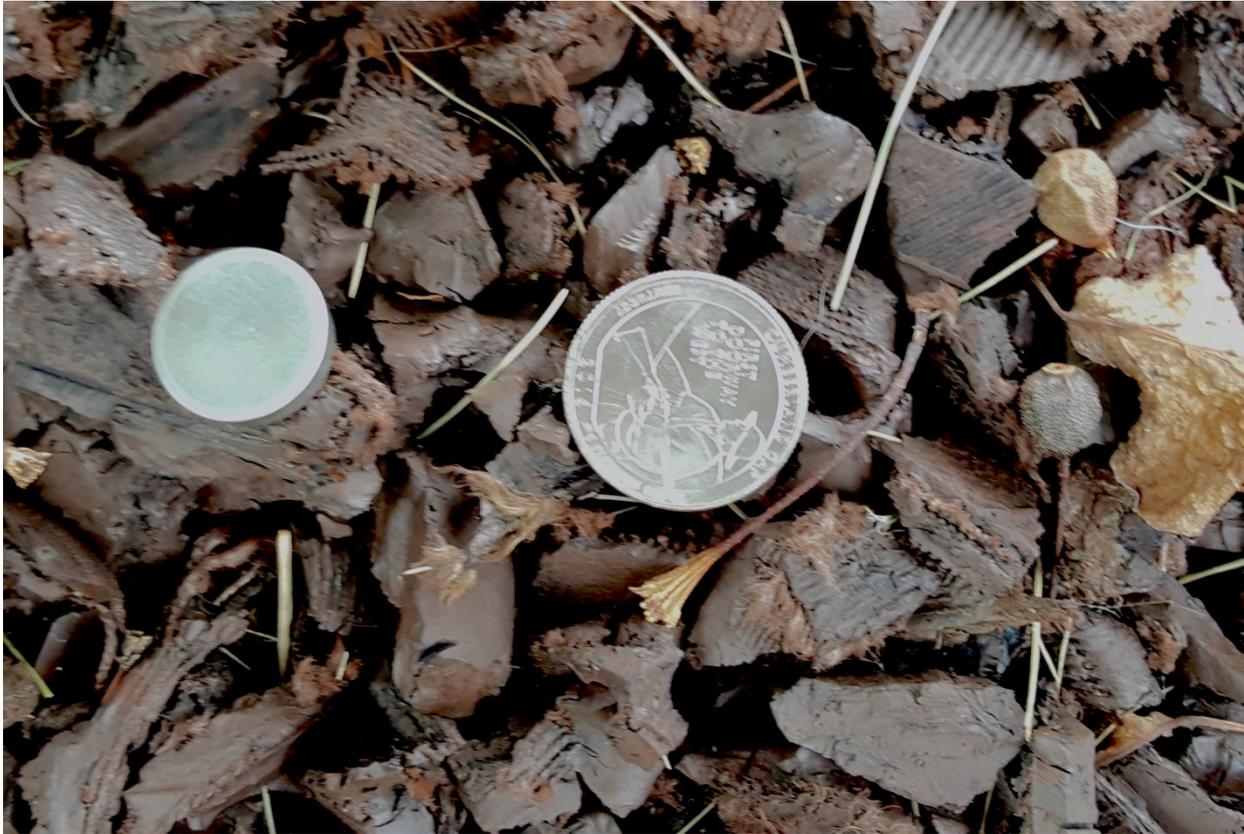
Figure 2.12. Photograph of “iButton” (left) used to monitor nest temperatures of Northern Map Turtles. A quarter is shown on the right to indicate scale.

Using the same nests monitored for survival noted above, the research team placed temperature-sensitive data loggers (‘iButtons²’) on selected nests to monitor incubation temperatures every 30 minutes from egg-laying through hatchling emergence (see Fig 2-12). These data were compared with data from nests constructed after rehabilitation of the nesting areas, to see if nests constructed in 2015 have a different thermal profile from nests constructed in prior years.

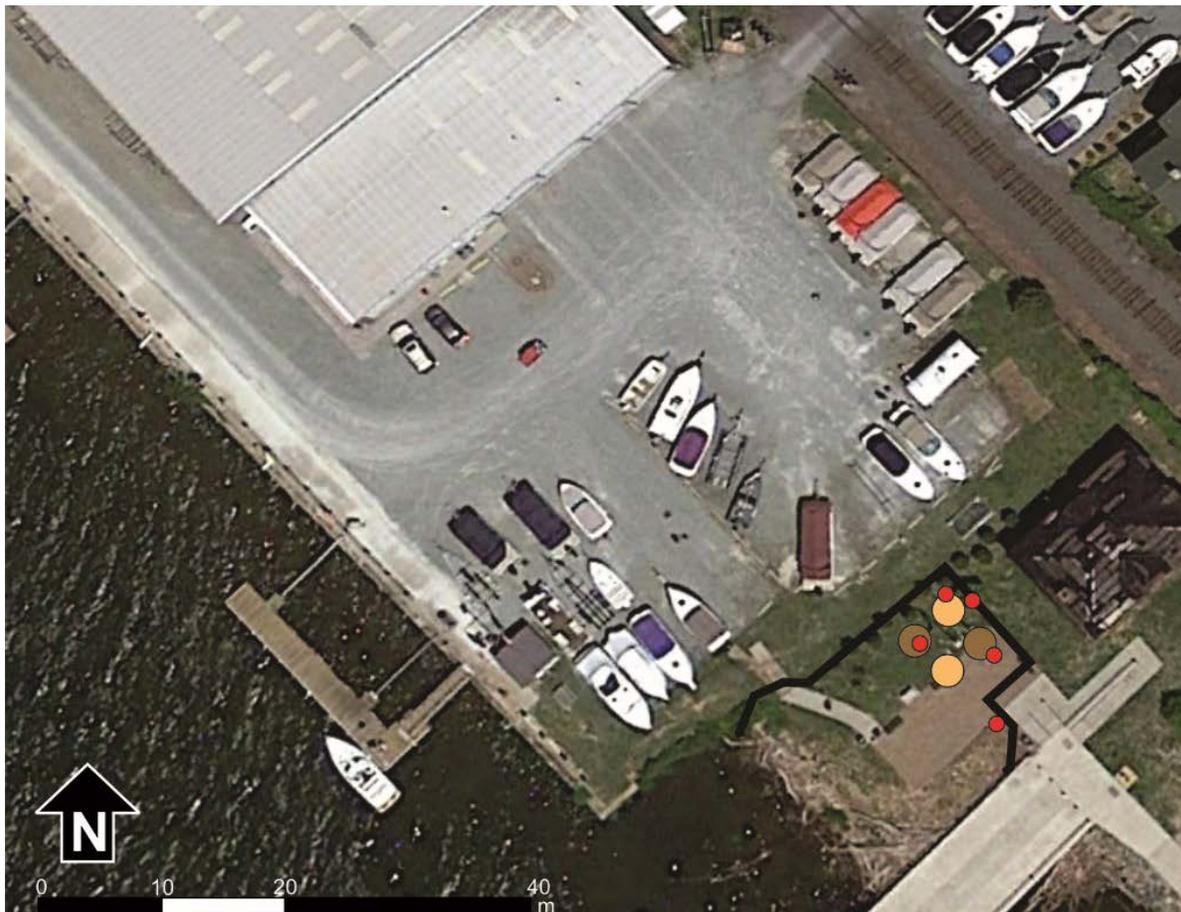
Figure 3.1A. Map showing locations of all Map Turtle nests in Port Deposit during 2015 (red circles) near the Gas House. The nesting mounds established at the Gas House site are shown by yellow and brown circles.

Nesting occurred in two primary areas in Port Deposit with one in the immediate vicinity of the Gas House and another upstream of the Gas House near the developed condominiums (see Figures 3-1A and 3-1B, respectively).

However, most of these incomplete nests (five of eight) were seen only in the early part of the nesting season, primarily in late May. The remaining three nesting attempts were found on a single day in late June. The first viable nests (those with eggs and which were completed) were built inside the perimeter of the wildlife fence starting on May 28th. Of the five complete nests located within the wildlife fence, two were dug in or partially in the soil mounds and one in the sand mound. One of the three nests was completely within the soil substrate of one of the mounds and two were in the underlying substrate but with the perimeter of the nest mound. Of the remaining two nests, one was built along the silt fence within 1 m of a soil mound and the other built along the silt fence well away from the mounds (see Fig. 3-1A).

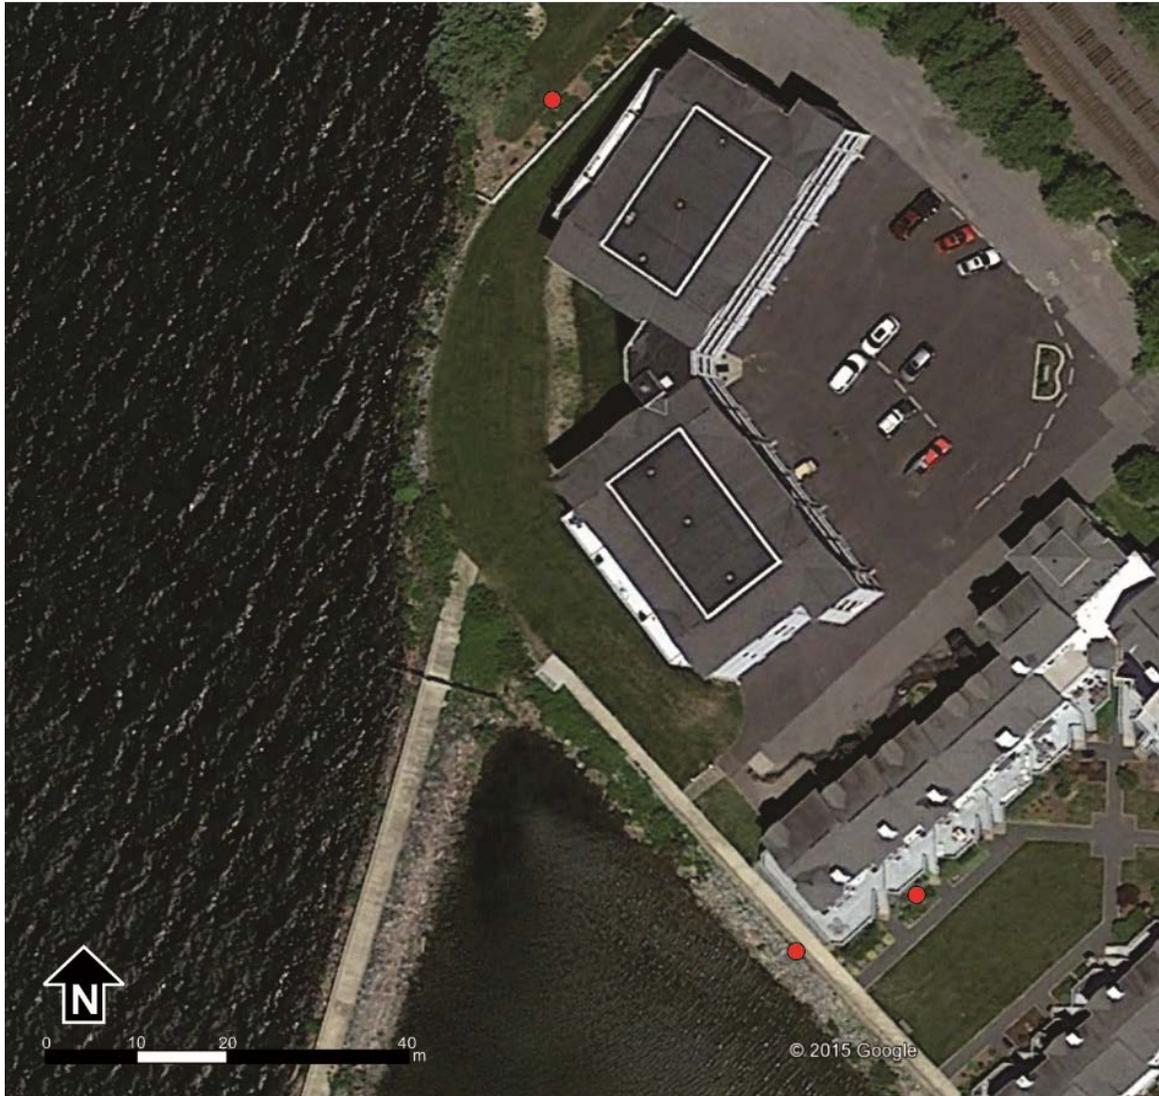
Figure 3.1B. Map showing locations of all Map Turtle nests in Port Deposit during 2015 (red circles) near the upstream condominiums.

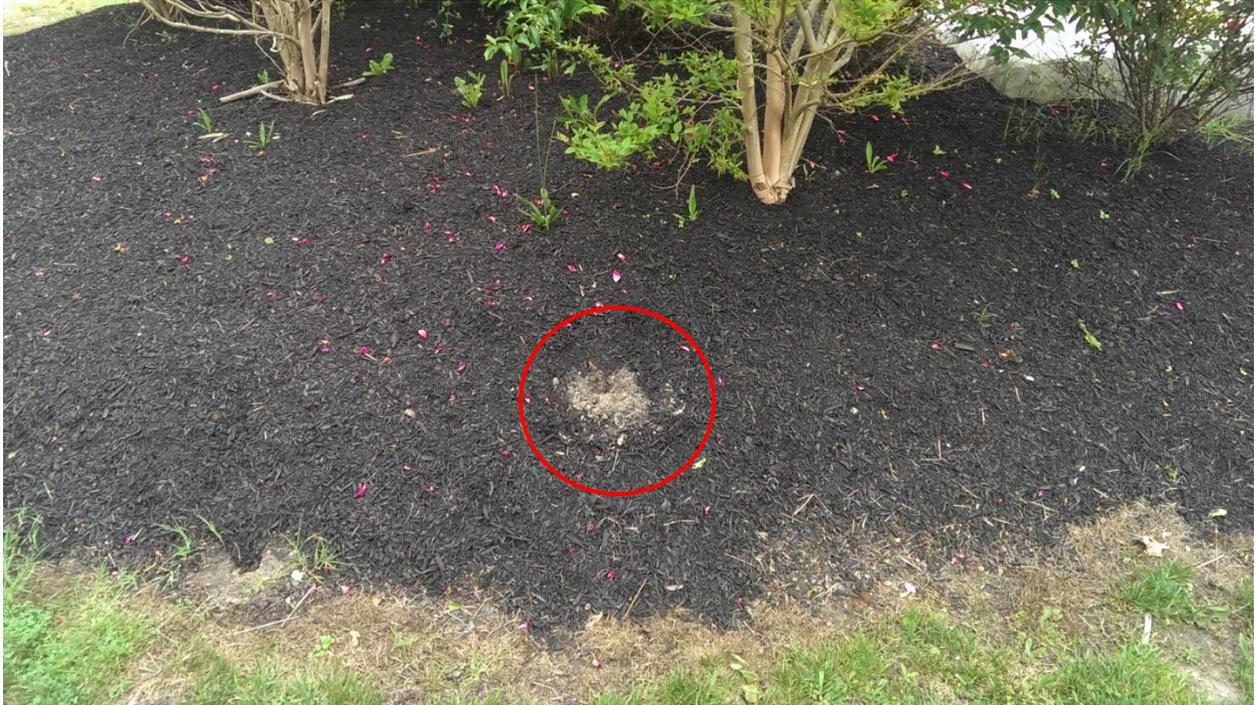
Figure 3.2. Photograph of incomplete nest (inside red circle) found outside the perimeter of the wildlife fence early in the season (May 27th 2016).

Both direct visual observations and the location of several incomplete nests outside the perimeter of the wildlife fence indicated that the initial behavioral response of the turtles was to avoid both the enclosed nesting ground and the associated soil mounds. Figure 3-2 shows a photograph of such a nest, one of eight attempts found in the mulched soils approximately 14 m downstream of the enclosed nesting grounds.

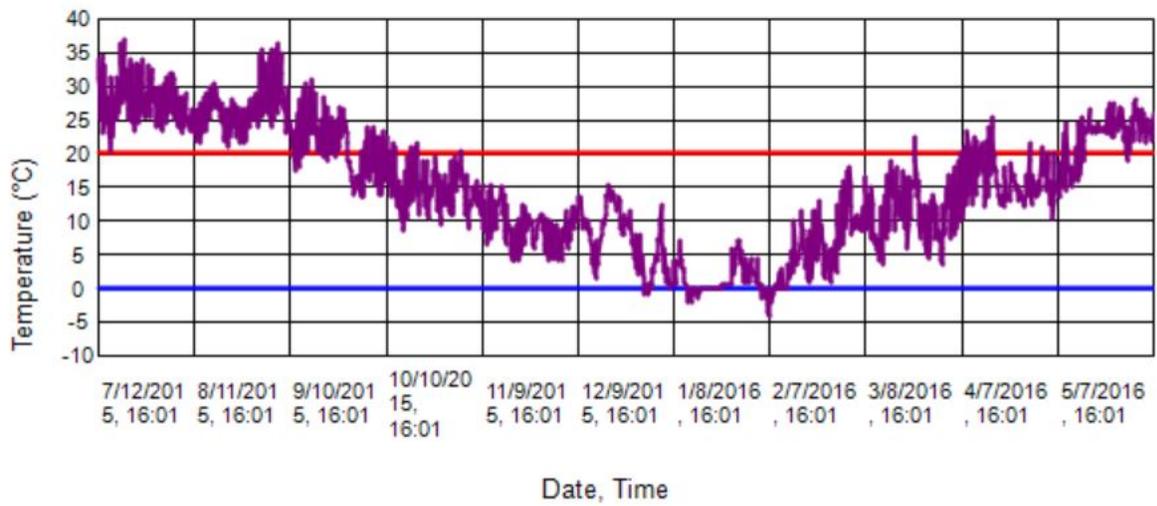
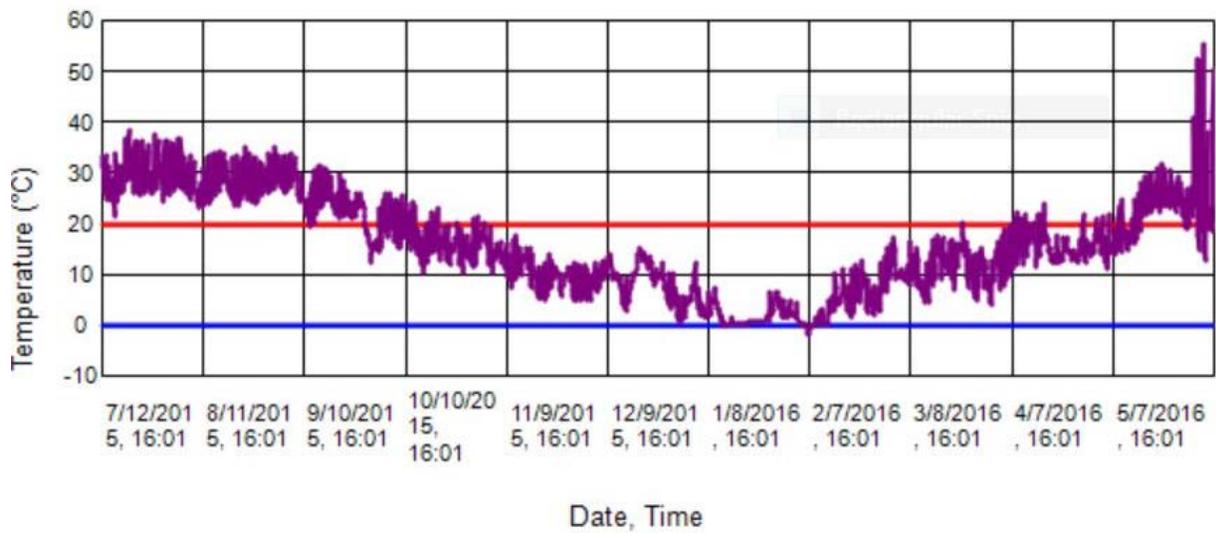
A typical nest temperature profile, as measured by the iButtons, for two nests constructed in 2015 and which hatched in 2016 are shown in Figure 3-3. The temperature profile data collected for nests constructed in 2013-2014 are quite similar to nests constructed in 2015 and no substantial differences were seen between years, although sample sizes are small.

Figure 3.3. Graph of nest temperatures experienced by Map Turtles nesting in rehabilitated nest sites in 2015 at the Tome Gas House.
