RESEARCH REPORT

**PRECISION MONITORING OF BRIDGE DECK CURVATURE CHANGE
DURING REPLACEMENT**

UNIVERSITY OF MARYLAND, COLLEGE PARK

May 2016

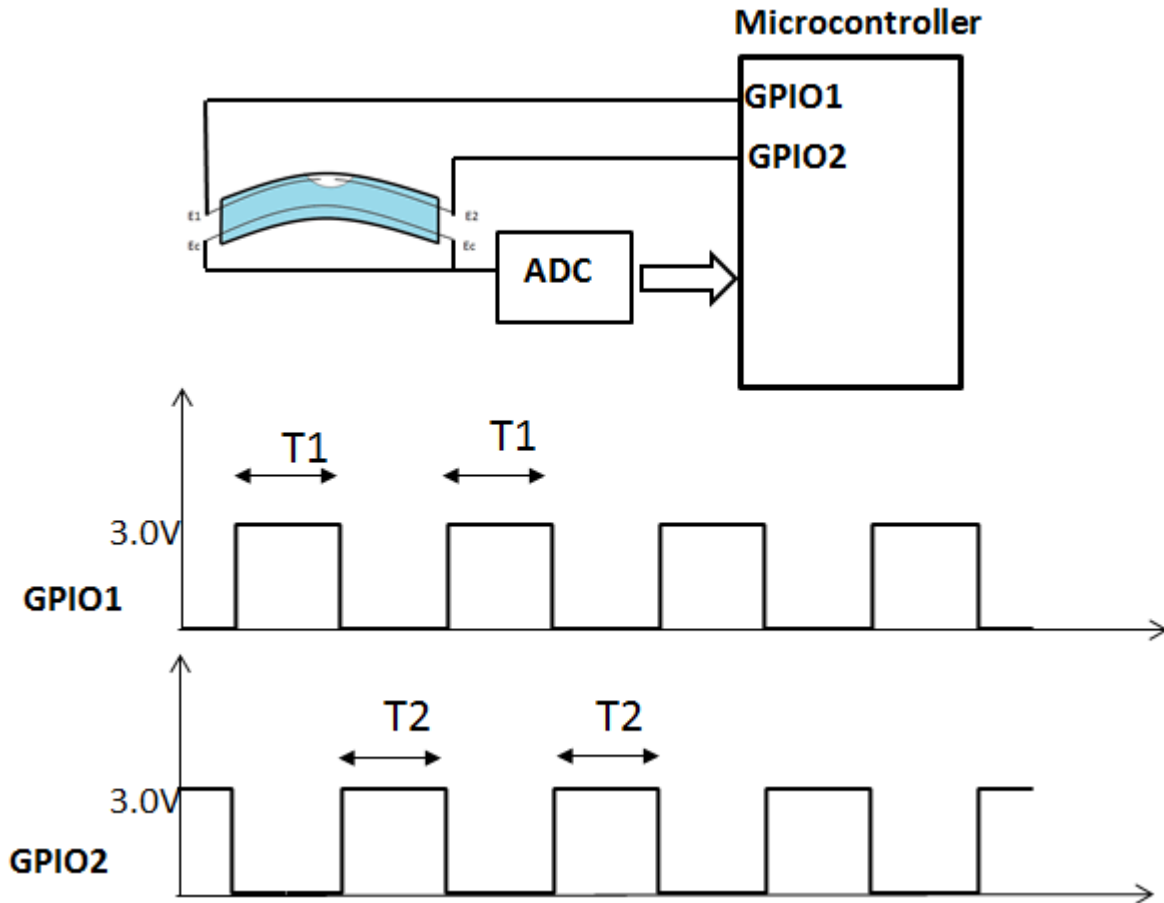
Figure 3: Electrical signal conditioning for electrolytic tilt sensors.

Analog to Digital Converter (ADC) as the first conversion. Then the microcontroller reverses the voltages on GPIO1 and GPIO2 by applying the same voltage on GPIO2 while voltage on GPIO1 is zero, and holds those voltage levels for another time period, T_2 . At the end of T_2 , a second conversion of common electrode voltage will be done. The difference of the two conversions is proportional to tilt of the device.

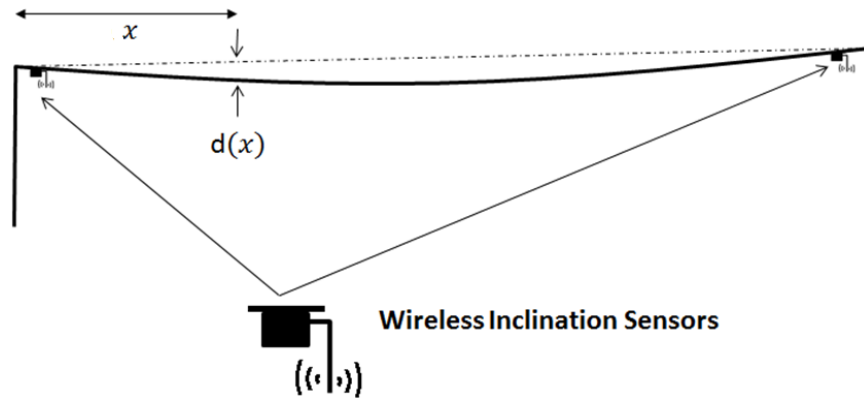
Figure 7: Illustrating locations of wireless inclinometers for monitoring deck vertical displacement.

As a remark on placement of wireless inclinometer sensors, it must be noted that for good numerical stability in calculations, it makes sense to choose inclination measurement points x_1, x_2 to have the maximum separation from each other on the span. For this purpose, two wireless inclinometer sensors can be installed close to the two piers at the either side of the span. This placement scheme is shown in Figure 7.

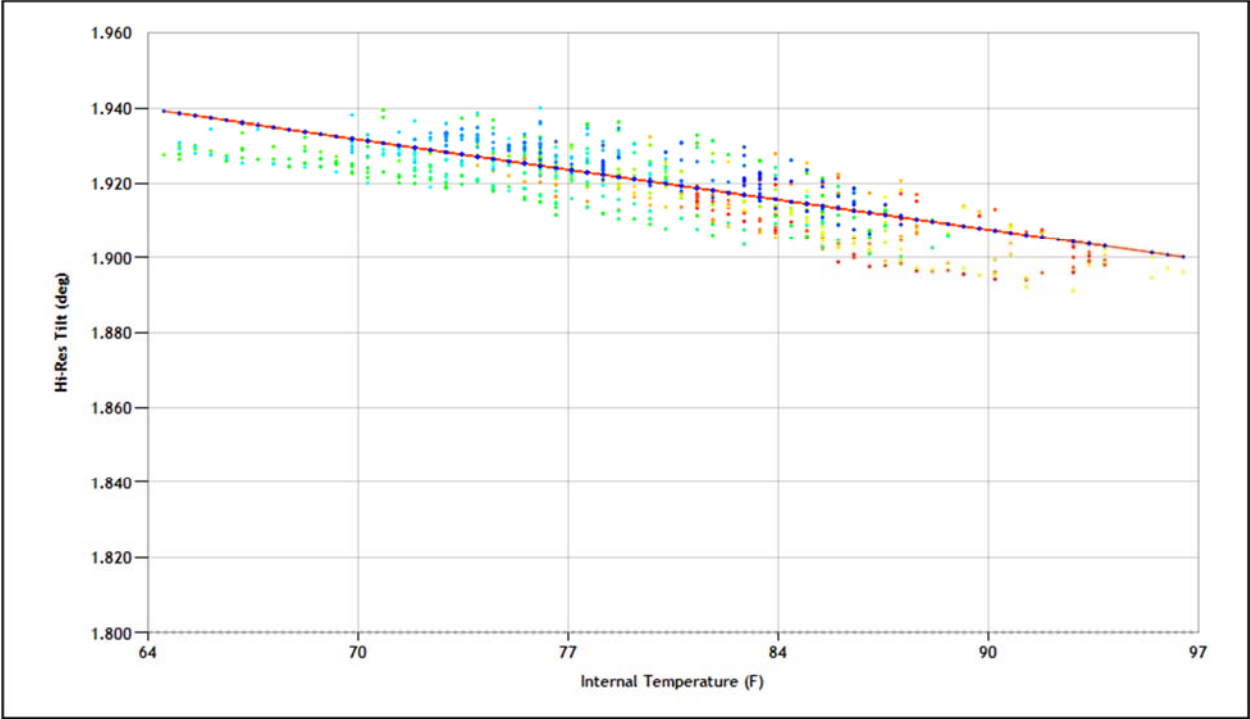
Figure 9: Sample regression analysis of tilt and temperature data.

As a further evidence of linear dependence of the inclination on temperature, the graph in Figure 9 shows a regression analysis of the inclination measurements of the wireless sensor versus temperature. As the graph shows, inclination of the deck is linearly dependent on temperature, and in this case, the regression analysis shows that the inclination and temperature are related by the following linear equation:

where θ is inclination and t is temperature. The above equation implies that per degree of temperature change, the inclination changes by approximately -0.0012 degrees (or about -4.3 arc seconds). The temperature effect becomes more important considering large range of temperature variations. For example, in Maryland, where the evaluation was done, temperature could be as cold as 0°F during the winter while the summer temperature could exceed 100°F. This implies that at full temperature swing, the change in inclination could be close to 0.12 degree, which could cause significant vertical displacement, especially in long spans. The strong linear dependence of inclination on temperature indicates that monitoring curvature and vertical displacement for the purpose of determining change during deck

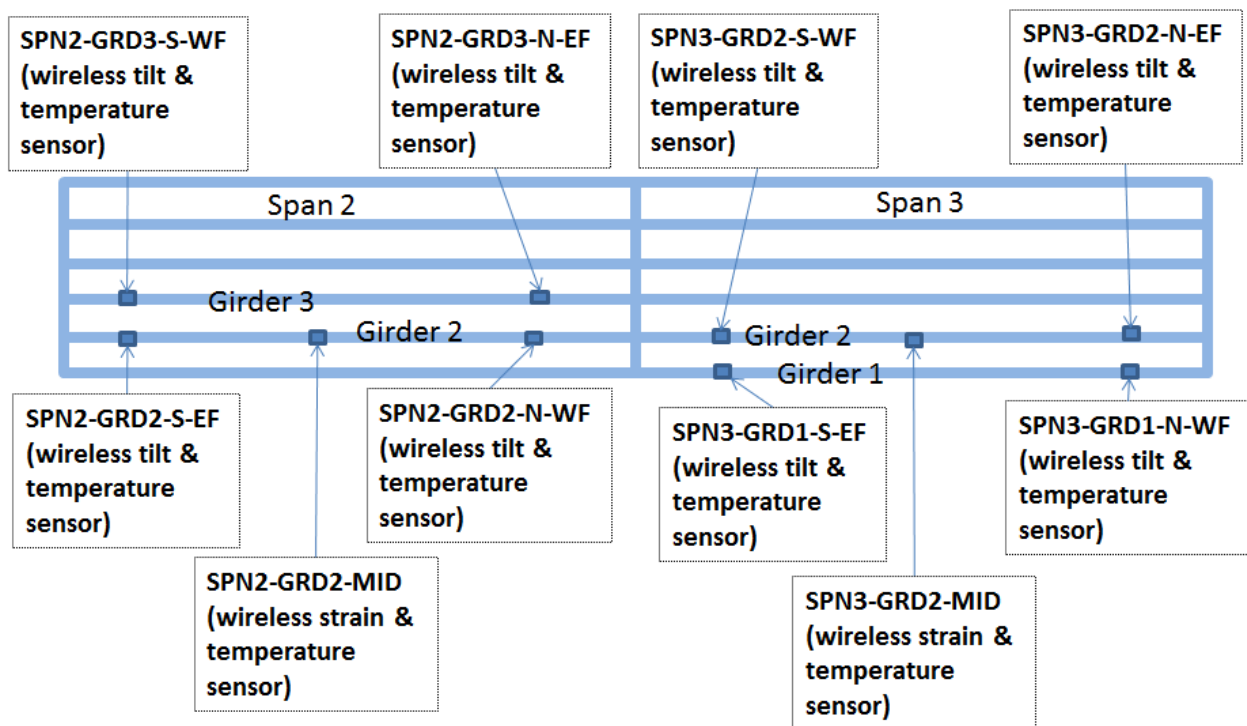
Figure 10: layout of the installed wireless inclination and wireless strain sensors in Span 2 and Span 3 of the bridge.

The wireless inclinometer sensors were deployed on Jan 16th 2015 on a portion of the bridge on MD 13 over Pocomoke River in Worcester County, Maryland. Wireless inclinometer sensors were attached to the girders in Span 2 and Span 3. Figure 10 shows the layout of monitored spans and the locations of the wireless inclinometers, and Figure 11 shows the portions of the bridge plans for the spans where the placement was done. A Google Earth Satellite image of the bridge is shown in Figure 12. For condition awareness and feedback on loading, wireless strain sensors were also attached to one girder in each of the two monitored spans. Monitoring strain is very useful to add additional information about the loading on the girder. Additionally, it has the advantage of giving precise timing of deck removal process of the old deck as well as when the new deck is constructed. All of the 10 installed sensors have the capability of reporting temperature in addition to primary measurements (inclination and strain). Representative pictures of the deployed wireless inclinometer sensors and wireless strain sensors are shown in Figures 13 and 14 respectively.

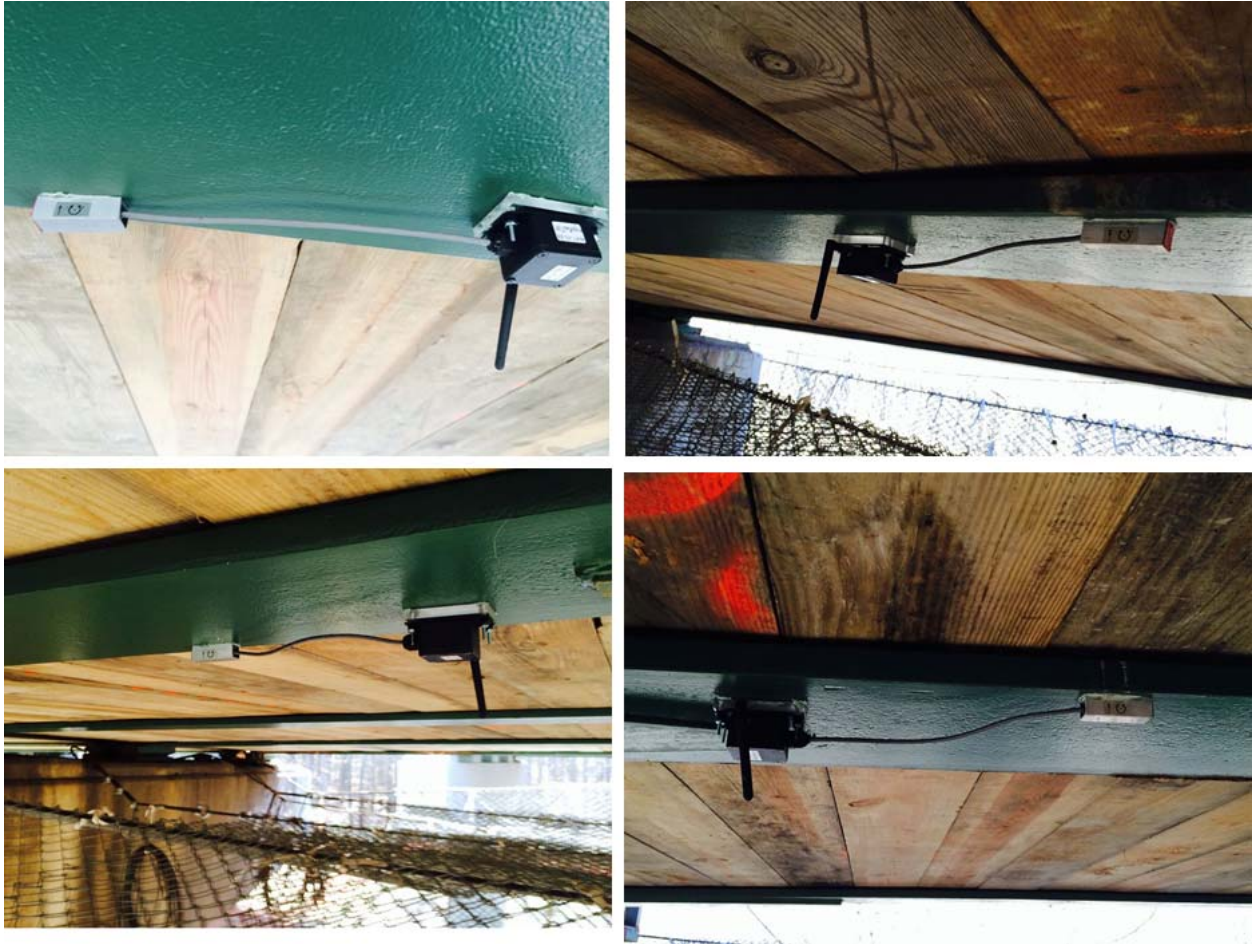
Figure 13: Sample pictures of wireless inclinometer sensors deployed in Span 2 and Span 3 of the bridge.

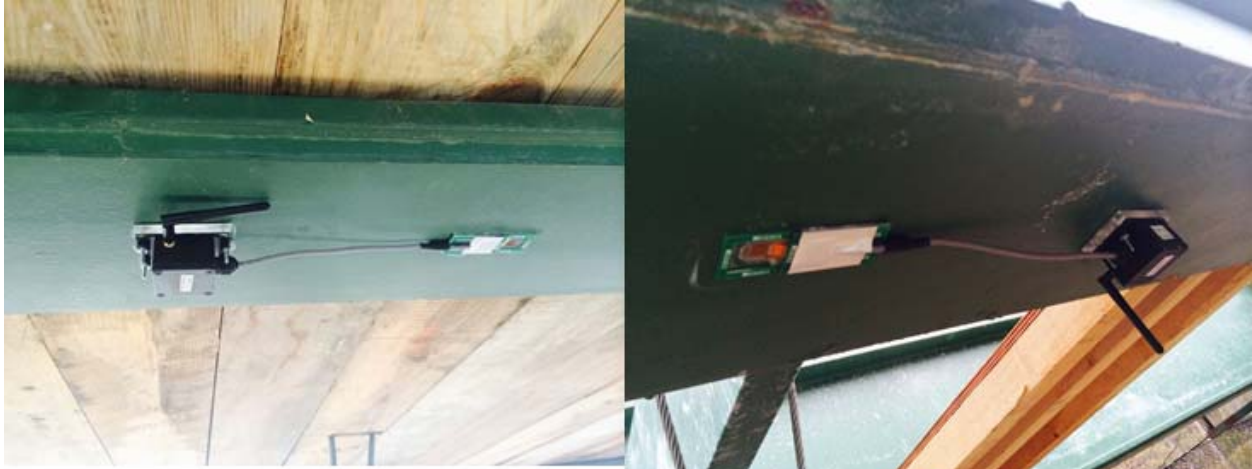
Figure 14: Wireless strain sensors deployed in Span 2 and Span 3 of the bridge.

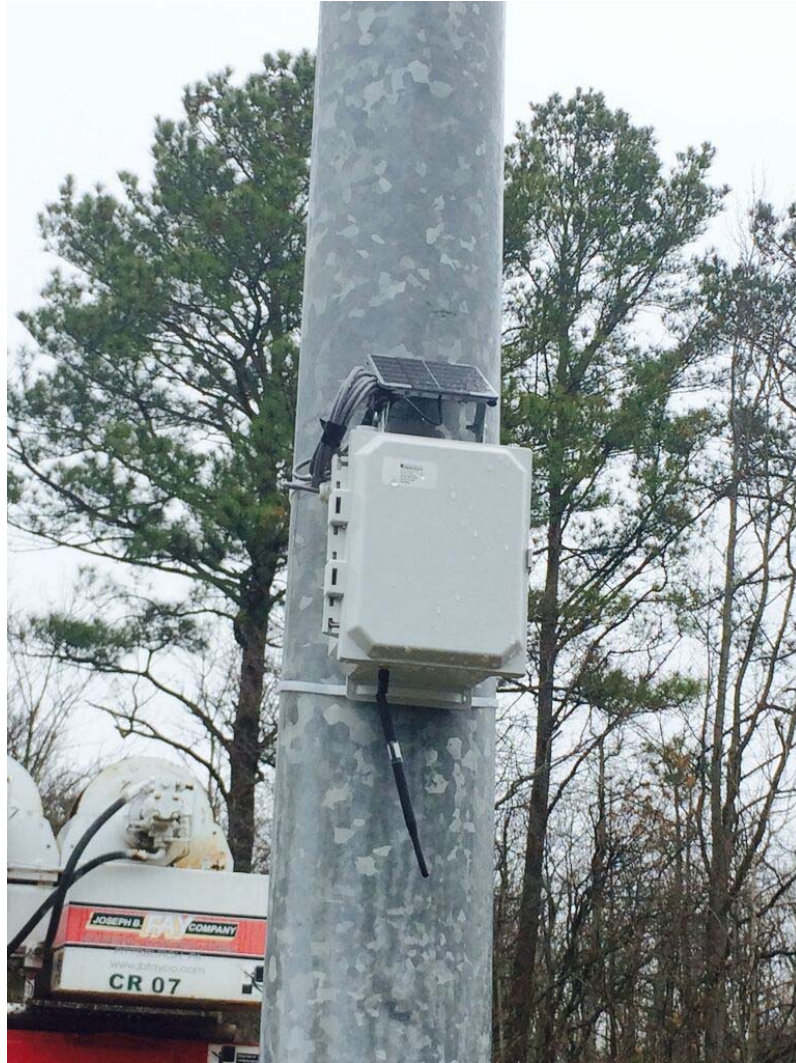
Figure 15: Solar powered wireless cellular gateway.

To stream data from the sensors in real time, a cellular gateway was installed at the bridge location. The gateway, which is solar powered, had wireless receivers to collect data from all the wireless inclinometers and the wireless strain sensors. The gateway had cellular communication capability, and it transmitted data to a server at the University of Maryland. The picture of the cellular gateway is shown in Figure 15.

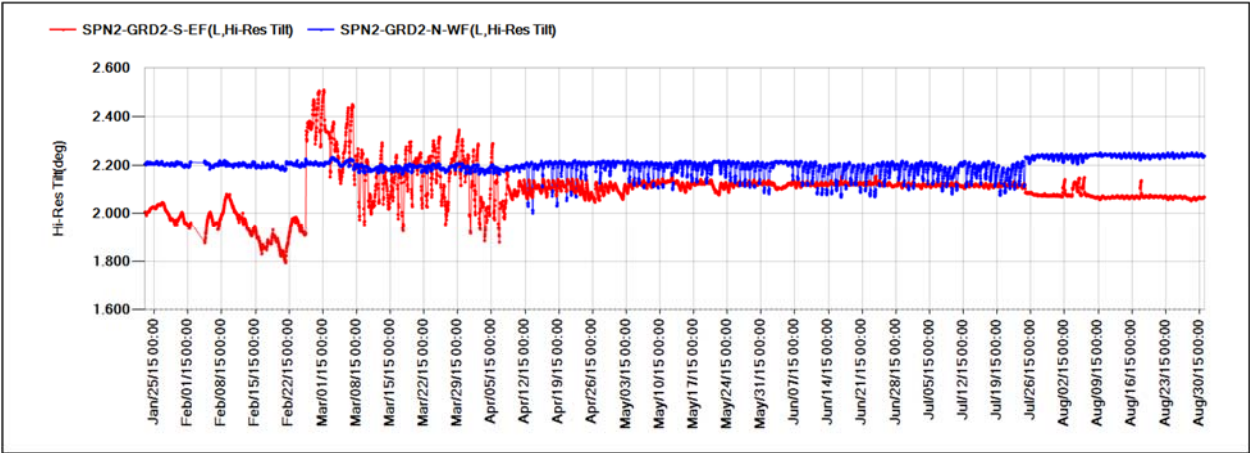
Figure 16: The 8-month inclination data, from January 2015-August 2015 for Span 2, Girder 2; the two graphs show inclination data for the wireless inclinometers attached to the north and the south sides of the girder.

As previously indicated the first group of graphs, Figures 16 – 19 show the inclination, strain and temperature of the girders in Span 2, from January 2015 until August 2015, throughout deck replacement process. As shown in the figures, changes in inclination can be observed in early March, when the old deck was removed, and late in July, when the new deck was added. The graph in Figure 18, which shows the strain measurements in the middle of Span 2, confirms that the old deck was indeed removed in early March and the new deck was added to the bridge in late July. This is because the strain graph shows the noticeable and sudden decrease of about 140 microstrain in early March, while the same amount of sudden increase is shown late in July. Finally, the graph in Figure 19 shows the temperature throughout the process. Figures 20- 23 provide the similar inclination, strain and temperature data from the girders in Span 3.

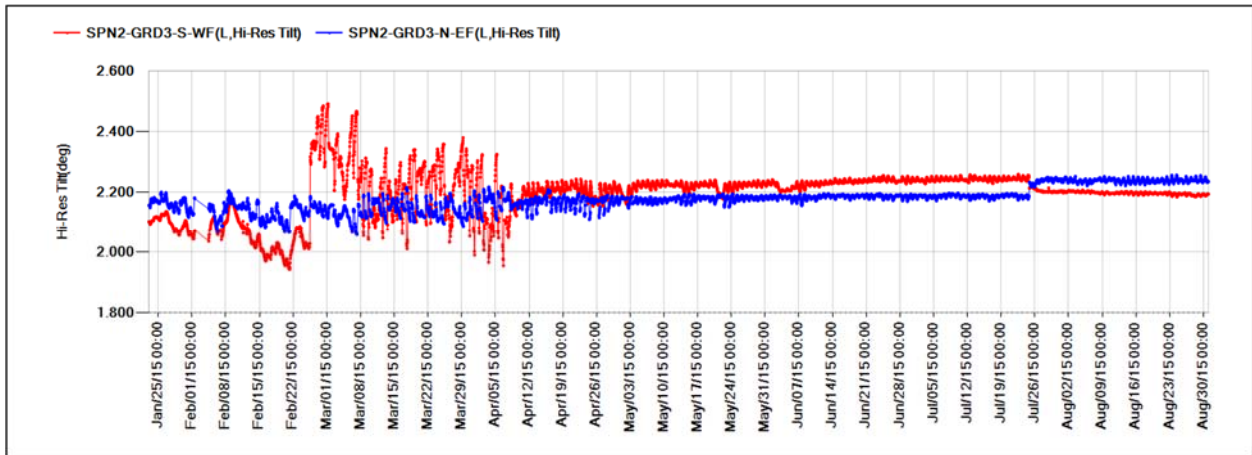
Figure 17: The 8-month inclination data, from January 2015-August 2015 for Span 2, Girder 3; the two graphs show inclination data for the wireless inclinometers attached to the north and the south sides of the girder.

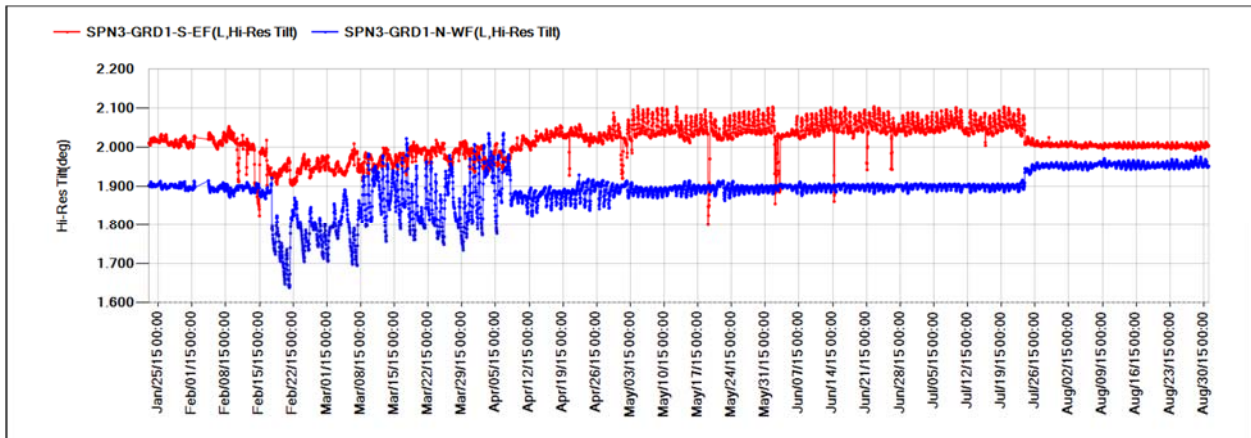
Figure 20: The 8-month inclination data, from January 2015-August 2015 for Span 3, Girder 1; the two graphs show inclination data for the wireless inclinometers attached to the north and the south sides of the girder.

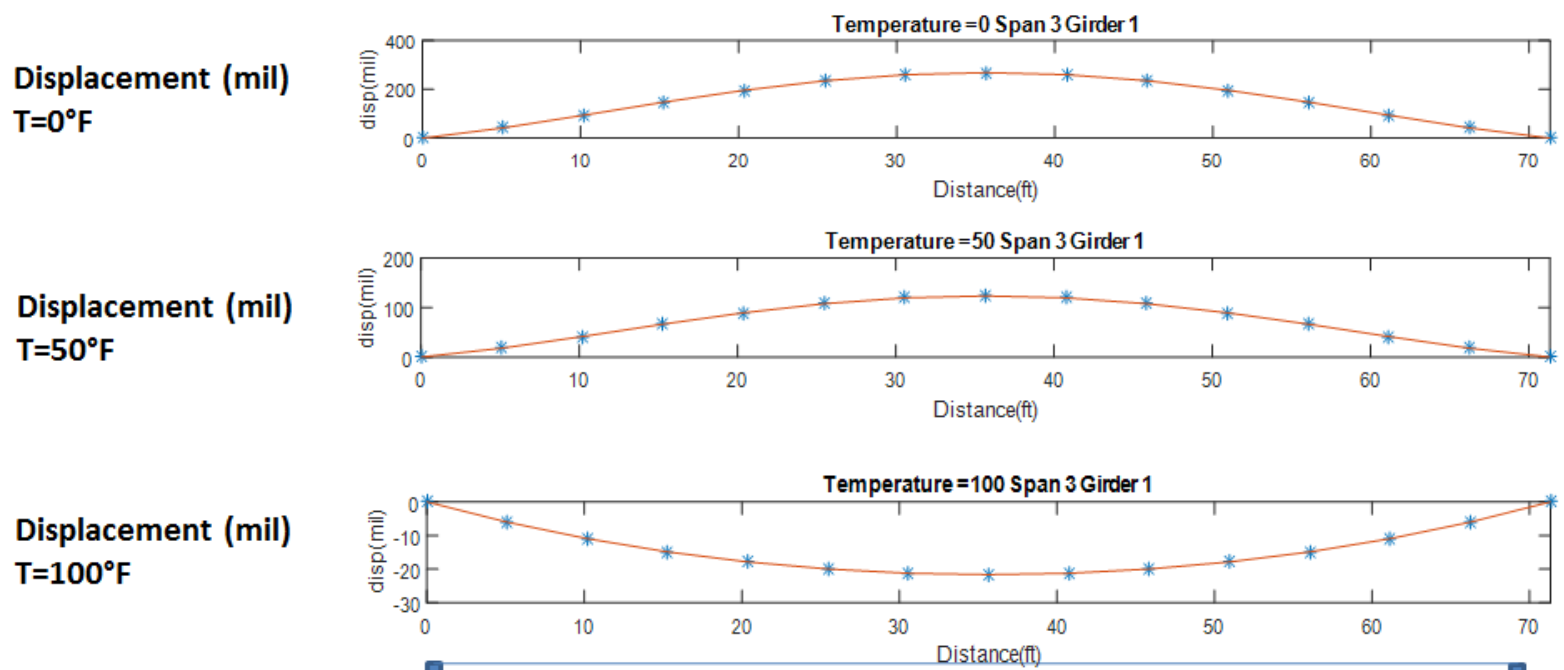
Rebound Calculation
 Span 3 Girder 1 vertical displacement change at various temperatures
 Before deck removal (January 15) and after deck replacement (July 15)

Figure 32: Rebound of Span 3, Girder 1, resulted by deck removal. Analysis conducted at various temperatures, T=0, T=50, and T=100 degrees Fahrenheit.
