MARYLAND DEPARTMENT OF TRANSPORTATION STATE HIGHWAY ADMINISTRATION

Highway Rock Cut Inventory and Failure Potential, Allegany County, Maryland

FINAL REPORT

May 2020

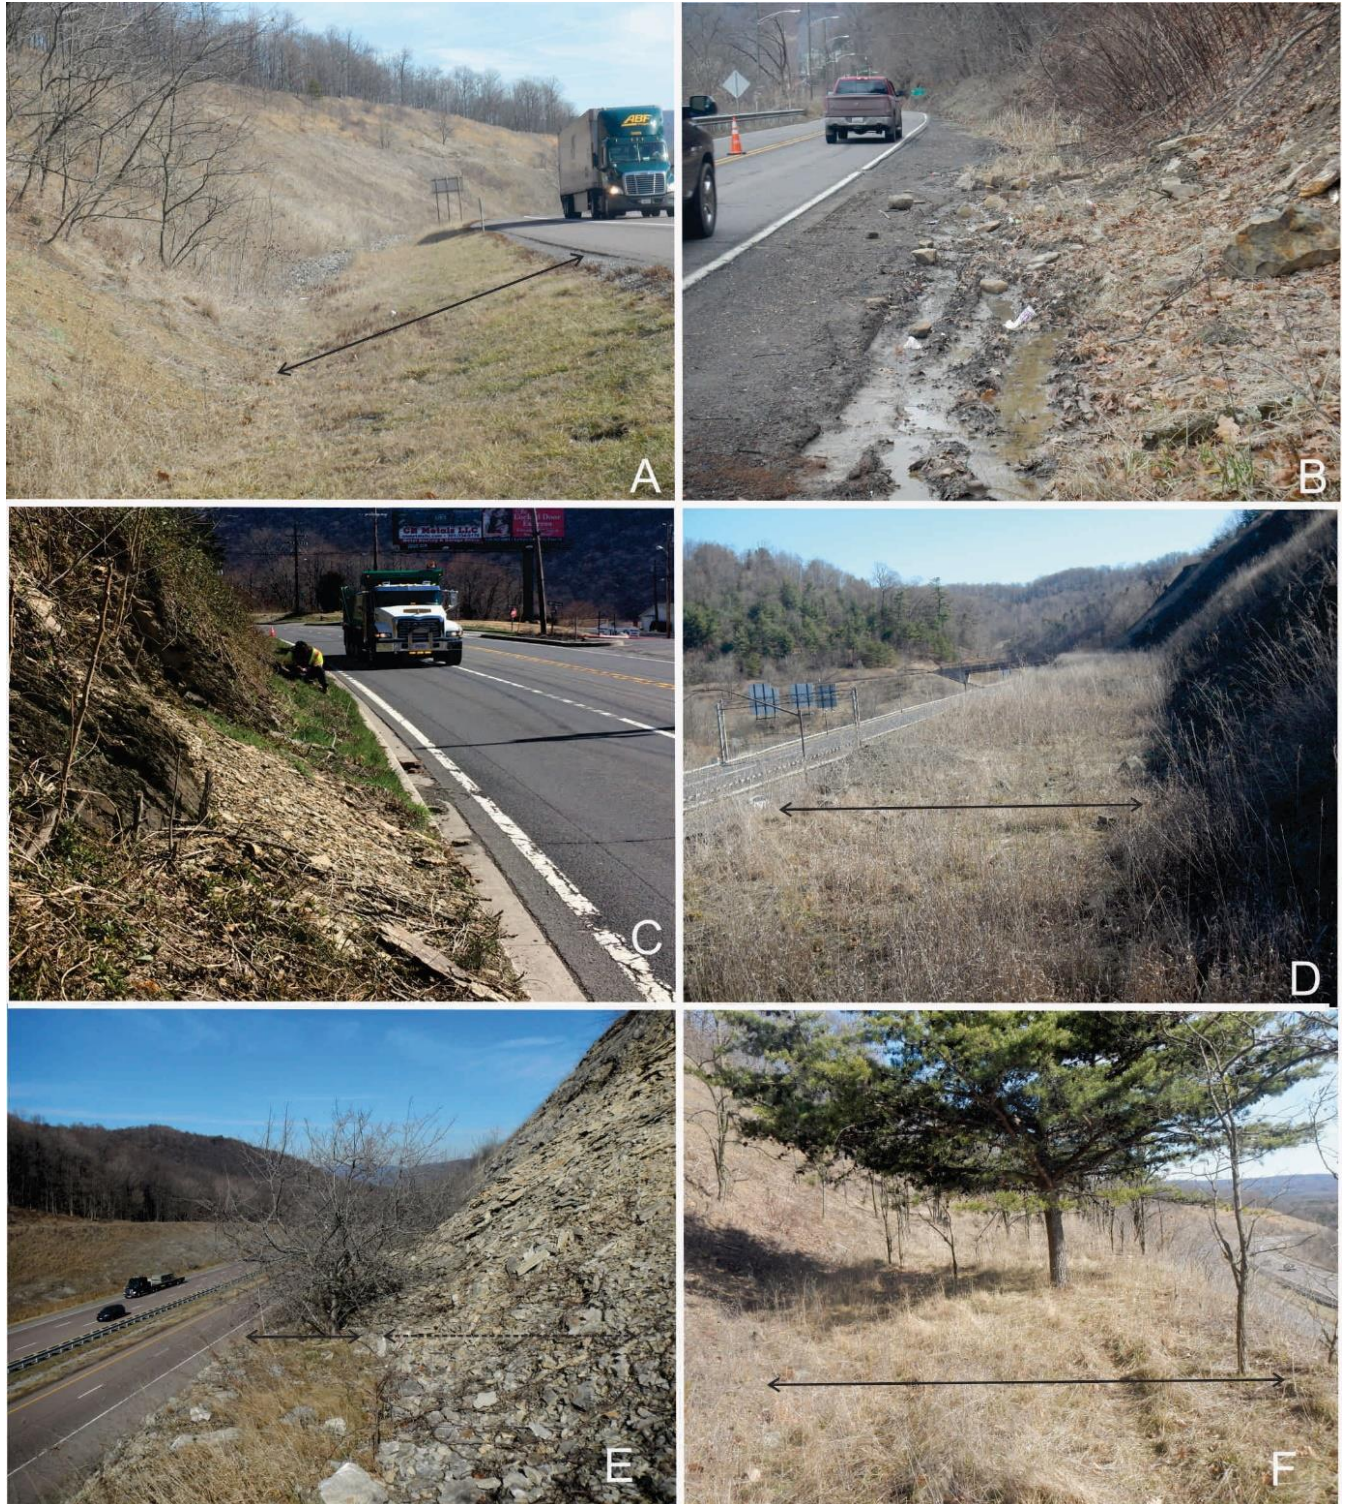
represent elevated catchment areas, when they become filled with debris they can themselves become a launching factor, propelling rolling debris on to the roadway, and beyond roadside catchment (Figure 5E). Thus, filled benches switch from a safety factor to a hazard. When benches become filled, they also tend to spawn vegetation growth (Figure 5F).

Figure 5. Benches and catchments styles and character. A, Catchment shoulder sloping away from roadway. B, Flat catchment shoulder. C, Shoulder inclined towards roadway. D, Elevated catchment bench clear of debris. E, Elevated bench nearly filled with debris. F, Elevated bench with woody vegetation.

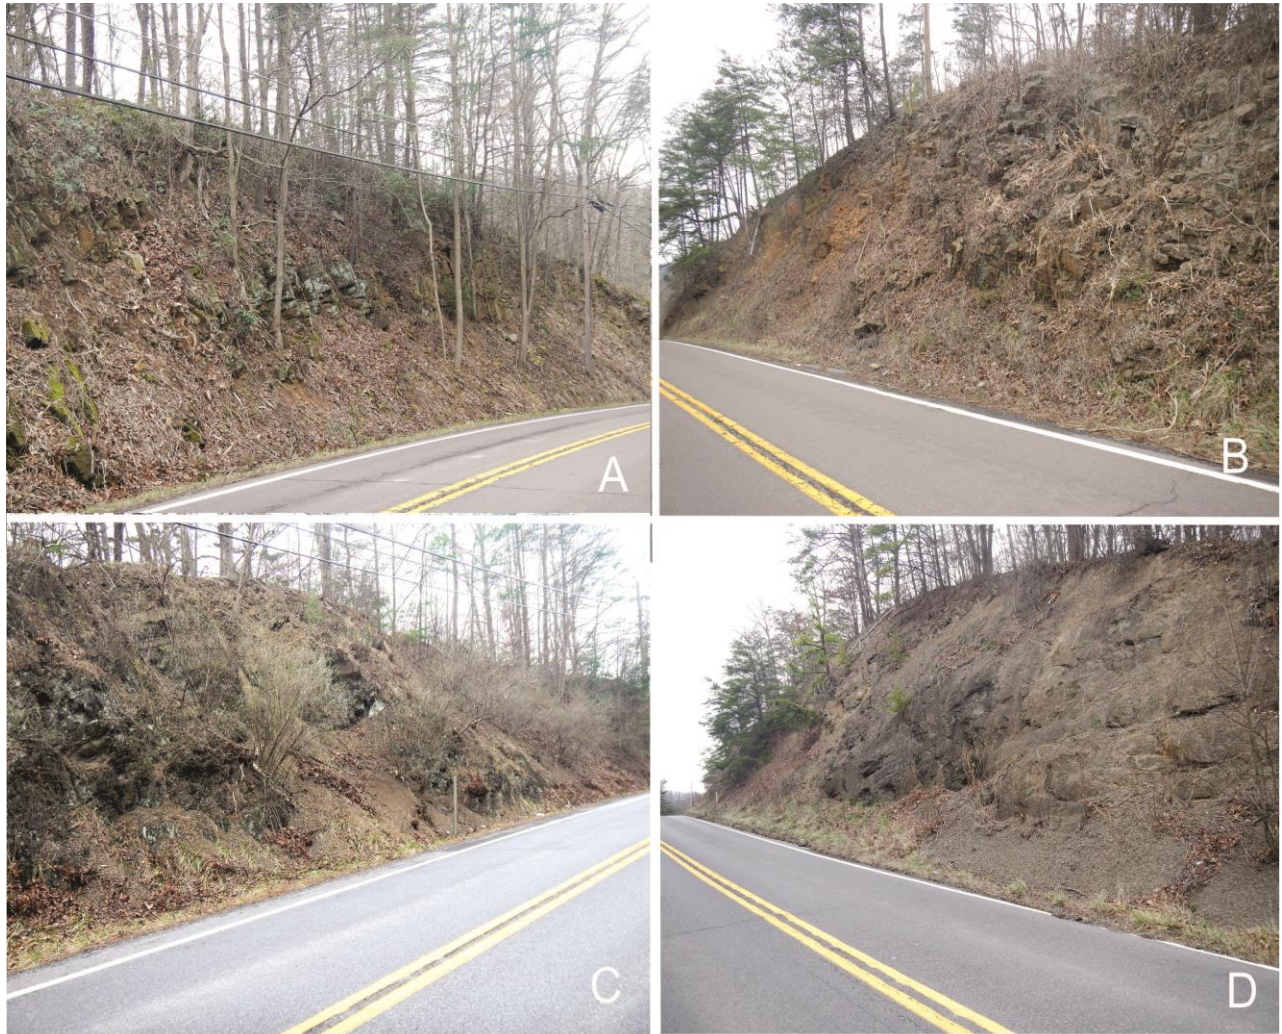
Figure 8. Differences in vegetation between north-facing and south-facing slopes. A, Rooted tree saplings and grasses developed on a north-facing slope of sandstones of the Oriskany Formation. B, South-facing slope from the same road cut as A. This face contains grasses and few shrubs. C, Highly vegetated north-facing slope on shales of the Brallier Formation. Vegetation includes rooted trees, saplings, shrubs, and grasses. D, South-facing slope corresponding to the location shown in C. This slope exhibits only sparse grasses.

As a general observation, vegetation of all types tends to be better developed both where water is present on the outcrop. North-facing slopes maintain moisture that allows increased vegetation development. Branson and Shown (1989) proposed that north-facing highway slopes tended to contain shrubby vegetation, while south-facing slopes more often displayed grassy and herbaceous flora (Figure 8). These authors opined that the cause for these vegetation differences was related to the differing levels of solar radiation. They maintained that south-facing slopes were associated with increased levels of sunlight that resulted in elevated temperatures, reduced moisture, and a reduced potential for plant colonization and growth. Furthermore, these authors suggested that increased duration of freeze-thaw potential on north-facing slopes led to greater moisture availability in those locations. It is in this position that most lichens and mosses were observed during the current study (Figure 9A). In contrast, the presence of grassy vegetation on south-facing slopes tended to be present where water was preserved in fractures and partings of the bedrock units (Figure 9B). Saplings and rooted trees were generally found to verify Branson and Shown's (1989) findings in that they tended to be better established on the north-facing exposures at road cuts (Figures 8 C, D).

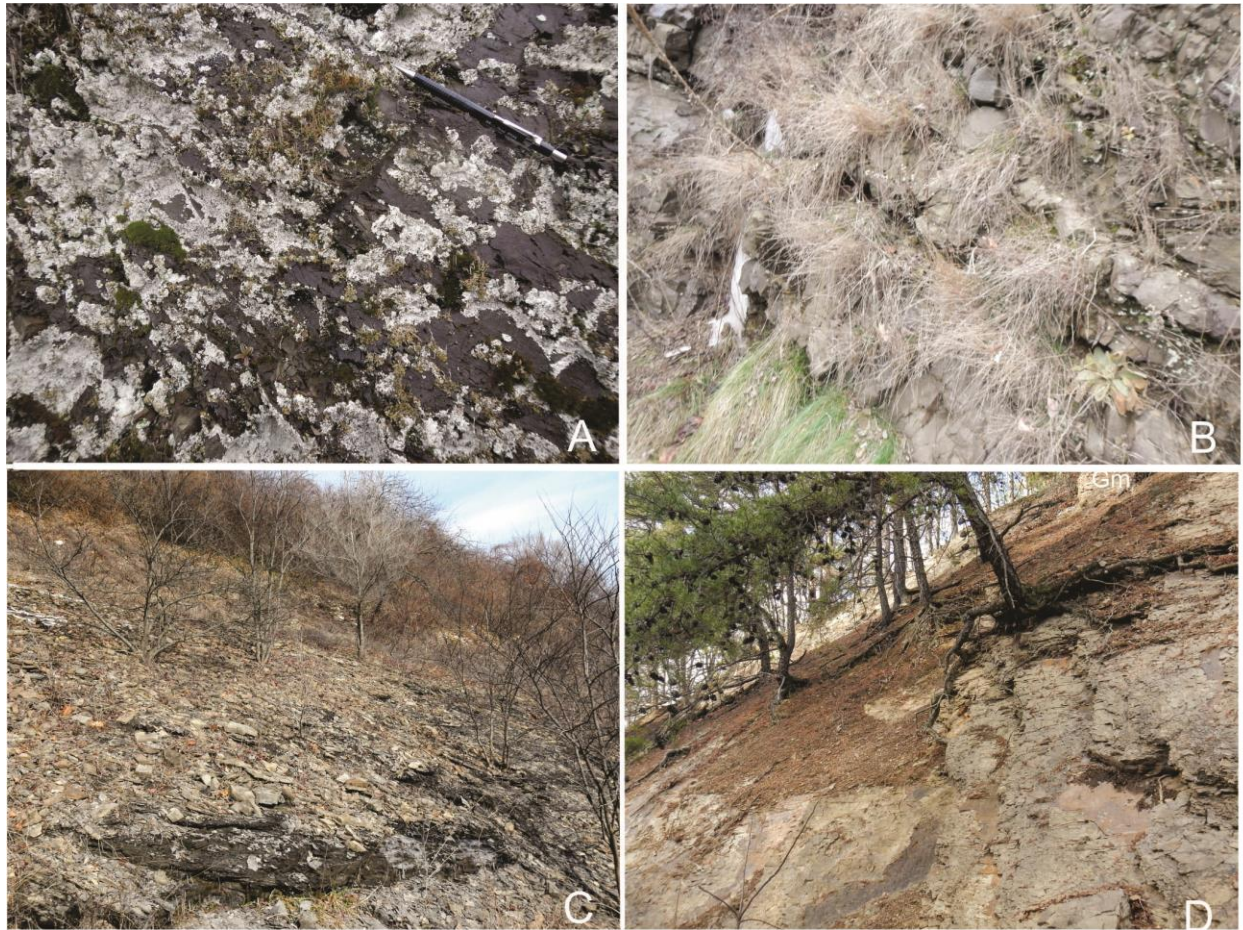
Figure 9. Types of vegetation on roadside slopes. A, Lichens and mosses. B, Grasses in clumps or coatings. C, Rooted saplings. D, Embedded and rooted tree trunks.

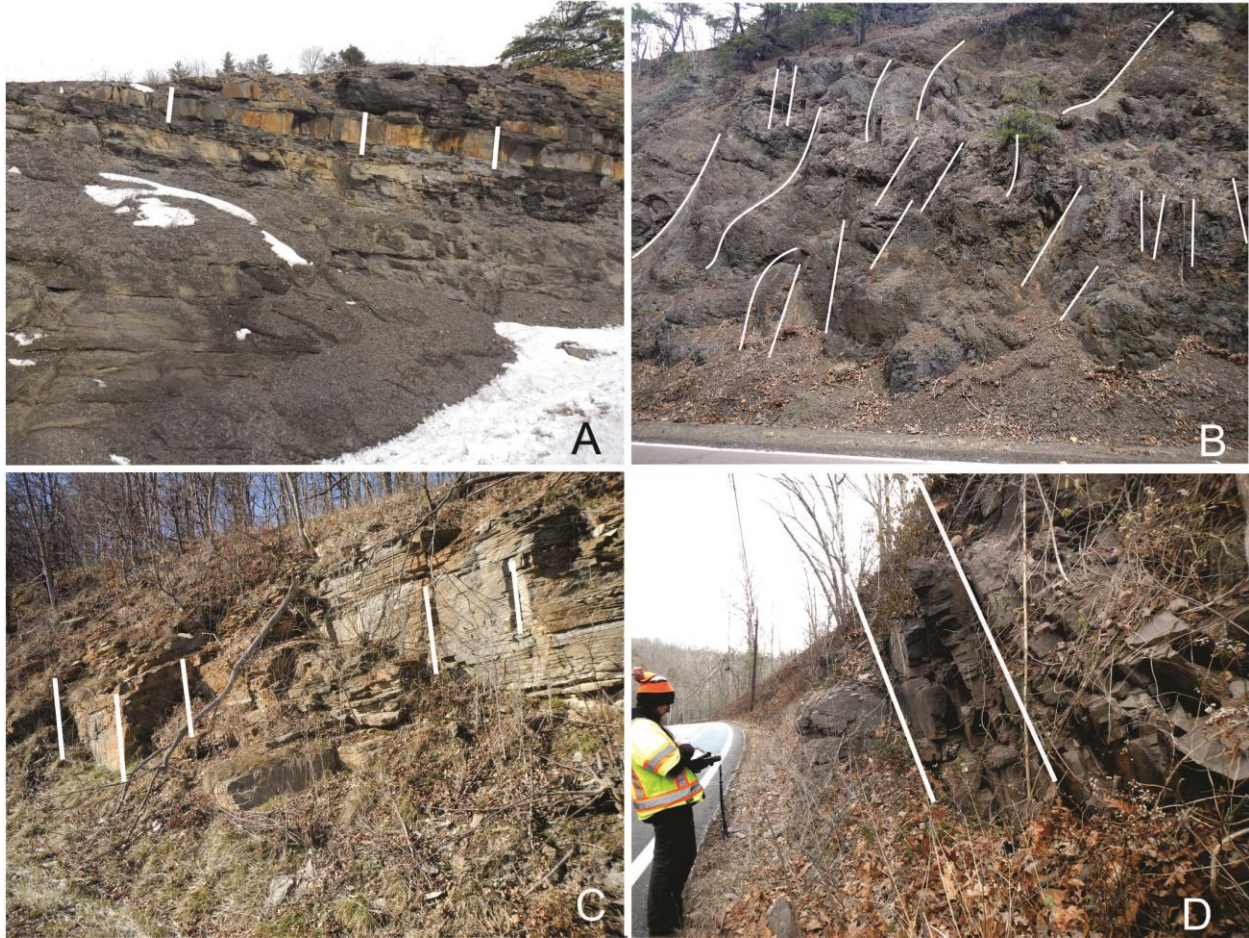
The orientation of joints or other fracture systems with respect to the roadway is important to note because such failure planes dictate a propensity and direction of slope failure. For the current study, joints and fractures that dipped away from the roadway were considered adverse while those dipping towards the highway were recognized as favorable (Figure 11). Although this may seem contrary to general reasoning, it was theorized that the adverse orientations were more likely to produce rockfalls and favorable more likely to yield rock slides and rock rolls. Vanderwater et al. (2005) noted that using the terms *favorable* and *adverse* for rockfall hazard was “ambiguous.” This is because the term *favorable* when used for fracture plane characterization implies favorable as stable, and did not necessarily represent favorability for failure.

Figure 11. Failure plane character. A, Discontinuous and favorable orientation. B, Discontinuous and random orientation. C, Discontinuous and adverse orientation. D, Continuous and adverse orientation.

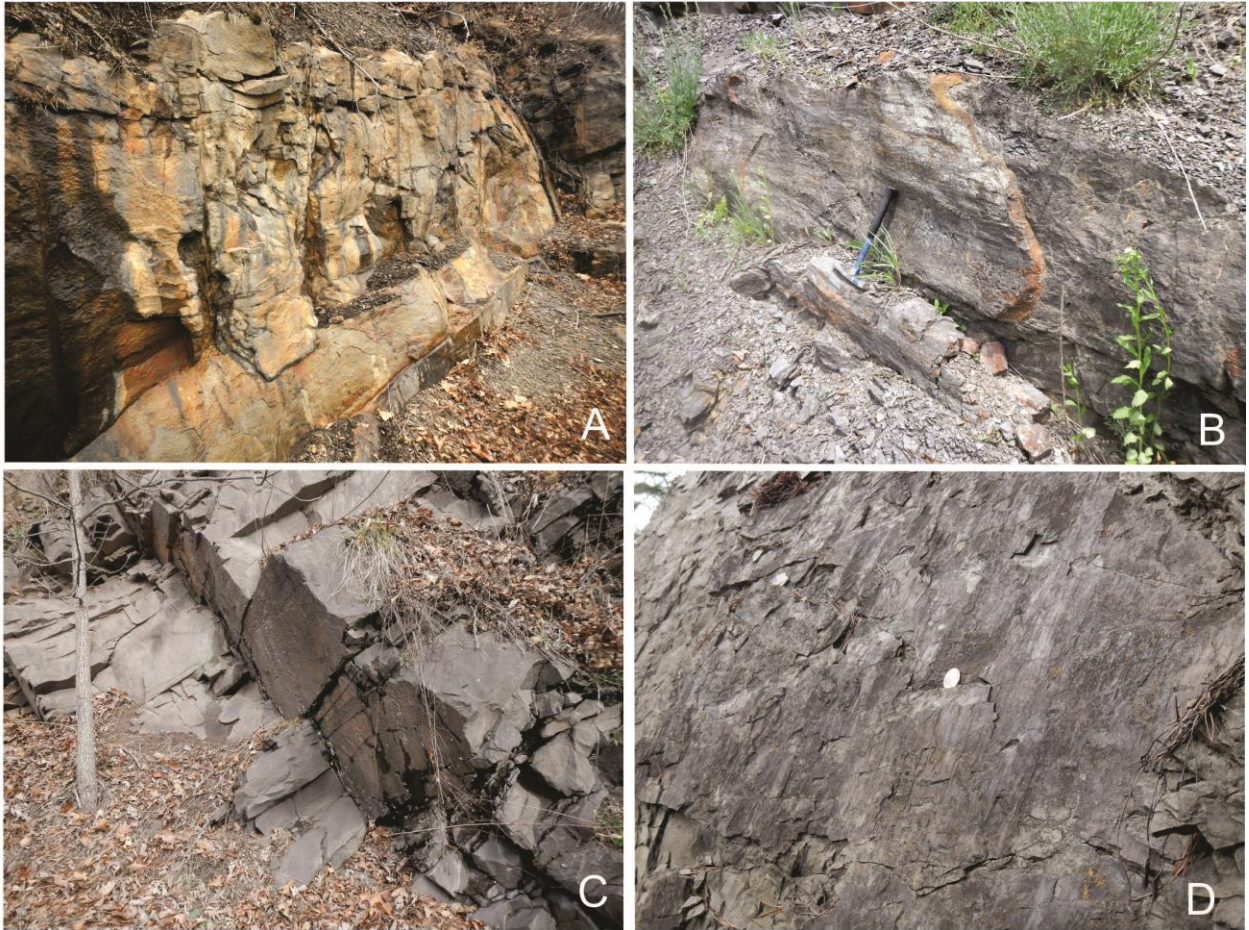
character is considered important because it provides insight as to the potential for further movement along the observed discontinuity. Rough surfaces have a rough and irregular texture to the touch (Figure 12A). Undulating surfaces suggest a level of shearing and movement along the surface (Figure 12B). These surfaces tend to be rounded rather than smooth and planar. Planar surfaces typically display smooth surfaces that may be parallel to one another (Figure 12C). Lastly, slickenside surfaces are tectonically smoothed fractures and suggest that movement parallel to the fracture surface has taken place (Figure 12D).

Figure 12. Rock friction. A, Rough and irregular. B, Undulating. C, Planar. D, Slickensides.

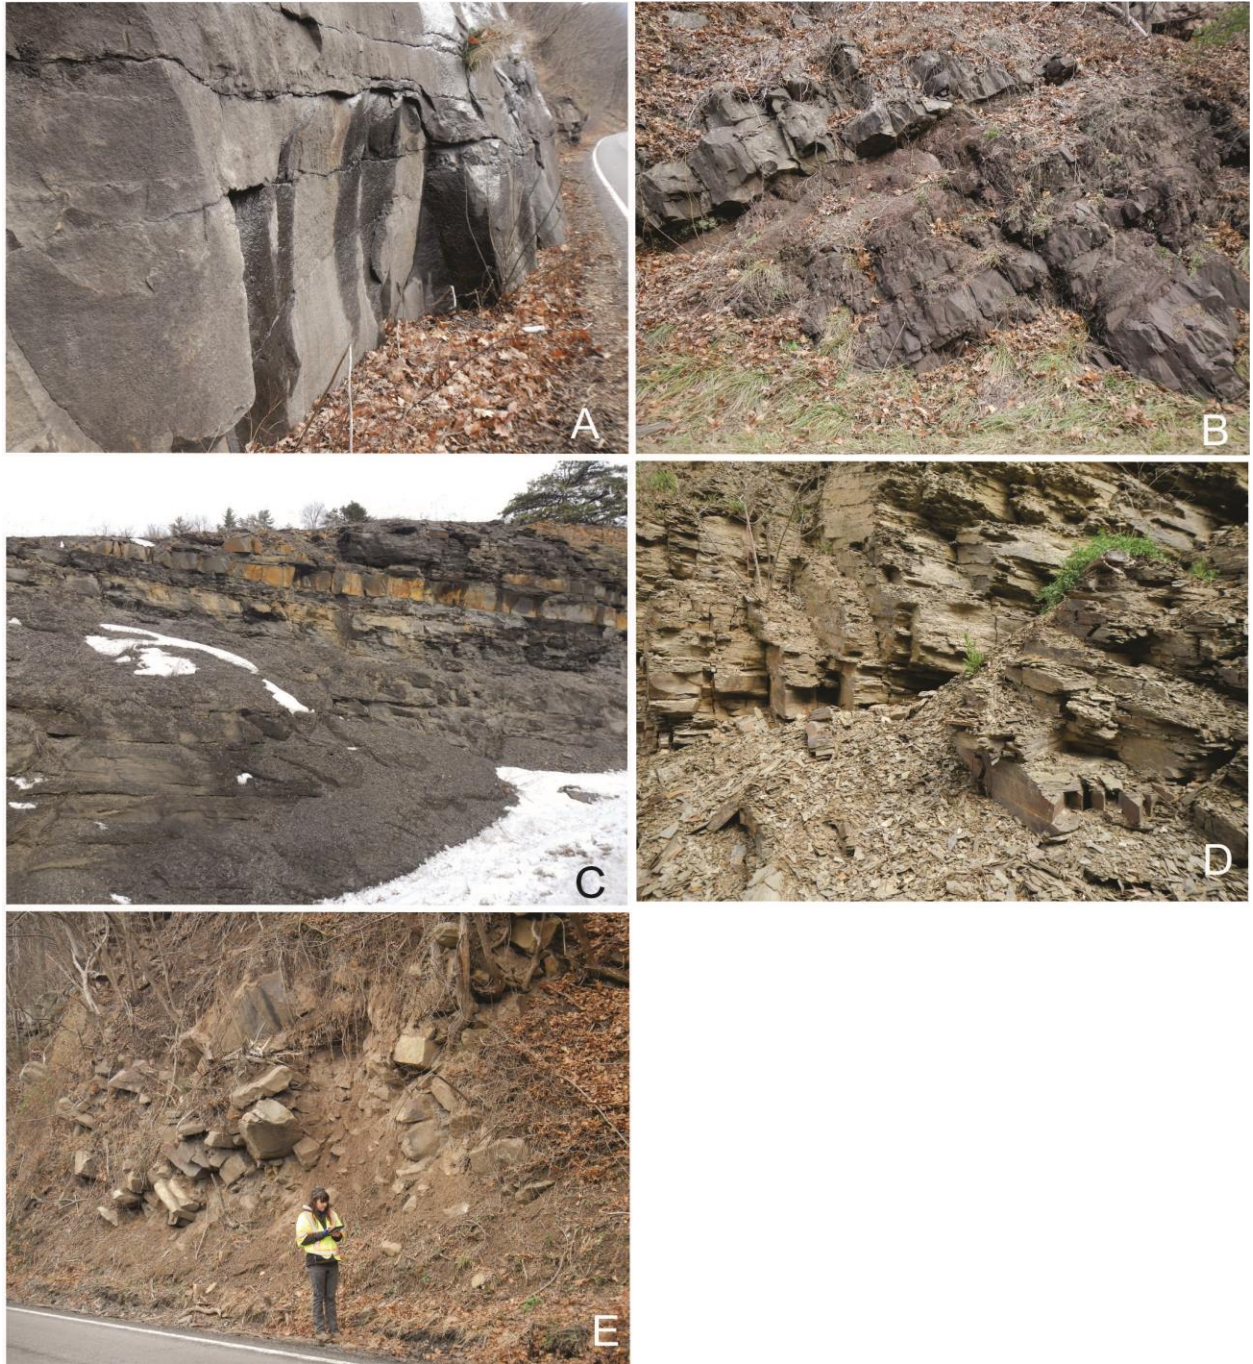
Figure 16. Lithology. A, Massive sandstone/limestone. B, Sandstone/limestone with shaly interbeds. C, Shale with sandstone/limestone interbeds. D, Massive shale. E, Block in matrix.

greatest potential for massive rock slides. Subhorizontal intervals of massive shale rarely are capable of creating steep slopes. These units tend to weather to slopes of small chips and thick soil. These slopes are readily vegetated, and where abundant water is available, can produce slumps and rotations into the roadway. Lastly, irregular sandstone blocks in existing or preexisting landslides can form incoherent masses of loose blocks (Figure 16E). These blocks can roll or slide into the roadway under the influence of frost action or gravity.

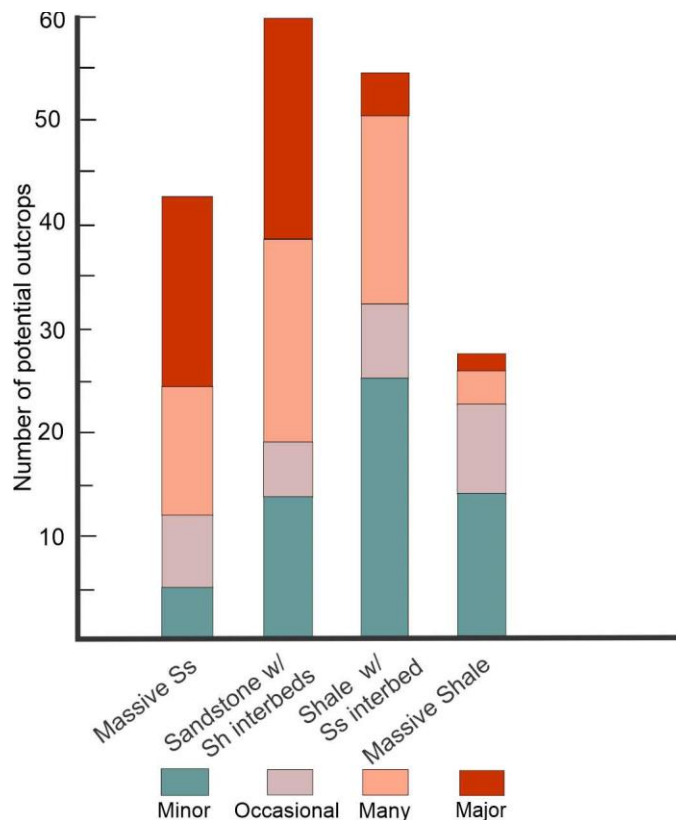
Figure 23. Lithology and its potential relationship to differential erosion.

As discussed in the earlier section on differential erosion, this feature is related to both the weathering rate and lithology. Because differential erosion or differential weathering is more pronounced in interbedded lithologies, it would appear to have a greater tendency to produce loosened rock fragments within those lithologies. Figure 23 illustrates this relationship between differential erosion and lithology. Contrary to *a priori* notions, massive lithologies that are resistant to erosion, such as sandstone and limestone, as well as those resistant lithologies with thin interbeds of shale display a definite differential erosion potential. Meanwhile, shales with
