**MARYLAND DEPARTMENT OF TRANSPORTATION  
STATE HIGHWAY ADMINISTRATION**

**RESEARCH REPORT**

**MDOT CULVERT INSPECTION**

**UNIVERSITY OF MARYLAND UAS TEST SITE**

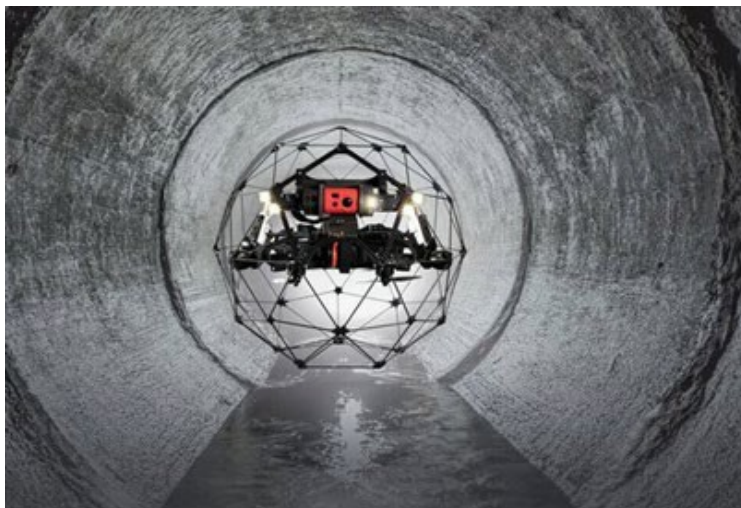
Figure 1. Flyability Elios 2 UAS conducting culvert inspection.

Of the four options, the Flyability Elios 2 (Fig. 1) was the clear front-runner in terms of quality of data, ease of use, inspection-specific features, and overall suitability. It was designed specifically for inspections in confined spaces. More than 90% of the examples of industrial inspections with caged UAS use this system. By far the most mature of the available systems, it was also the only system to include training with the package. The primary negative

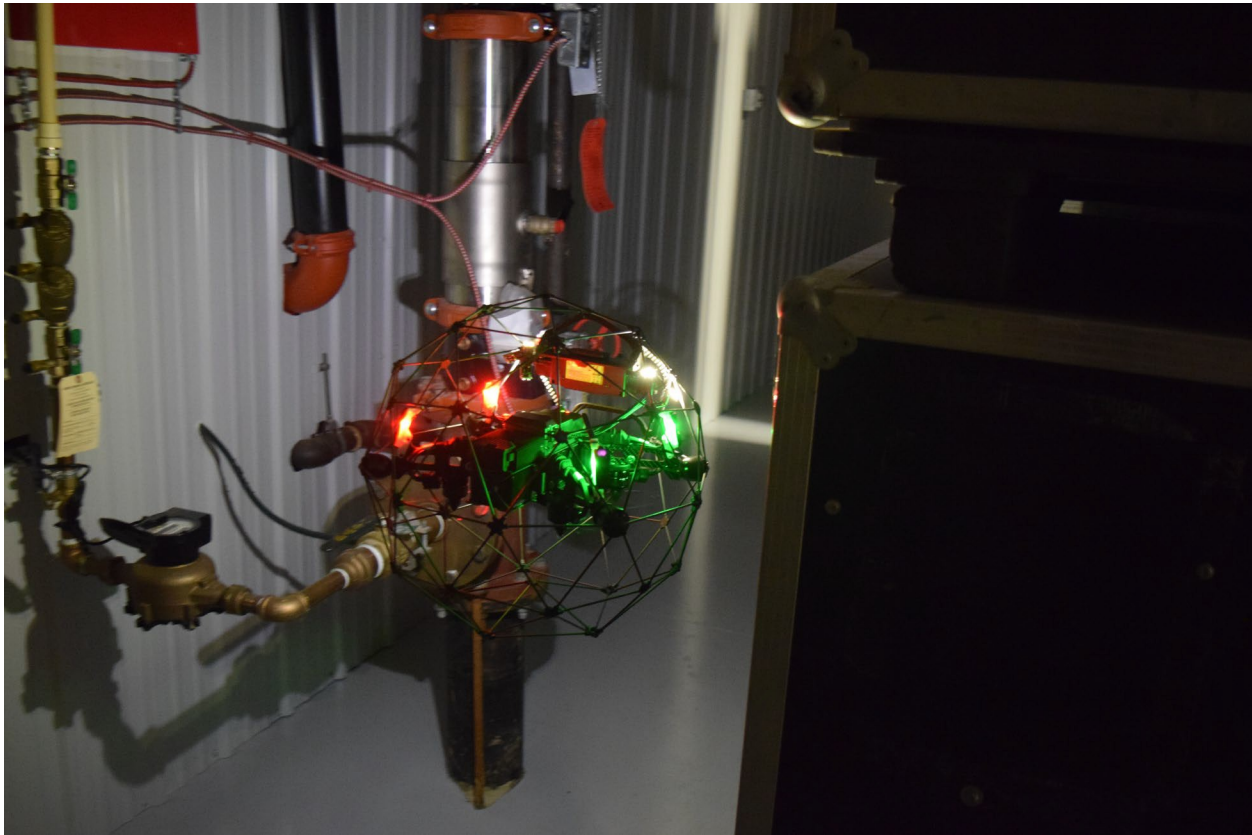
Figure 6. UMD flight tests/training. The Elios 2 navigates through confined space at the UAS Test Site.

Initial (functional) flight tests were completed on January 19<sup>th</sup>, 2021, as part of the UMD pilot team's system acceptance and manufacturer training. The training itself consisted of several video walkthroughs covering basic aircraft operations to include flight controls, limitations, and general safety considerations. Although being thoroughly outlined within the videos, actual training flights could not be directly administered by an Elios 2 instructor. As such all initial flights were conducted at the discretion of UMD's Chief Pilot and were completed within existing UAS Test Site operational and safety protocols. These initial flights occurred within the hangar space available at the UAS Test Site whereby the UMD pilot team, beginning with basic flight maneuvers, gradually worked up to the successful navigation of a tight enclosure (Fig. 6) to simulate the dynamic of flying inside a culvert.

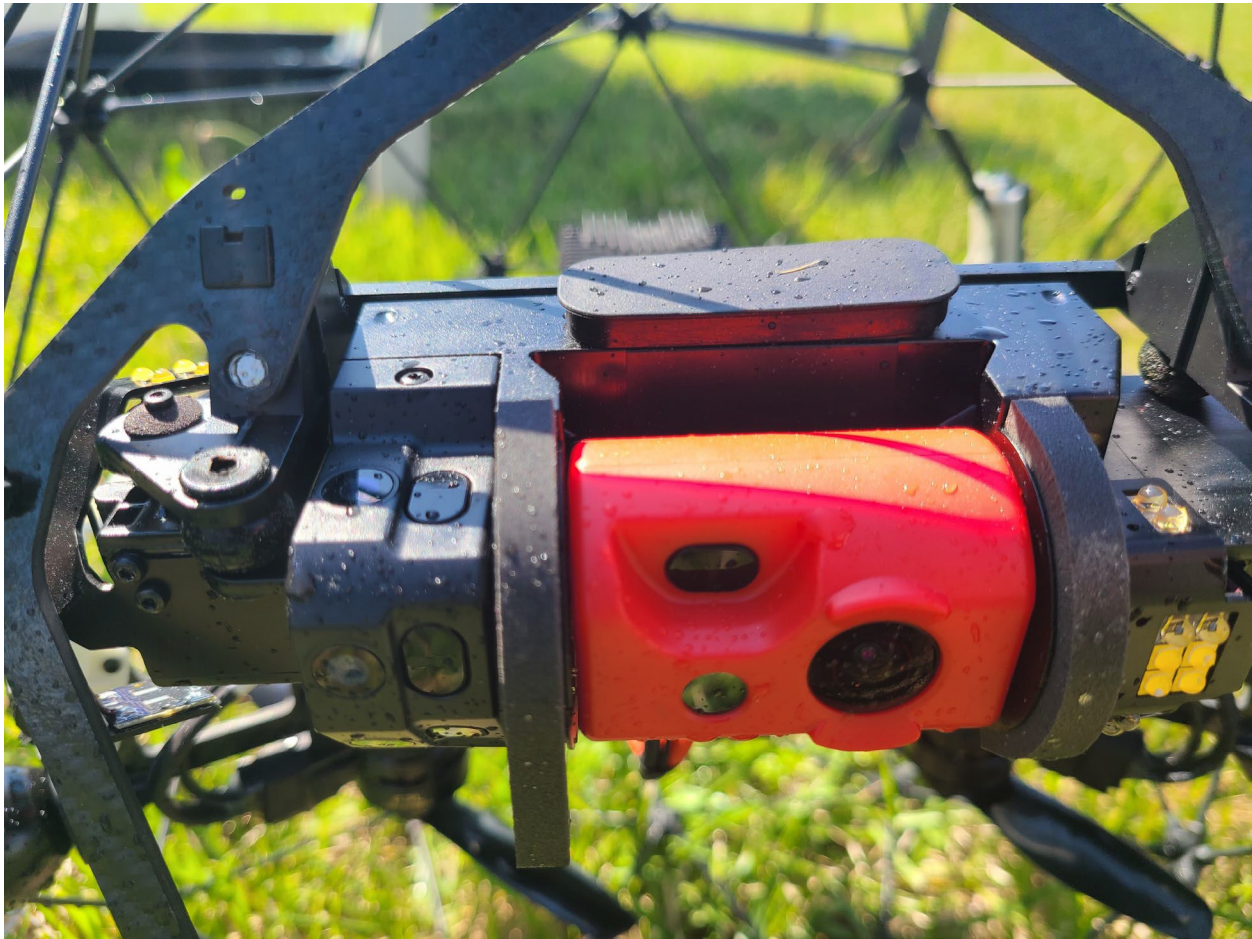
Figure 7. Elios 2 after confined space water testing.

Further flight testing was completed at the UAS Test Site as a necessary function of UMD's airworthiness evaluation process. Besides basic structural and operational inspection items, the team's main concern was validating the aircraft's advertised resistance to water (understanding that the intended use case for the Elios 2 involved flight into the confined space of a culvert in which the presence of standing or flowing water was likely). Additionally, the downward force of air created by the aircraft's rotors as it flew within a given culvert could conceivably exacerbate the state of any existing water and potentially create enough displaced droplets to cover the aircraft and obscure the camera. In this case, the overall viability of the system within this given application would be called into question. To effectively evaluate this, the pilot team recreated a culvert environment, complete with standing water. Multiple flights were conducted within this simulated environment during which the Elios 2 performed as advertised. The extent of any displaced water on the system, while present, did not pose a notable threat to proper function of the aircraft, its sensors, or the camera itself. The overall airworthiness evaluation culminated with this test. The Elios 2 was subsequently deemed "airworthy" and ready for practical field testing (Fig. 7).

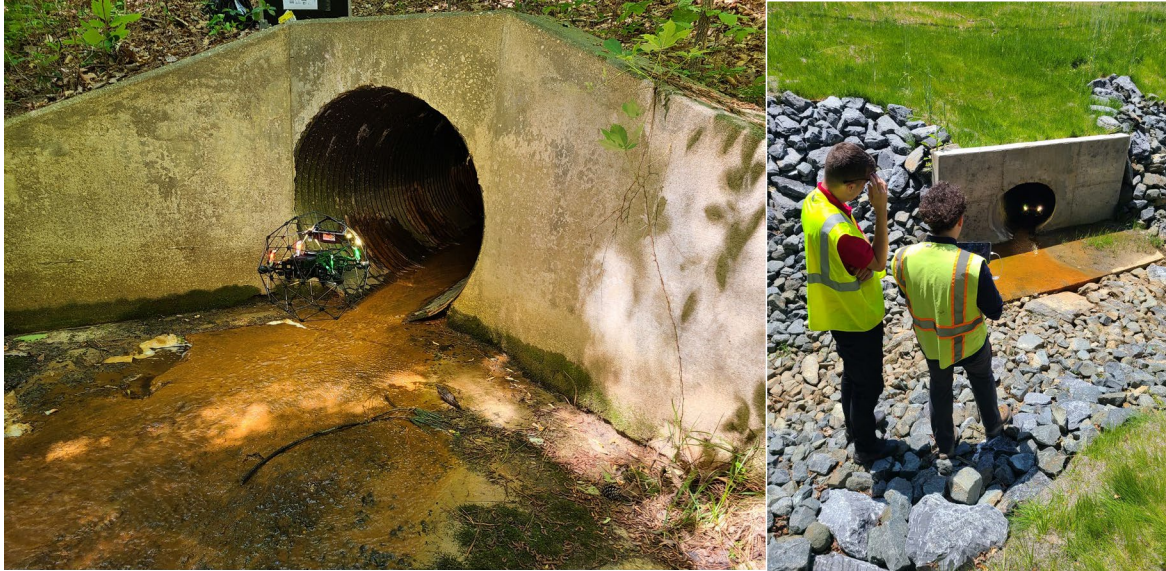
Figure 8 (Left). Elios 2 being flown into Pipe 3.

Figure 9 (Right). UMD pilot observes Mr. Horowitz operating at Pipe 1.

Throughout both days, for each culvert inspection, the Elios 2 was placed on level ground near the opening of the pipe. The operator remained nearby within visual line of site of the aircraft. Upon initial takeoff, the operator would slowly position the sUAS into the center of the culvert and begin a forward flight path inside. Once the aircraft was established within the ‘tube’ the operator would reposition himself to be directly in line with the opening to ensure the radio signal of the hand control unit would have the most direct and unobstructed path to the aircraft. This also allowed the operator to maintain line of site with the aircraft as it advanced further into the pipe. (Note that a Range Extender was provided with the Elios 2. The team employed the extender during the inspection of Pipe 2 but, due to the design of the range extender itself, found no notable benefit for this application.)

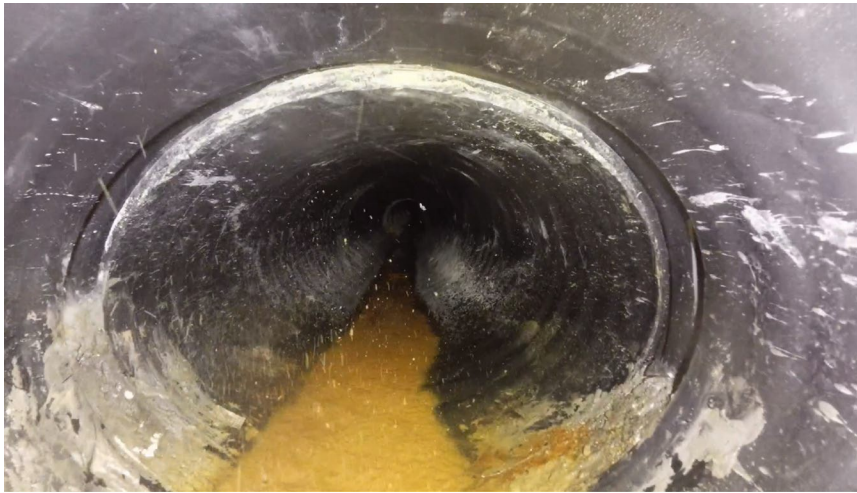
Figure 10. Imagery from the Elios 2 inside Pipe 1.

Once inside the culvert, the Elios 2’s various sensors aid in avoiding obstacles and maintaining a flight path consistent with the center of the tube. The operator’s primary job at that point is to mitigate forward velocity and make small adjustments to the flight path as needed. In general, the sUAS maintained a high level of stability and controllability within the culverts. However, if the aircraft got too close to the culvert lining, a vacuum effect seemed to be produced by the rotors which would pull the aircraft toward the wall. In these instances, the aircraft’s outer cage would drag along the wall until the operator could successfully reorient it. The aircraft remained unimpeded inside the cage and this scenario presented no tangible impact to the safety of the operation. At times, though, it did negatively affect the quality of the video as the camera angle would change somewhat sporadically each time the cage impacted the wall. This situation could be mitigated to a certain extent by constant and proactive operation/navigation of the aircraft.

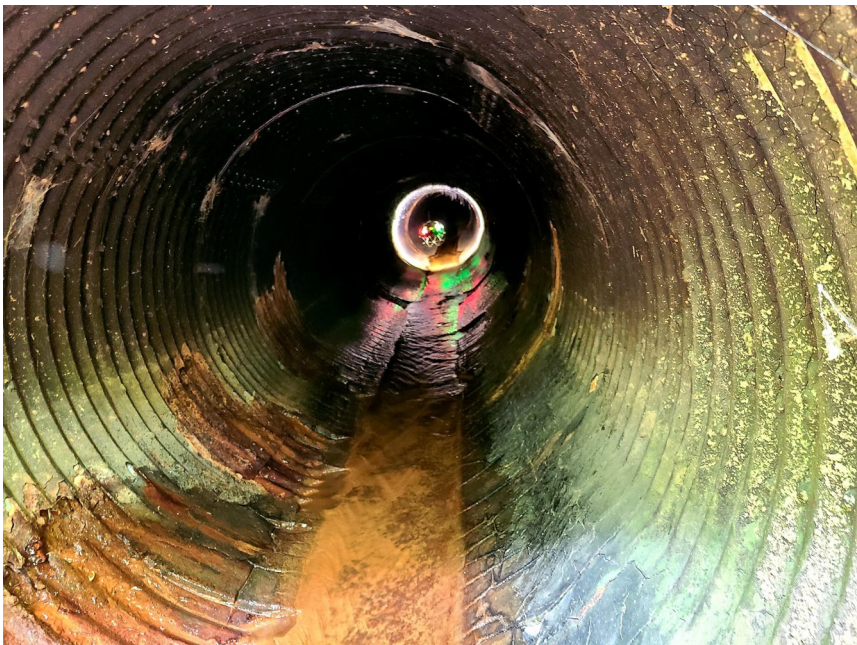
Figure 11. Elios 2 operating inside Pipe 3.

As the team moved from culvert to culvert, it became clear that the Elios 2 was a very capable platform. The video quality was more than adequate for real time inspection work and the aircraft was able to power through any small snags and debris as it slowly floated along. However, certain operational constraints and considerations were observed. First, the aircraft's endurance is limited. The battery only allows for approximately 10-15 minutes of total flight time which translates to just five minutes of flight into a pipe (as the remaining time is needed to safely navigate the aircraft back). This proved to be insufficient to fully exploit the furthest reaches of certain culverts. Additionally, the aircraft performed less efficiently in smaller culverts. For example, while operating in Pipe 4 (Tom Swamp Run Dam, which has a diameter of only 24"), the aircraft was far more likely to get caught in the 'vacuum' effect previously described and would frequently drag along the outer walls. This slowed the progress of the inspection and demanded more performance from the aircraft as it powered through the added friction. Conversely, the added space within larger culverts enabled the operator to achieve higher speeds and more easily avoid any significant obstructions.
