**MARYLAND DEPARTMENT OF  
TRANSPORTATION STATE HIGHWAY  
ADMINISTRATION**

**RESEARCH REPORT**

**ADVANCING GEOTECHNICAL ASSET MANAGEMENT -  
PHASE I**

**MARCH 2024**

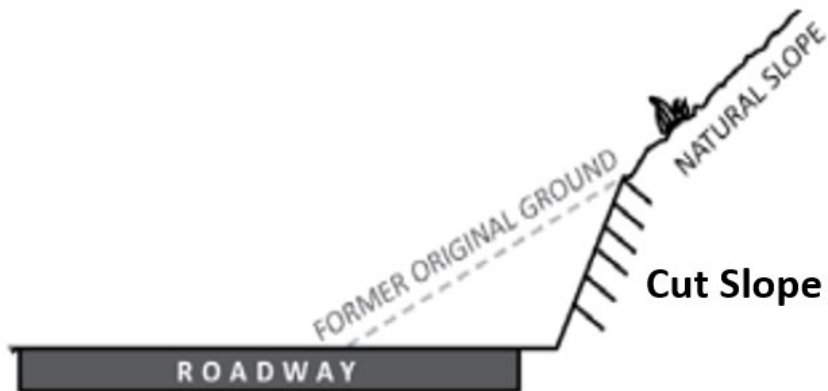
Figure 2: *Cut Slope*

**Cut Slope.** A cut slope asset enables a roadway to maintain an elevation below adjacent ground. The cut slope retains the adjacent soil or rock and maintains vertical separation between the highway and the property above the slope. Cut slopes serve a similar function as retaining walls, except with a flatter slope angle. Two sub-categories of slopes are engineered cut slopes and natural slopes. Engineered cut slopes are permanently excavated into terrain, while natural slopes have been formed through geologic processes such as a river or through other natural means. Engineered cut Slopes can be comprised of soil, bedrock or both. If any bedrock excavation was required to construct the slope, it will be considered a rock cut slope; otherwise the cut slope will be a soil cut slope. The minimum threshold height for a cut slope to be included in the inventory is 10 feet separation from the adjacent grade, unless the cut slope is judged to create an unacceptable hazard to the safety of users and maintenance personnel.

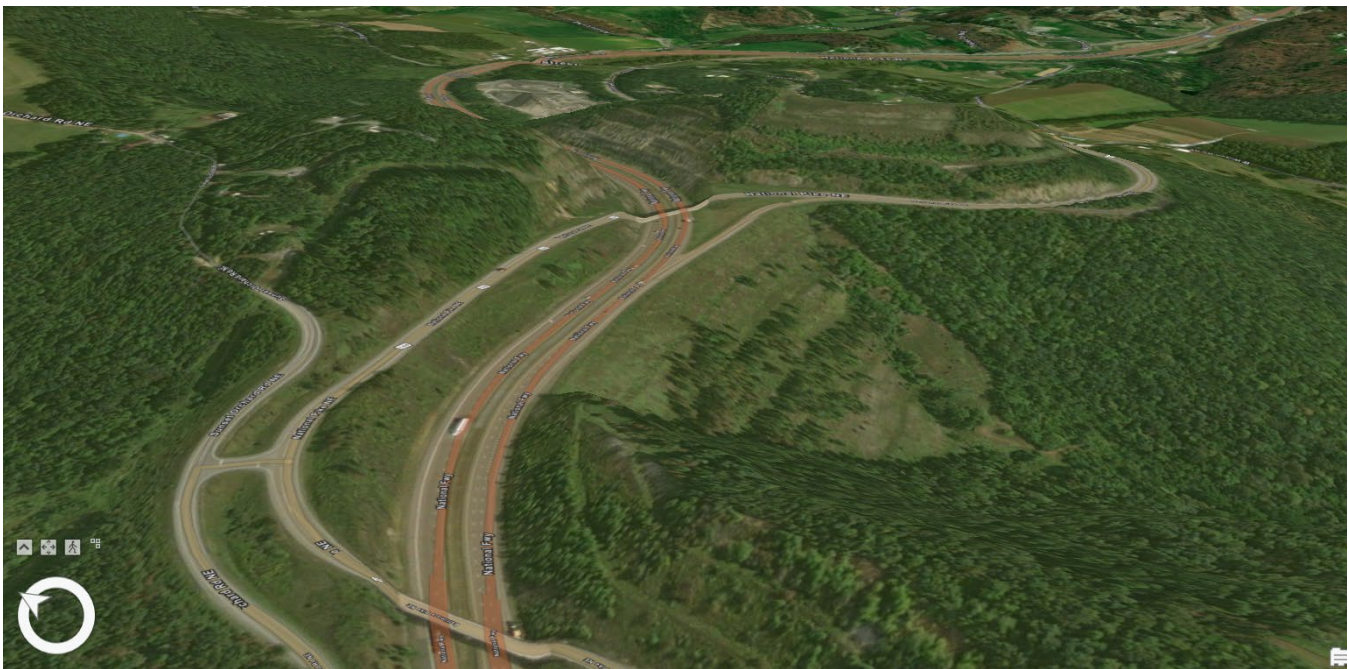
Figure 4: *Aerial Imagery used to discern highways*

ArcGIS Pro was used to develop initial slope inventory using available aerial imagery and lidar elevation data.

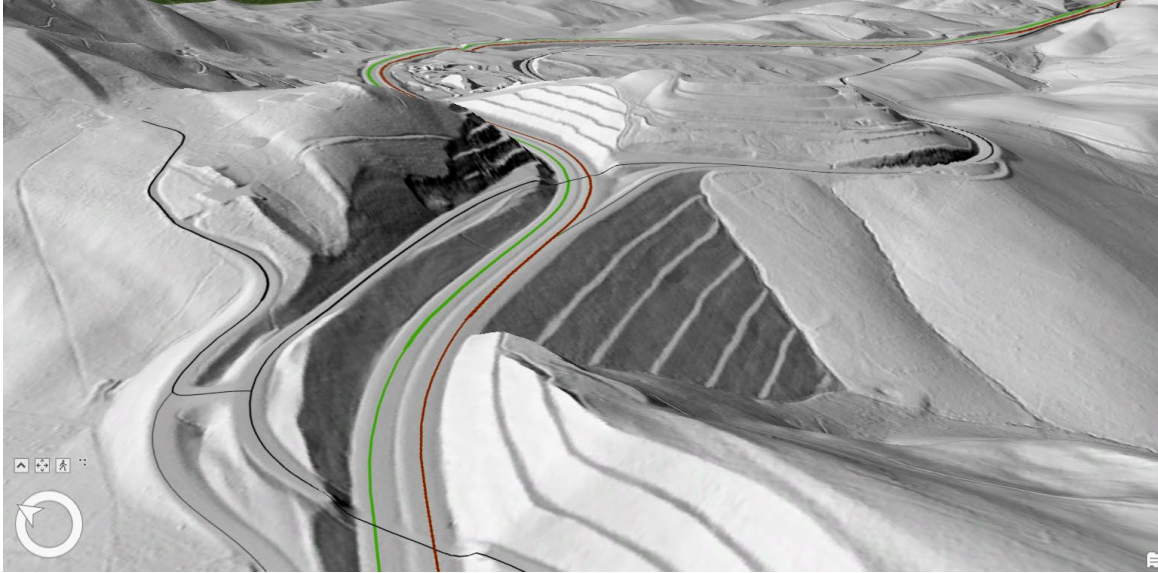
**Figure 5:** Lidar Hillshade, Courtesy of Maryland iMAP, illustrating the digital elevation model used to identify zones of elevation change adjacent to highways

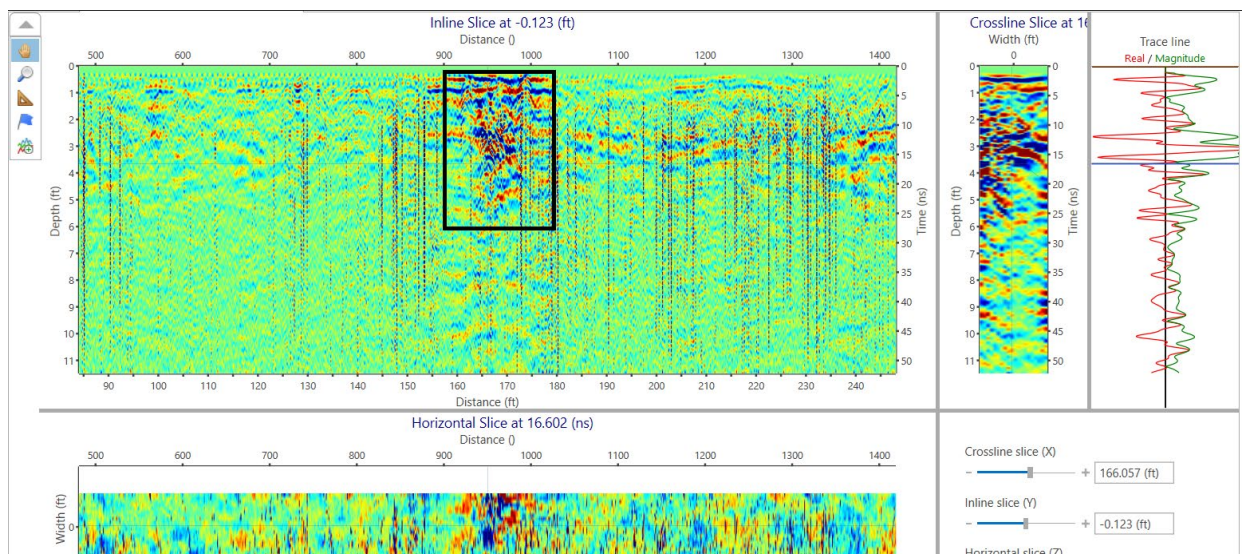
**Figure 12:** GPR Results above void

The following figure is an example of 3D GPR usage to characterize the vicinity of subsurface voids within a granular embankment in 2023. The GPR clarified that only the median shoulder and fast lane were affected by the voids and isolated the region requiring excavation to a depth of 18 feet and pipe replacement. The outside lanes were protected and monitored but were allowed to remain open. New drainage connections were made, and subsurface drainage components were replaced. The excavation was backfilled with controlled low strength material in stages allowing for proactive, rapid ground modification repair work to be done without a sinkhole developing through the roadway surface.

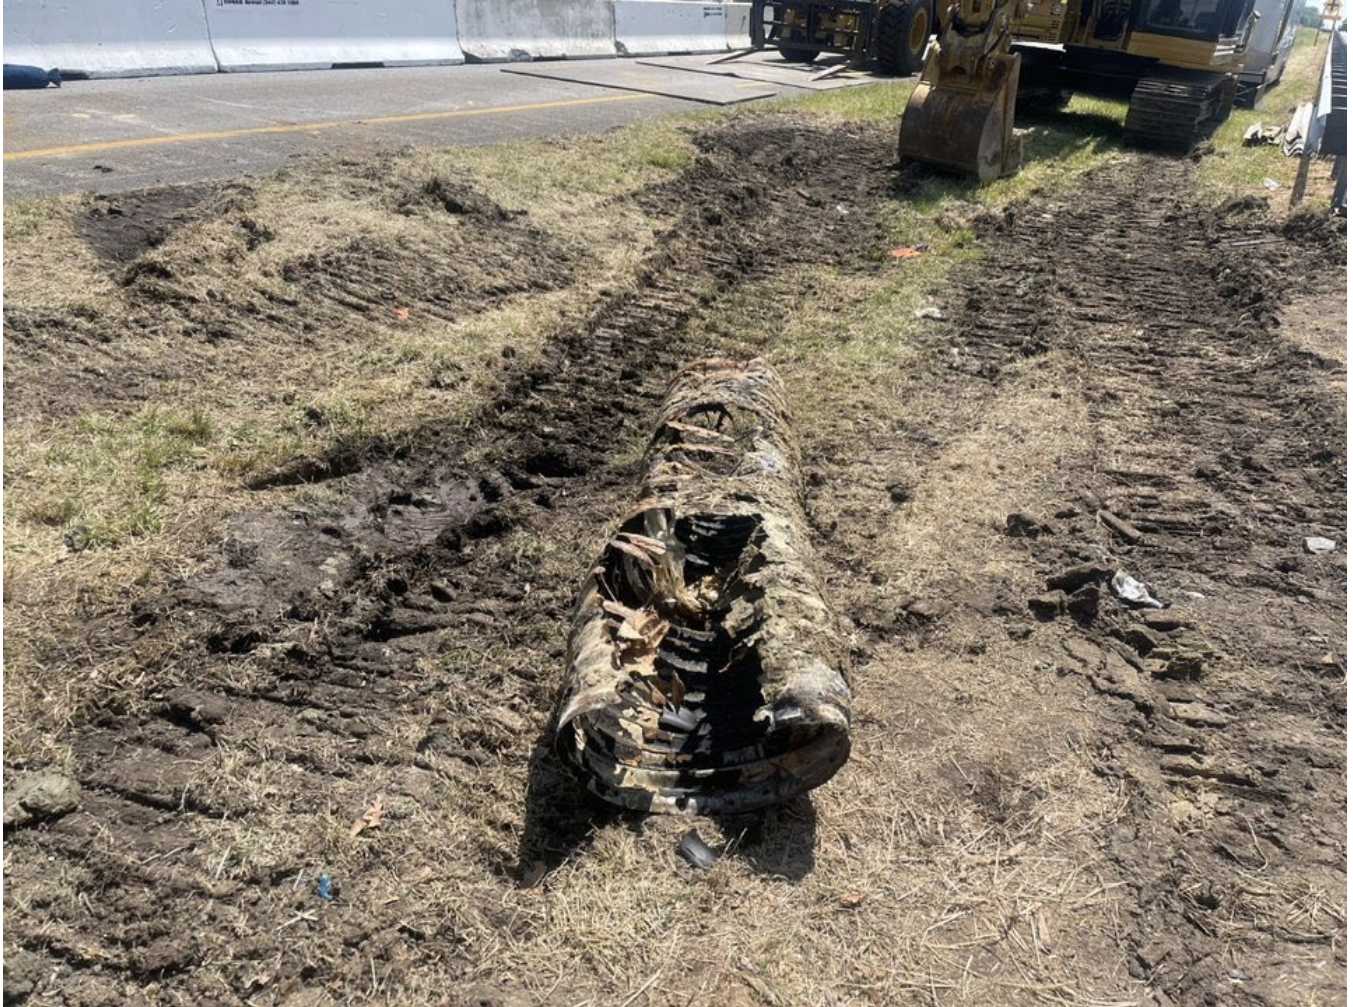
**Figure 13:** *Damaged Corrugated Metal Pipe after Extraction. This pipe was the cause of the subsurface void.*
