# GOVERNOR THOMAS JOHNSON BRIDGE

## Evaluation of Suicide Deterrent Systems

August 2022

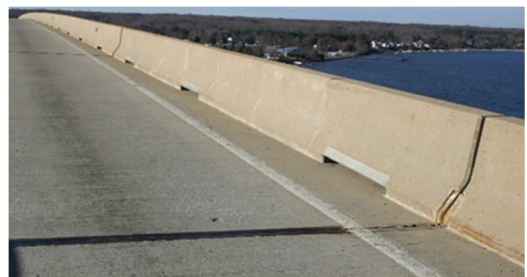
**Figure 2. Existing Bridge Parapet**

The Governor Thomas Johnson Bridge is approximately 1.4 miles long (7,200 feet) and crosses over the Patuxent River and Town Creek. There are two lanes of traffic on the bridge, one each direction, with minimal shoulders and no sidewalks or dedicated bicycle lanes. There are signs on the approaches to the bridge warning of cross winds and that crossing is unadvisable for bikes and mopeds. According to the MDOT 2040 Maryland Bicycle and Pedestrian Master Plan 2019 Update, the bridge is not on a designated bicycle route. The bridge currently has a 2-foot, 8-inch tall, concrete parapet on both edges of the bridge deck, with a 5-foot-tall chain link fence constructed on top of the parapet in some spans (Figure 2).

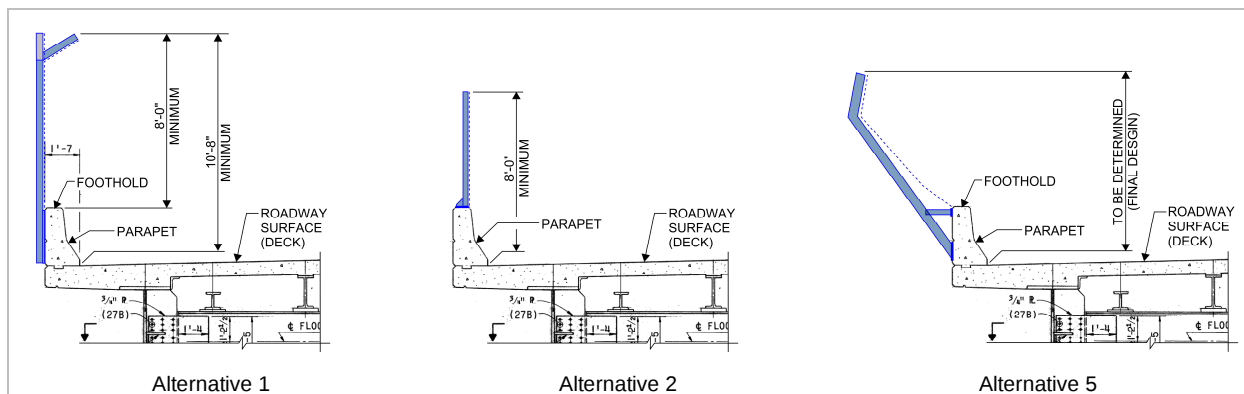
**Figure 5. Alternatives 1, 2, & 5 (Barrier) Conceptual Sketches**

A review of numerous barrier deterrent systems and standard bridge protective fence details indicates that heights vary, but a minimum height of approximately 8 feet is commonly used above the walking or roadway surface, or above any perceived foothold (stepping point). Based on results from a study by Hemmer, Meier, and Reisch, it was determined that barrier suicide deterrent systems be of a height of at least 7.5 feet and secured at their ends to prevent people from climbing around them (Hemmer et al, 2017). Additionally, the barriers are typically developed with anti-climb features and materials, such as an angled return at the top of the barrier and the use of woven wire mesh, that impede the ability of the deterrent system to be scaled. Figure 5 shows the three conceptual suicide deterrent system alternatives that utilize a barrier system. Alternatives 1 and 2 are similar to typical bridge fencing. Alternative 1 is located on the rear face of the existing parapet and set to 8 feet in height from the top of the parapet, since the top of the parapet provides a potential foothold. This alternative provides some additional offset between the SDS and traffic, which provides an opportunity for an anti-climb angled return at the top of the barrier. Alternative 2 is installed on top of the existing parapet and is intended to be detailed such that the top of the parapet cannot be used as a foothold; therefore, the height of the SDS is set at a minimum of 8 feet from the roadway surface. Alternative 5 is intended to be a hybrid between the barrier and netting systems, providing the greatest offset between the SDS and traffic, allowing for an anti-climb return at the top of the SDS, but also limiting the angle and horizontal projection away from the bridge. The height of Alternative 5 is to be further evaluated in final design, if selected.

Alternatives 1, 2 and 5 explore a range of effects on the ZOI. Alternatives 1 and 2 both have an effect on the ZOI, although each to a different degree. Since Alternative 1 is located behind the existing parapet, it has less effect on the ZOI. While still within the ZOI, the risk of damage due to straying vehicles and increased maintenance costs, as a result, are minimized. Alternative 2 has a more substantial effect on the ZOI, however it represents a similar condition to the areas of the bridge where fencing has already been installed on the parapet. Available accident data evaluated between January 2015 and December 2021 indicates there have been no accidents involving the existing fence. Alternative 5, depending on its angle of inclination away from the existing parapet, will likely not have an effect on the ZOI. Alternatives 3 and 4 are outside the ZOI and will have no effect.

The barrier SDS alternatives, Alternatives 1, 2, and 5, will likely be connected to the bridge by utilizing post-installed anchors to positively anchor the SDS to the existing parapet. This method will require drilling into the existing concrete and installing the post-installed anchors (undercut, expansion, adhesive, etc.) per the manufacturers' recommendations. Care will need to be taken to avoid the parapet reinforcement to the full extent possible and the embedded utility conduit. This method of connection will require the removal of any existing fencing prior to installation of the SDS. Alternative 2 will also need to avoid conflict with the existing fence anchor bolts, which may control post locations and spacing. Additionally, repairs may need to be made to the existing parapet prior to installation of the barrier SDS to ensure adequate structural capacity. Refer to subsequent sections.

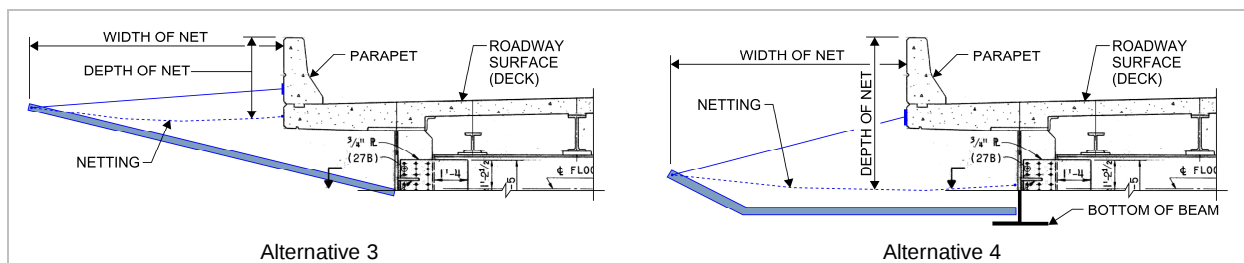
**Figure 6. Alternatives 3 & 4 (Netting) Conceptual Sketches**

The geometry of horizontal netting suicide deterrent systems is based on the depth below the roadway surface (pedestrian level) and the horizontal projection (width) away from the edge of the bridge. Limited information is available on geometric recommendations for netting deterrent systems, as a result, two conceptual alternatives were evaluated to explore the range in depth of netting below the roadway surface. The alternatives in Figure 6 show two netting options, where the net is placed near the roadway surface (pedestrian level) and where the net is placed towards the bottom of the bridge beam (below the roadway surface) but above the USCG navigation clearance envelope.

The bridge superstructure depth (distance from roadway surface to bottom of beam) varies significantly over the length of the bridge. The superstructure depth varies from 4 feet, 6 inches in the approach spans to just over 21 feet, 9 inches in the main span over the navigation channel. Hemmer, Meier, and Reisch recommend that safety nets should lie significantly below the roadway surface (pedestrian level) to deter jumping. As a result of their statistical evaluation, a depth of approximately 13 feet may be required to sufficiently deter jumping. Based on the geometry of the bridge, this distance can only be achieved for Alternative 4 within the main spans. This depth is not readily achieved in the approach spans for Alternative 4 or any of the spans for Alternative 3, considering the net is located above the bottom of the beam. With Alternatives 3 and Alternative 4, particularly where the netting has to be located near deck level due to shallow beam depths, it will likely be possible for a person to climb or jump onto the netting surface, navigate to the edge of the netting, and jump the remainder of the way to the ground or water level. If an individual jumps onto the netting and chooses not to commit suicide, rescue may be required.

The horizontal projection of the netting deterrent system needs to be adjusted to accommodate the distance that the system is located below the roadway surface. The lower the safety net lies below the roadway surface (pedestrian level), the further the net is required to project horizontally from the edge of the bridge (width of net). When measured from the top of the parapet, the longest span of the bridge, not including the vertical haunches of the beams, has a total depth of approximately 16 feet, 8 inches. Analysis shows that if the net system is placed 15 feet below the top of the existing parapet, then the net would conservatively need to project approximately 15 feet from the edge of the bridge deck. The required projection will have implications on the operations and maintenance needs of the bridge.

The netting SDS alternatives, Alternatives 3 and 4, will likely need to be connected directly to the steel and prestressed concrete beams, avoiding conflicts with existing floorbeams and diaphragms in the steel girder spans. This is a disadvantage for these alternatives, as drilling into prestressed beams is typically not recommended and may not be possible. Some of the prestressed beams have been previously repaired with fiberglass wrapping which will also need to be accounted for when considering the connections. Drilling holes into the steel girders is feasible but may not be recommended due to fatigue sensitive details present on the bridge and the fracture critical nature of some of the spans. Additionally, if the bridge's existing paint contains lead or other hazardous materials, drilling into the existing steel members will require containment and/or special equipment, increased worker health and safety protocols, and stringent requirements related to the disposal of any wastes generated by these operations. Furthermore, the netting system's cable connection to the existing concrete parapet or deck would likely necessitate the use of post-installed anchors in sustained tension, which is an undesirable loading condition. Repairs may need to be made to the existing parapet / superstructure prior to installation of the netting SDS to ensure adequate structural capacity. Refer to subsequent sections.

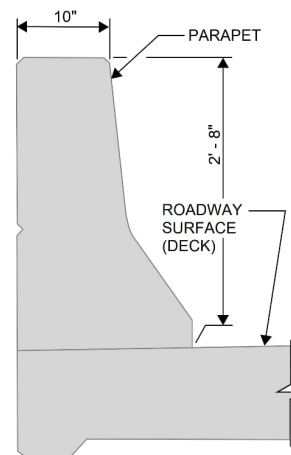
**Figure 7. Existing Parapet Dimensions**

The existing concrete parapet is 2 foot, 8 inches in height, measured from the roadway surface (Figure 7). The existing parapet was designed in accordance with the AASHTO Standard Specifications for Highway Bridges and is intended to perform as a vehicular protection system only. There is a 5-foot-tall chain link fence installed on the top of the existing parapet in some spans between Abutment A to Pier 5 (both sides), Pier 11 to 13 (north side only), Pier 19 to 34 (both sides), Pier 48 to 49 (south side only), and Pier 49 to 54 (both sides). The existing bridge deck overhang is typically 3 foot, 7 inches measured from the edge of deck to the centerline of the exterior beam. The deck overhang increases to 4 foot, 7 inches in Spans 39 to 41.

Structural evaluations utilizing AASHTO Standard Specifications for Highway Bridges, 2002 (AASHTO Standard Specifications) were performed to assess the adequacy of the existing parapet to deck connection and the bridge deck overhang under existing conditions and when subjected to the additional enveloped loads associated with the installation of the proposed barrier suicide deterrent systems (Alternatives 1, 2, and 5).

The evaluation of the existing parapet to deck connection included a combination of self-weight, the AASHTO Standard Specifications 10-kip (10,000 lb) railing load for which the existing parapet was likely designed, and wind load applied to both the parapet and the SDS. The wind load applied to the SDS included the effect of ice accumulation. Preliminary analysis based on the as-built condition of the existing parapet found adequate capacity to resist the additional SDS loads.

The evaluation of the existing deck overhang included a combination of self-weight, the AASHTO Standard Specifications 10-kip (10,000 lb) railing load or HS-20 truck wheel loading, and wind load applied to both the parapet and the SDS. The wind load applied to the SDS included the effects of ice accumulation. Preliminary analysis based on the as-built condition of the existing bridge deck overhang found adequate capacity to resist the additional SDS loads.

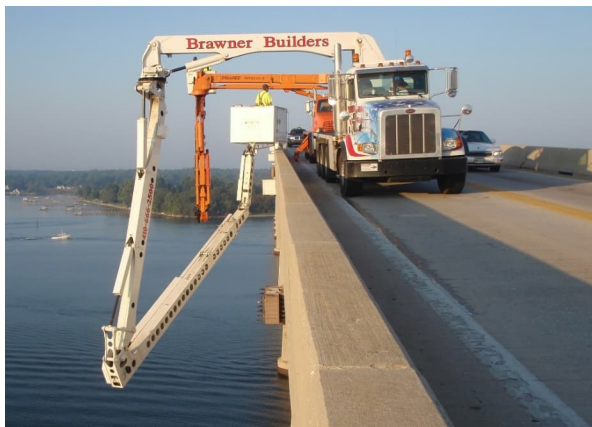
Figure 8. Under-Bridge Inspection Vehicle

The under-bridge inspection vehicles utilized to inspect the bridge provide the ability to clear obstacles in excess of 10-foot, 0-inch up to 15-foot, 0-inch, when measured from the roadway surface. See Figure 8 for an example of an under-bridge inspection vehicle currently used on the Governor Thomas Johnson Bridge. The tallest barrier alternative is preliminarily proposed at 10-foot, 8-inches above the roadway surface, therefore each of the SDS barrier alternatives evaluated are within the limits of the inspection vehicles. The Aspen Aerial A62 under-bridge inspection vehicle, which has an 11-foot maximum fence clearance, is used to inspect the fracture critical spans. Clearance over the tallest conceptual SDS barrier may be very close with this equipment but possible. The bridge superstructure depth varies along its length, which adds additional complexity to the inspection. Inspections

following the installation of the barrier suicide deterrent system can be performed without major changes to current practice in most spans; however, the inspection of the fracture critical spans will prove to be difficult or impossible without modifications to current practice. The total duration that the inspection takes may need to increase to allow for additional time to maneuver under some of the deeper spans and to prevent accidentally damaging the SDS. Full inspection of the fracture critical spans becomes increasingly difficult in the vicinity of the deeper girders in these spans. Even without the installation of the SDS, there are difficulties accessing some of the fatigue sensitive details and fracture critical elements for hands-on inspection in these spans. Currently, the boom for the under-bridge

inspection vehicle must be lowered to just above the existing parapet to reach some of the inner-most fatigue sensitive details. The addition of any SDS barrier in these fracture critical spans will make this maneuver, and as a result, the hands-on inspection of these elements not possible under current practices. However, some of these limitations could be mitigated through the use of special SDS design details and / or alternative methods of inspection, as follows:

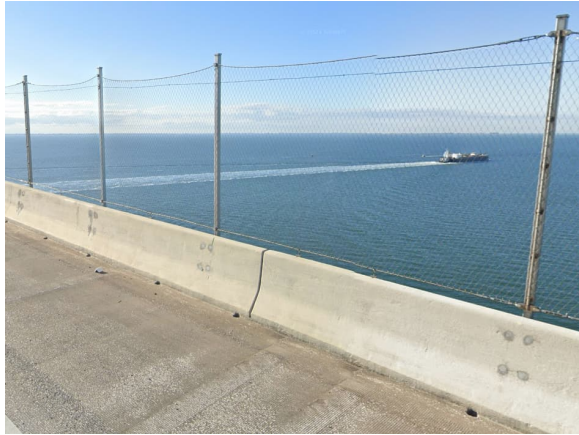
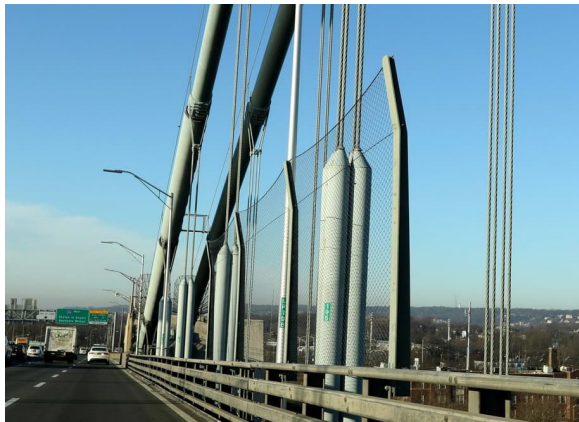
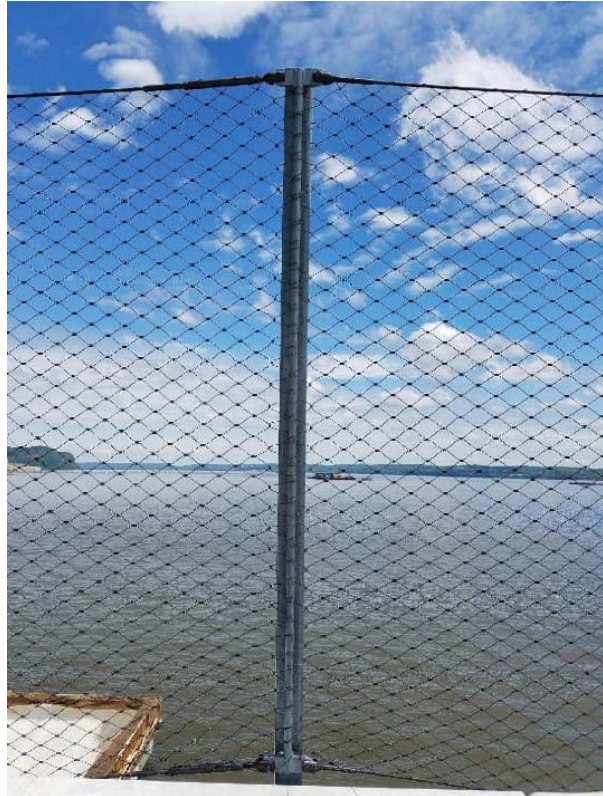
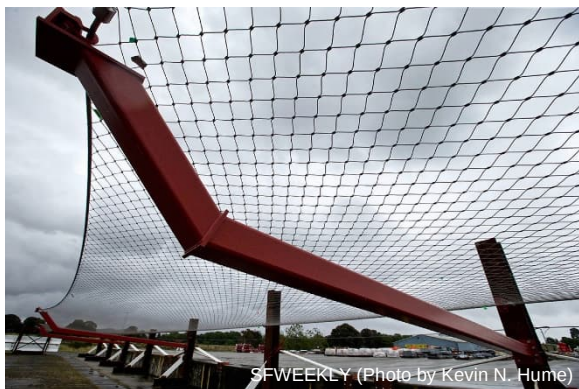
Suicide deterrent systems often implement the use of durable, lightweight, woven stainless-steel wire mesh with mesh openings sized to be resistant to climbing. The wires comprising the mesh are generally only 1.5mm to 2mm in diameter, making the mesh highly transparent, and thus reducing the impact to views from the bridge.

Woven stainless-steel wire mesh has recently been implemented on the suicide deterrent systems or access restriction barriers of several high-profile, long-span bridges, including the Sunshine Skyway, Verrazano Narrows, Golden Gate, and Tappan Zee Bridges (refer to Figure C1, Figure C2, Figure C3, and Figure C4 respectively).
